Safety issues related to free-fall lifeboats

The Australian Maritime Safety Authority (AMSA) issued a Marine Notice alerting the maritime industry to findings of two recent accident investigations conducted by the Australian Transport Safety Bureau (ATSB) and the New Zealand Transport Accident Investigation Commission (TIAC). These investigations have highlighted ongoing safety issues related to free-fall lifeboats and identified maintenance issues that the maritime industry should be aware of.

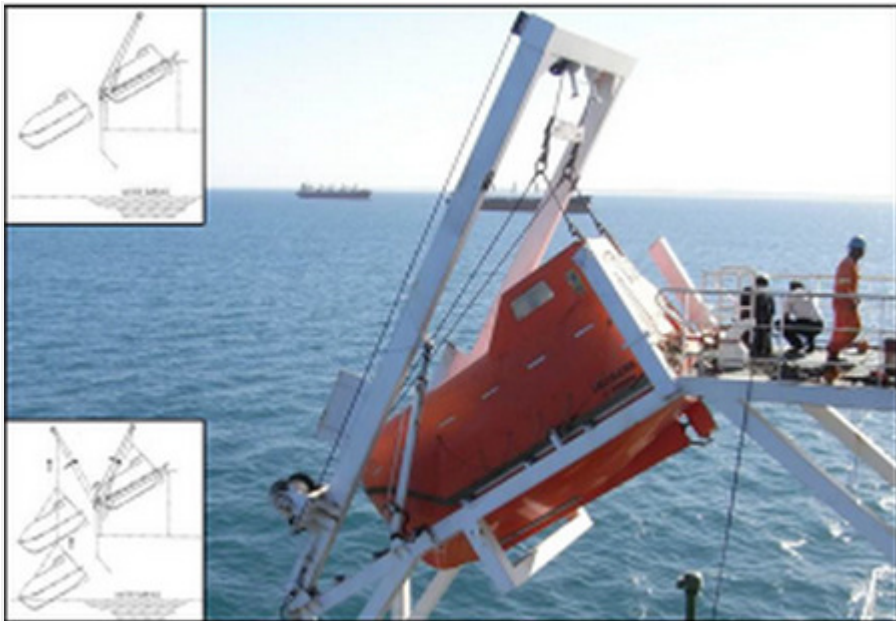
The incidents: Aquarosa (IMO No. 9506708) – On 1 March 2014, Aquarosa's free-fall lifeboat was inadvertently released during a routine maintenance inspection while the ship was en route to Fremantle, Western Australia. One crew member was injured in the incident and it took 5 hours for the crew to recover the lifeboat.

Aquarosa's Free-fall Lifeboat arrangement

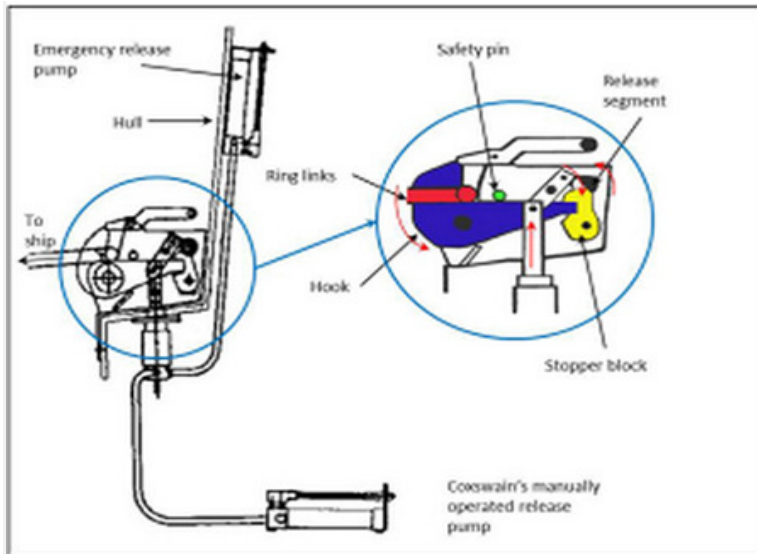
Aquarosa's free-fall lifeboat release system

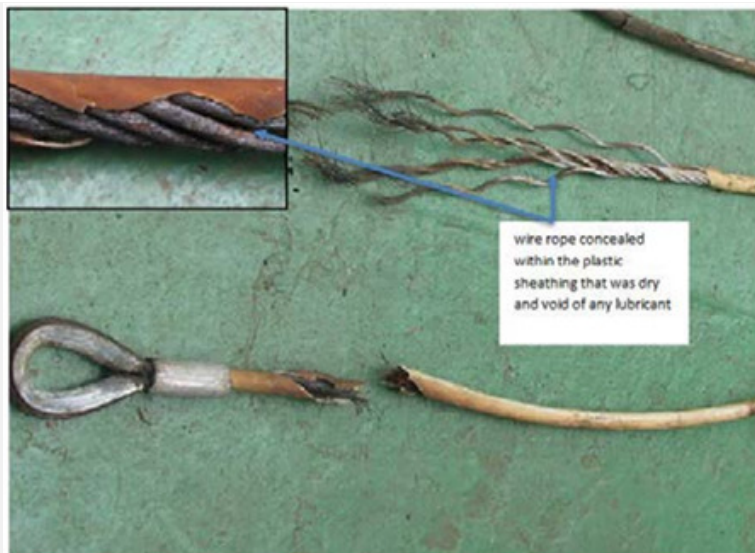
Da Dan Xia (IMO No. 9451290) – On 14 April 2014, the wire lifting sling for the ship's free-fall lifeboat failed catastrophically during recovery of the lifeboat after a routine launching exercise in Wellington, New Zealand. This resulted in the lifeboat falling several metres into harbour waters. One crew member was injured, and the lifeboat launching davit was rendered unserviceable. The ATSB identified that the Second Engineer accidentally activated the lifeboat's on-load release mechanism while carrying out a test procedure. When the Second Engineer cycled the hydraulic system, the retaining hook was released allowing the lifeboat to move down the launch ramp. The ATSB found that the hydrostatic on-load release mechanism hydraulic cylinder ram had not fully retracted after use, preventing the stopper block from resetting correctly. This left the release hook in a partially disengaged position. The ATSB noted that the design of the release mechanism cover plate prevented visual confirmation that the hook was correctly reset. The lifeboat was fitted with simulation wires to prevent it from launching under these circumstances. However, on this occasion, the simulation wires failed allowing the lifeboat to move down the guide rails into the sea. The ATSB found that the simulation wires failed due to a combination of incorrect installation and cumulative internal wear from numerous shock loading events that resulted from previous lifeboat launching drills.

Incident analysis – Da Dan Xia TAIC identified that the wire pennants parted under tensile overload. Subsequent testing confirmed that the sling wires had been significantly weakened by severe corrosion. This corrosion had gone undetected inside a plastic sheathing that the manufacturer had fitted to the wire. The sheathing prevented the crew from identifying the corrosion and did not allow for lubrication or the application of other corrosion-inhibiting substances. The crew were also unaware of the necessity for greater vigilance and the application of anticorrosive substances during inspections. TAIC found that the wires were of adequate strength when manufactured, but that the sheathing allowed saltwater ingress, aiding corrosion by retaining water, and prevented external observation.

Examples of the damage to Da Dan Xia's wire slings after failure

AMSA continues to observe numerous defects and deficiencies related to ship's lifeboats and liferafts. This is difficult to understand given the IMO and AMSA focus on risks associated with the incorrect operation and maintenance of survival craft. Wire failure was the critical factor in both the Aquarosa and Da Dan Xia incidents. This highlights the importance of: Ships' crews following established maintenance procedures and being vigilant and observant during all maintenance tasks. The examination of maintenance procedures to ensure they are effective. Effective crew familiarization and training, to minimize risk when crew are conducting test procedures and training drills. AMSA inspections Marine Notice 2/2014 highlighted the requirement for additional restraints to be installed on lifeboats during AMSA inspections. This requirement is a control mechanism that AMSA has implemented to reduce the AMSA inspector's exposure to risk. It is recommended that these restraints be used anytime maintenance is being carried out on lifeboats. The continued cooperation of all owners, operators and masters is appreciated.
