I. Description of Third Quarter 2016 PSC Inspections

1. General situation of third quarter 2016 PSC inspections of CCS classed ships

Classed Ship in Service Dept. of CCS Headquarters

October 12, 2016

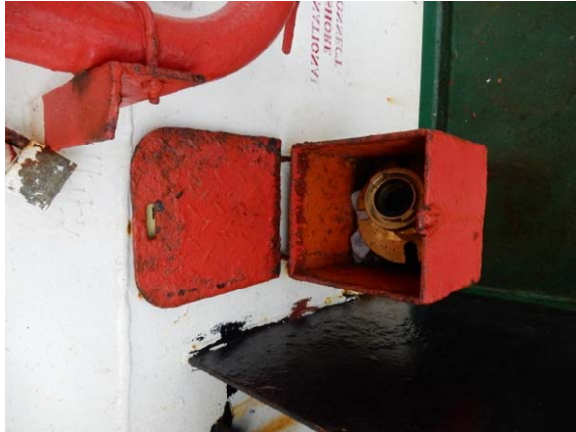
International shore connector for fire-fighting is not placed in the right position (rectified)

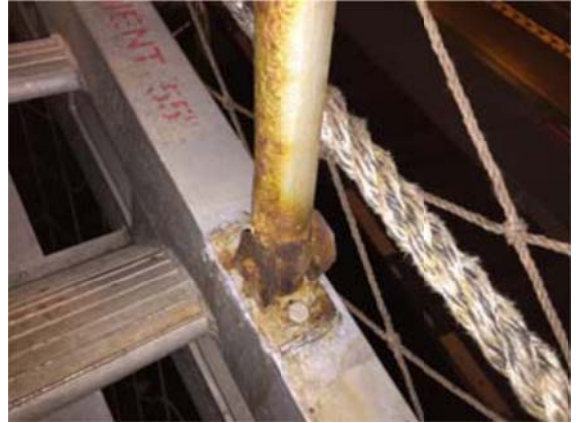
Corrosion exists at the column root of accommodation ladder

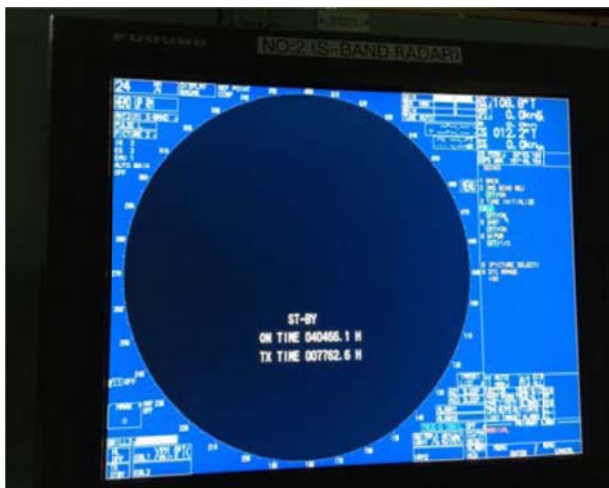
The actual service time of radar magnetron exceeds the time specified in the Product Specification

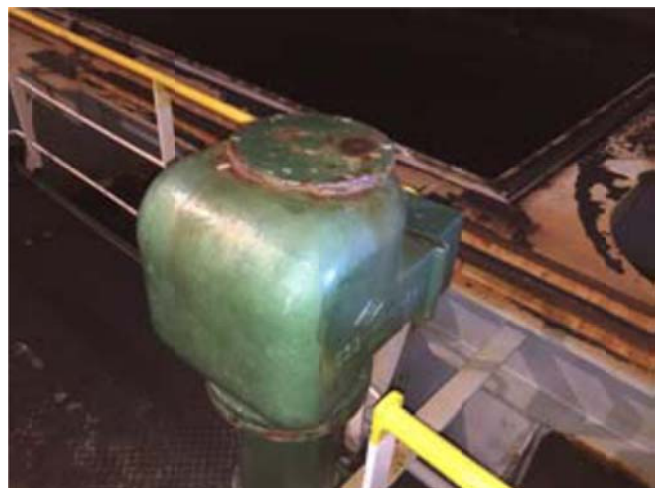
Cover on the top of air pipe head is corroded heavily

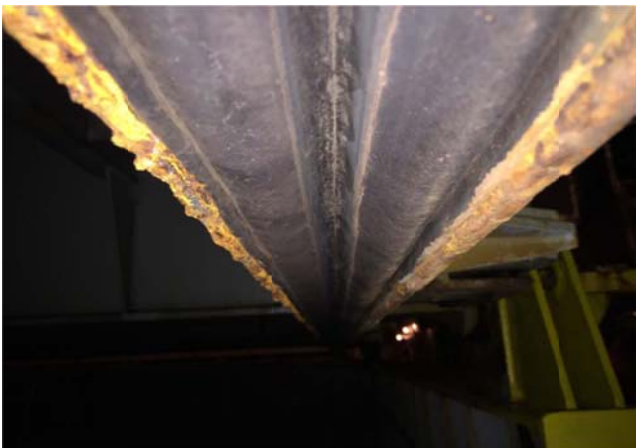
Sealing rubber strip of hatch cover is found with permanent

depression due to severe squeeze.

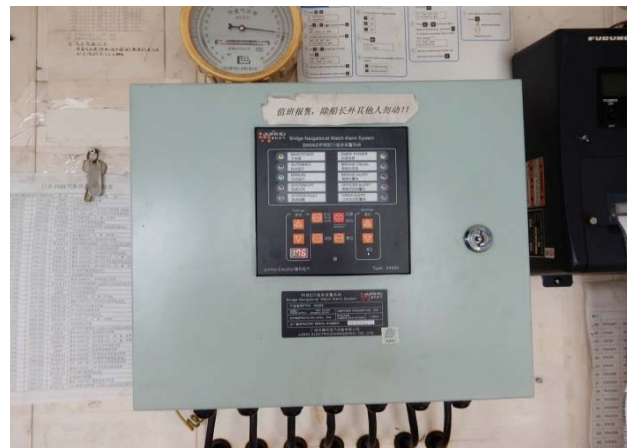
Crew members are not familiar with BNWAS operation

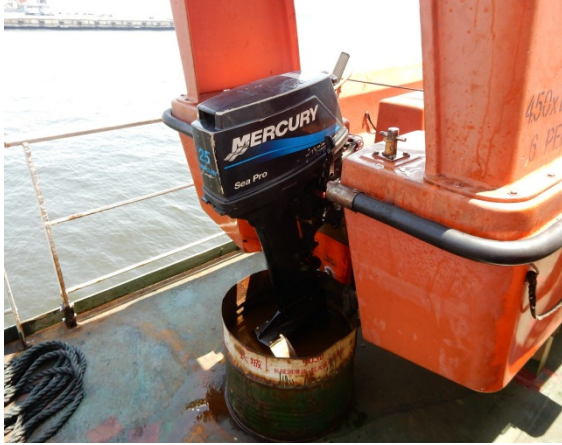
Rescue boat engine cannot start

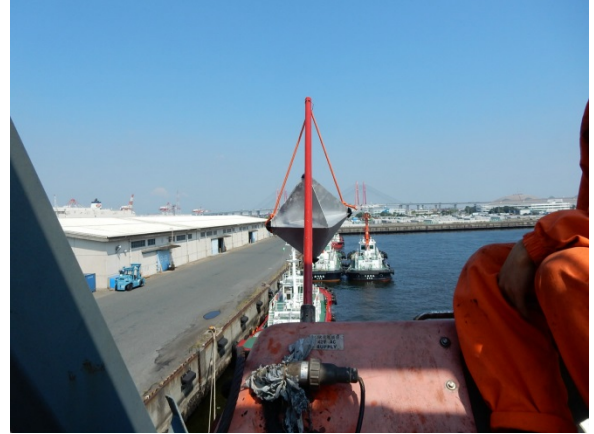
Crew members are not familiar with radar reflector

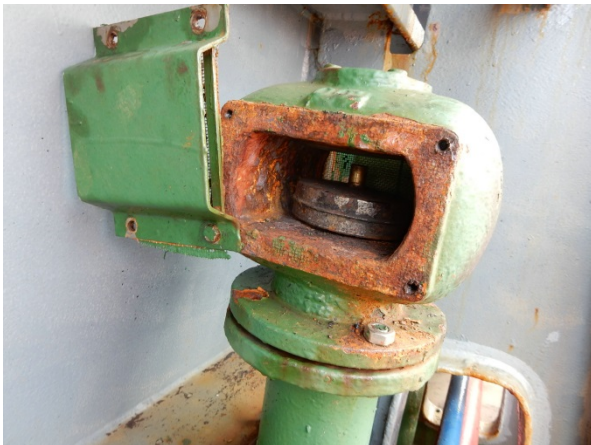
Float inside the air pipe head isn't active

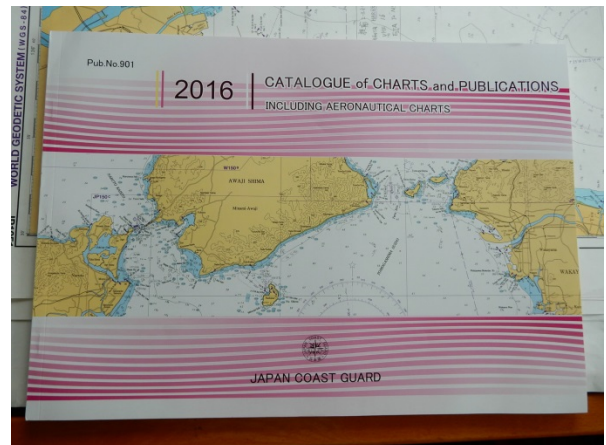
Lack of nautical charts in Japanese version (for ships sailing to Japan)

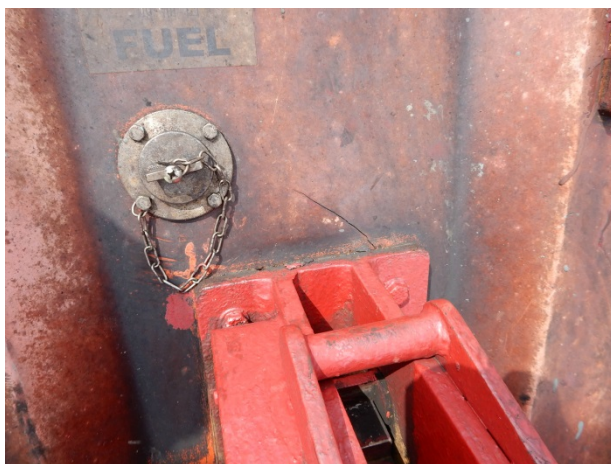
Cracks exist inside the lifeboat

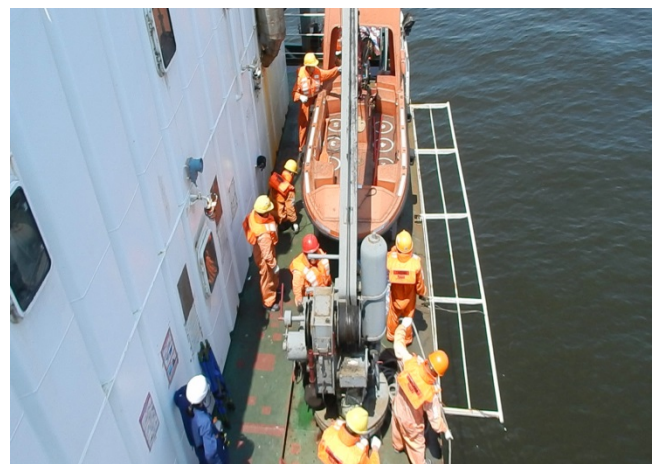
Not familiar with abandonment/rescue drills

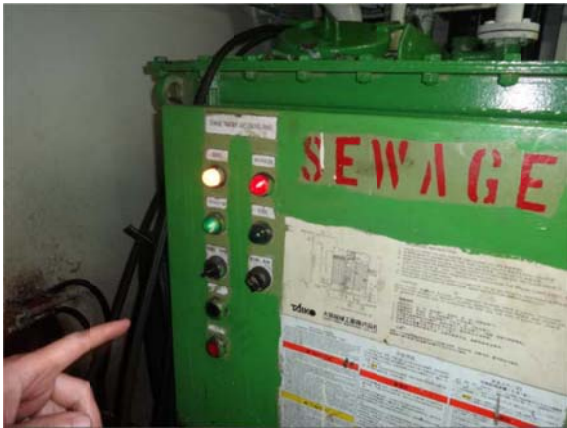
Sewage treatment unit hasn't been used for a long time

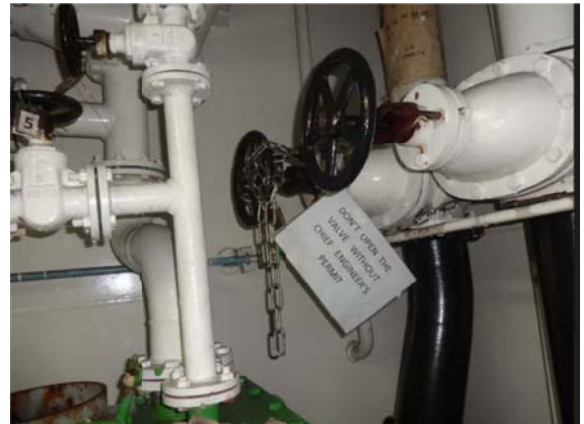
Sewage discharge valve is closed in the open position when the ship is within the port

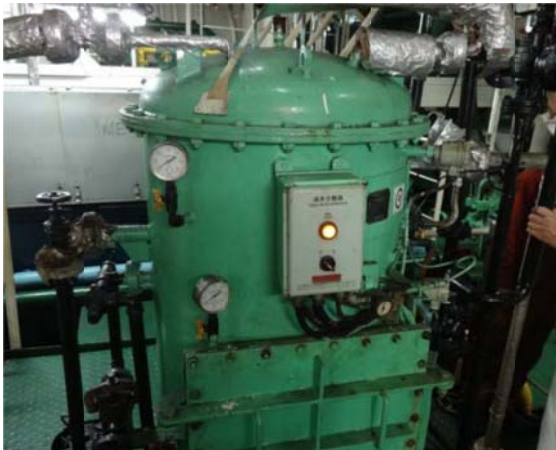
Oil-water separator of engine room hasn't been used for a long time

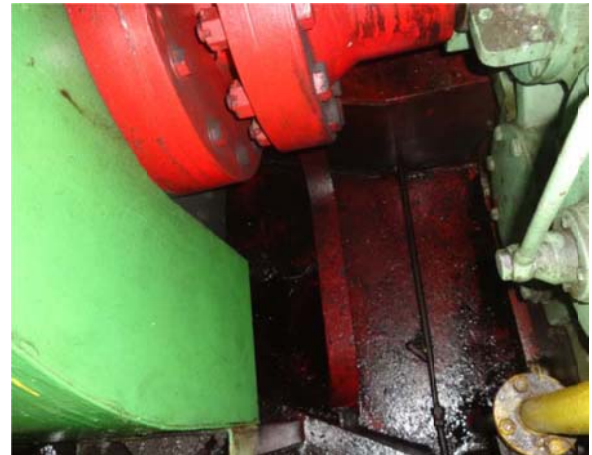
Heavy oil stains exist on the bilge

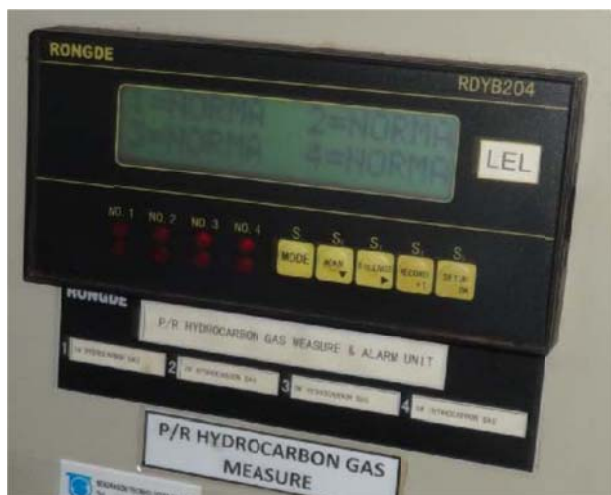
Pump gas detectors malfunction

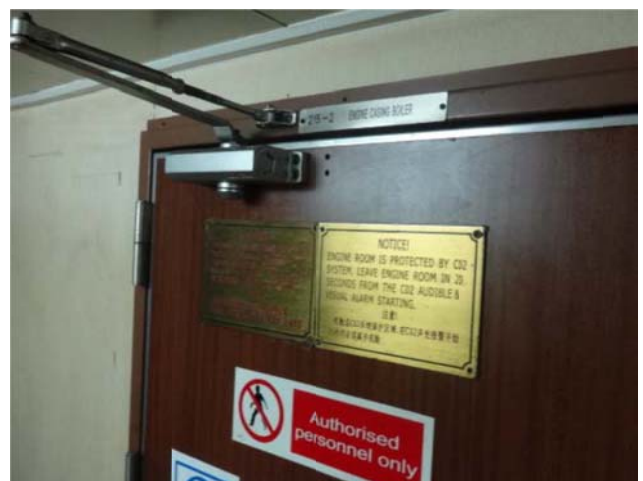
Fire-resisting door cannot be closed

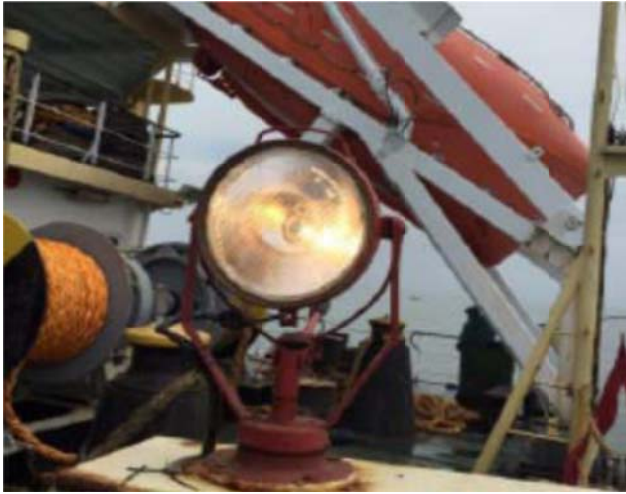
Emergency lighting does not work (repaired)

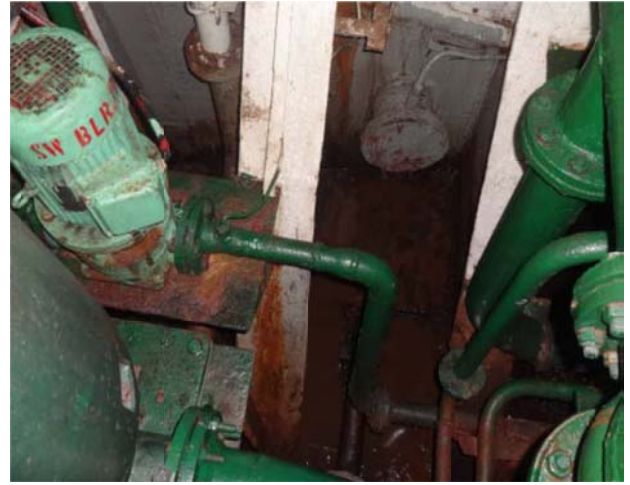
Water pump leaks

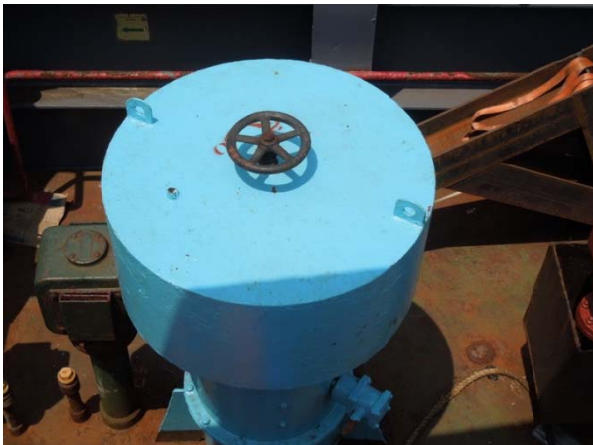
Ventilator cannot be closed

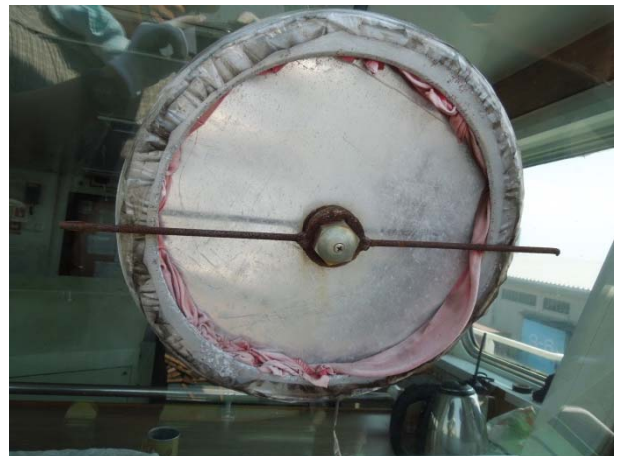
Bridge window wiper is damaged

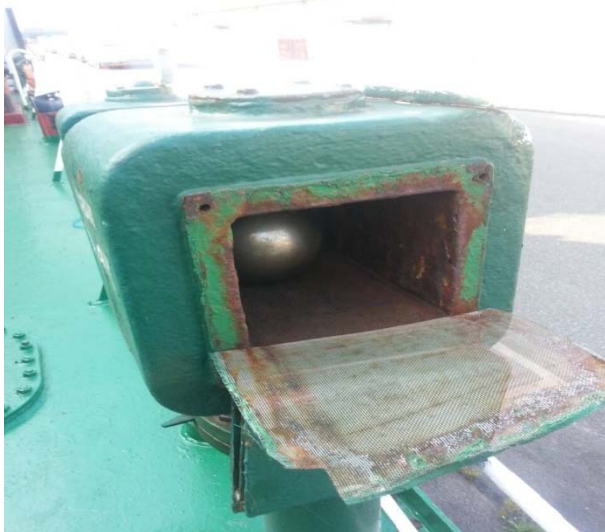
Air pipe heads malfunction

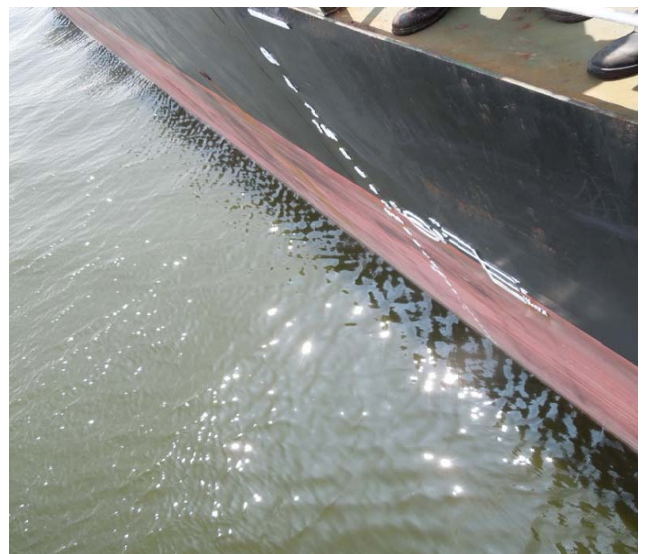
Load line mark isn't clear (repainted)

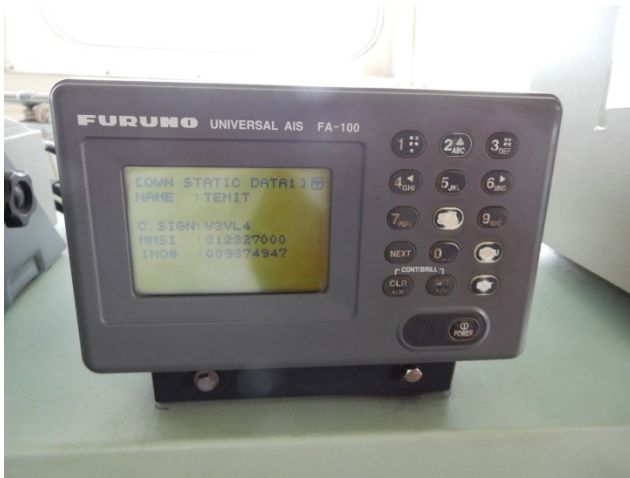
Crew members are not familiar with AIS operation

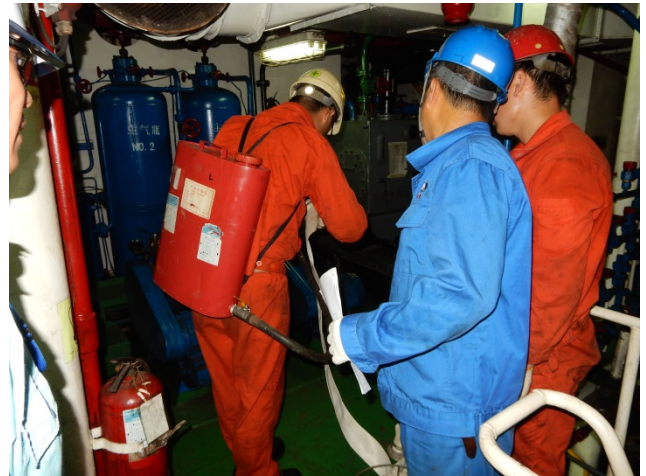
Crew members are not familiar with operation of foam extinguishing equipment

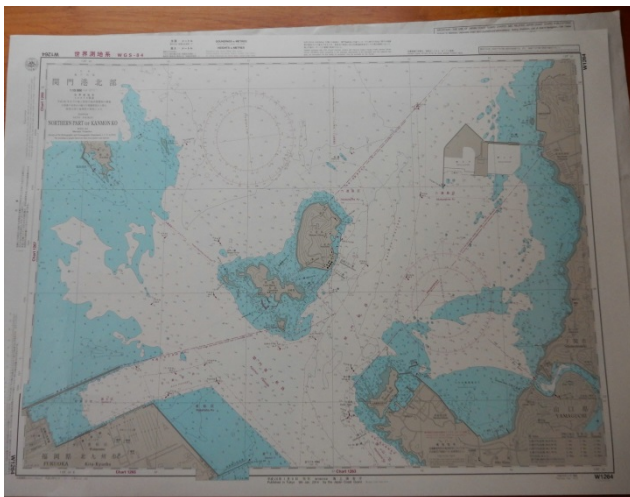
Lack of nautical charts in Japanese version (for ships sailing to Japan)

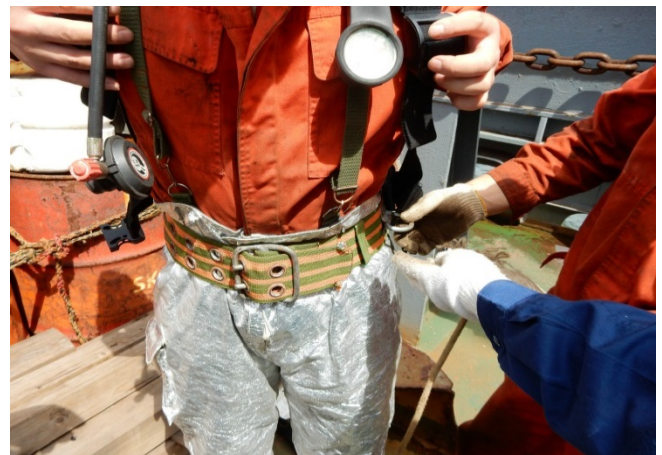
Crew members are not familiar with wearing fireman's outfit

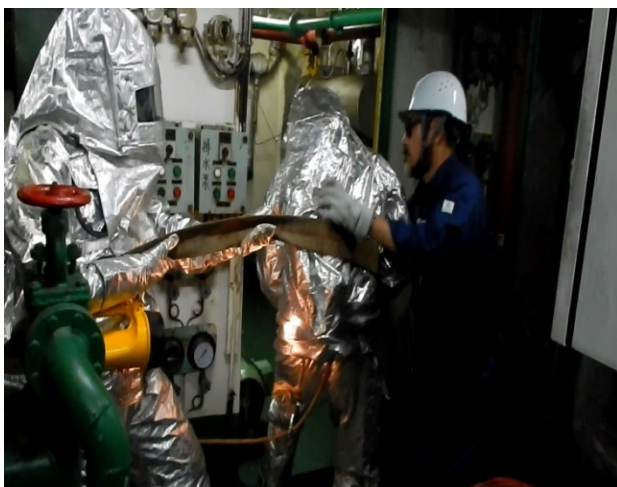
Not familiar with fire drills; senior officers are not familiar with their duties during the drills

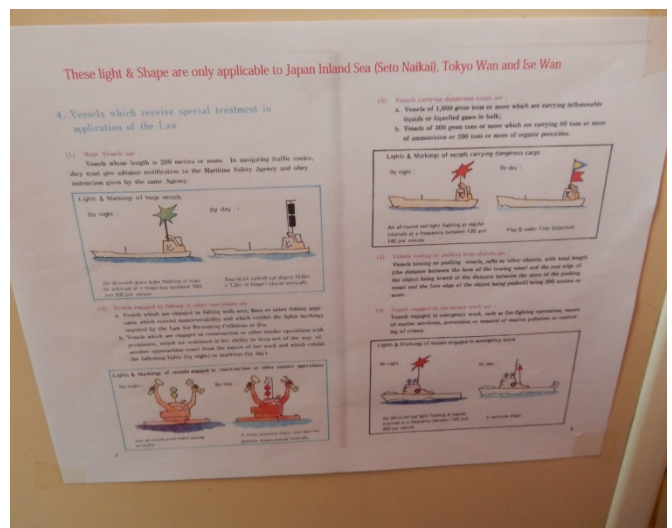
Senior officers have no idea of the meaning of navigation lights and shapes of Japanese waters

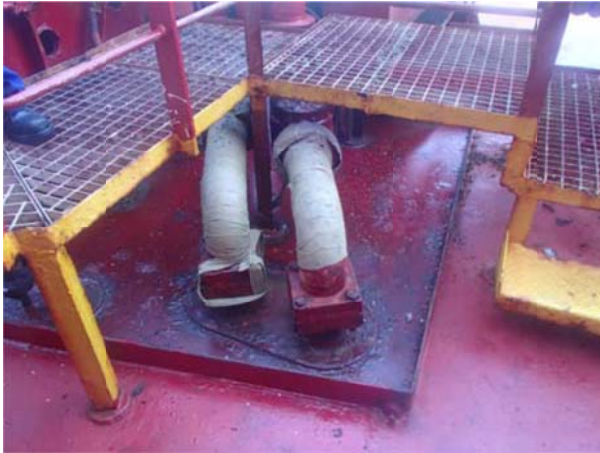
Oil from drip tray of mooring winches leaks through the oil drain plug

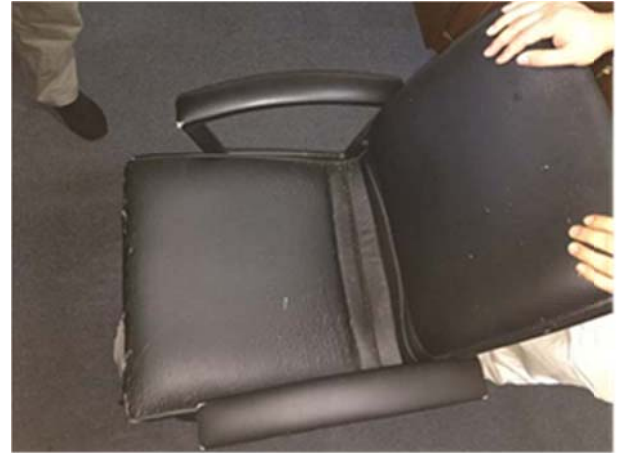
Surfaces of chairs and sofa are damaged

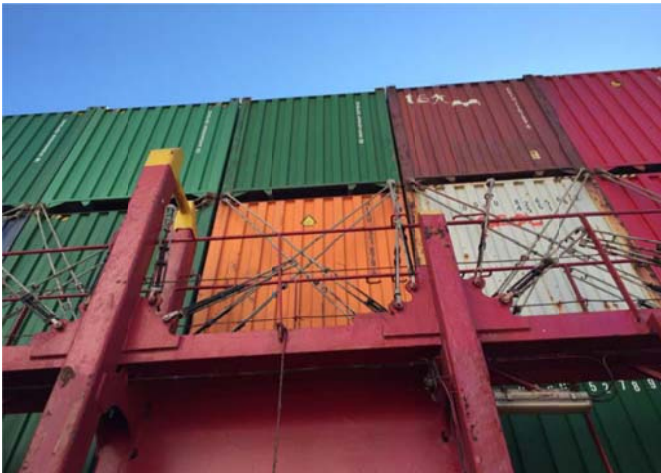
Containers are not effectively secured during navigation (before arriving at port)

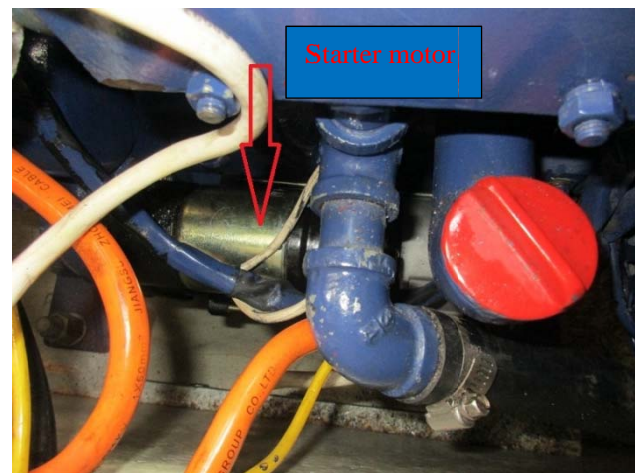
Starter motor of lifeboat engine malfunctions
