(Data as of June 30, 2016)

I. Conditions of PSC inspections for the second quarter of 2016

Periodic Brief Report on PSC Information for the Second Quarter of 2016

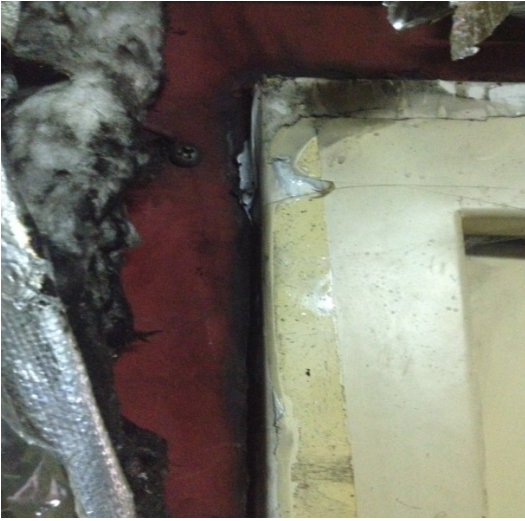
requirement; 4. Davit for rescue boat: limit switch out of work and can not operated with second power as required; 5. Fire door frame of emergency escape trunk heavily corroded and have a gap about 10mm through out from E/R to escape drums; 6. Publications: admiralty tide table (NP205-16); Ocean passage for the world; ISM Code, FSS Code, ISPS Code, LSA Code, COLREG 72 not available on board.
--	--	--	--	--

Light Coming from Gap between Fire Door Frame and Bulkhead (Riveted Door and Bulkhead)

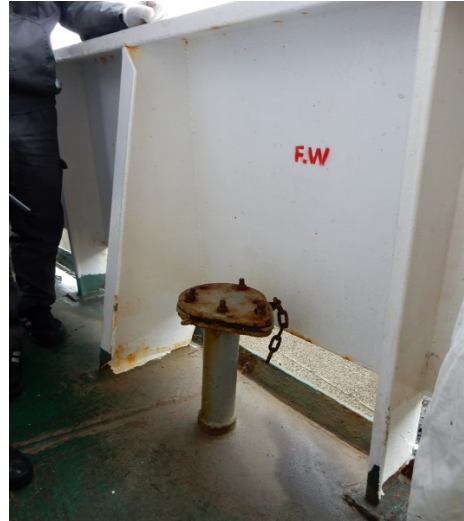
Serious Rusting of Water Filling Nozzle Cover of Fresh Water Tank

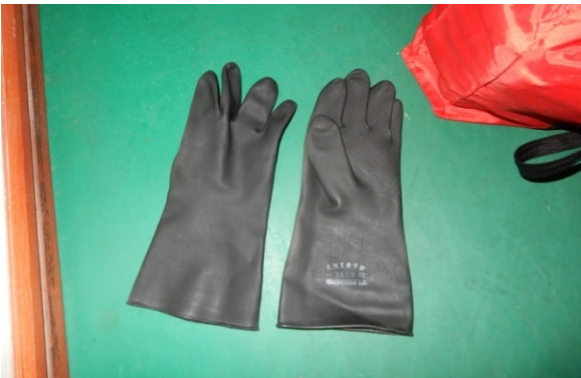
Chemical Protective Gloves Not Meeting Requirements

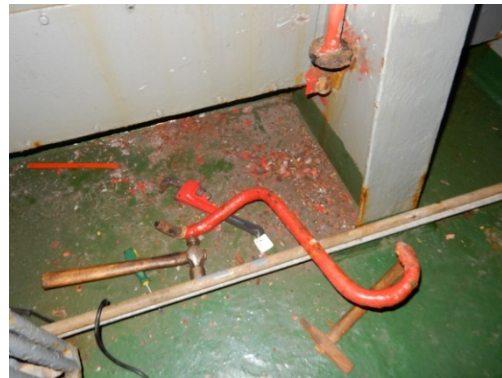
Rusting and cracking of Extinguishment CO₂ Pipe for Cargo Holds

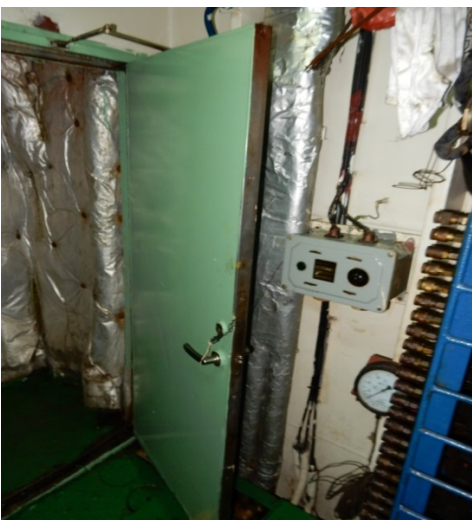
A60 Fire Door for Escape Tunnel Fastened by Ropes at Open Status

- Many ships are subject to deficiencies or even detention due to bad habits of crew members, such as the fire door is fastened in the open position, the tank sounding hole was kept abnormally open, the closing of quick closing valve is limited, the oily wastes and household garbage are discarded at will, the switches of emergency equipment and navigation equipment are not set at normal or automatic positions, and the overboard discharge valve of domestic sewage is not closed within a port. It is suggested that the companies strengthen the publicity and education to reduce the deficiencies or event detention due to bad habits of crew members.

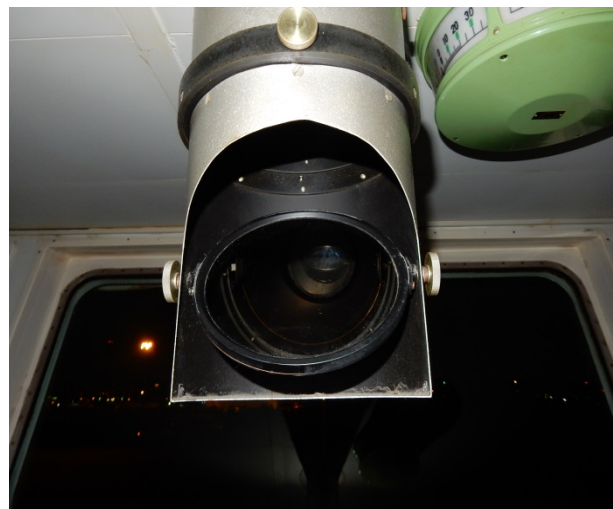
Insufficient Magnetic Compass Light Intensity and Unclear Reading

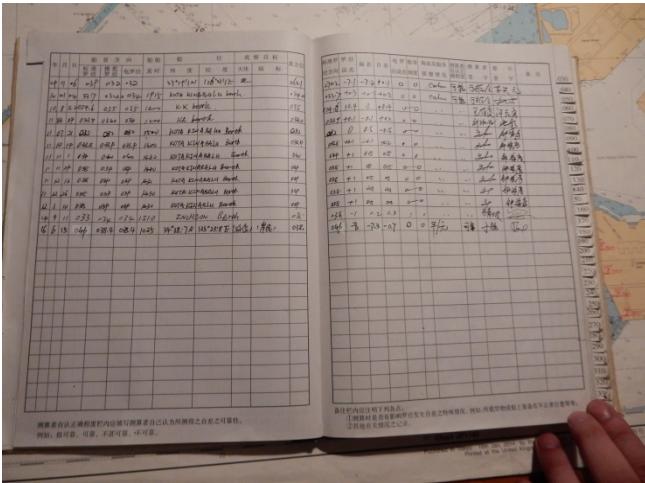
Crew Members Not Checking and Recording Magnetic Compass Accuracy as per Requirements

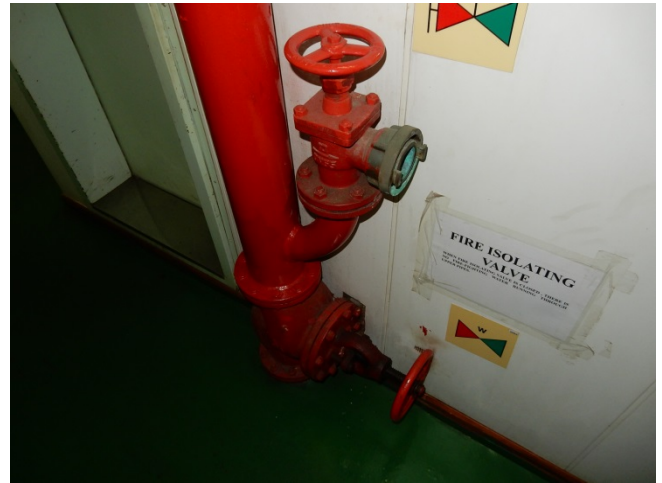
Crew Members Not Familiar with Position of Isolating Valve for Fire Main Pipe

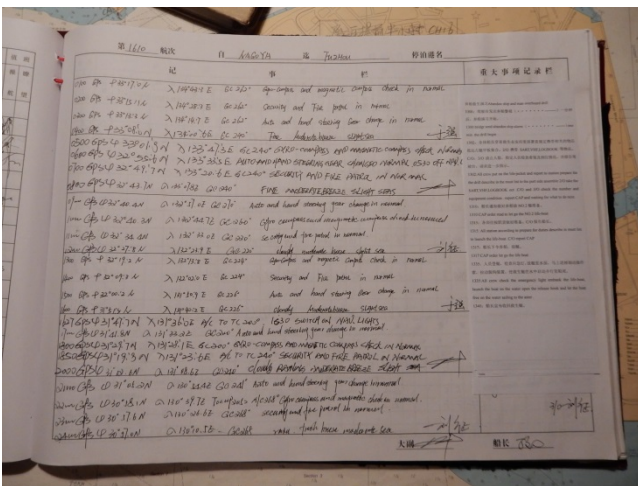
Logbook Indicating Drills and Launching during Ship Navigation

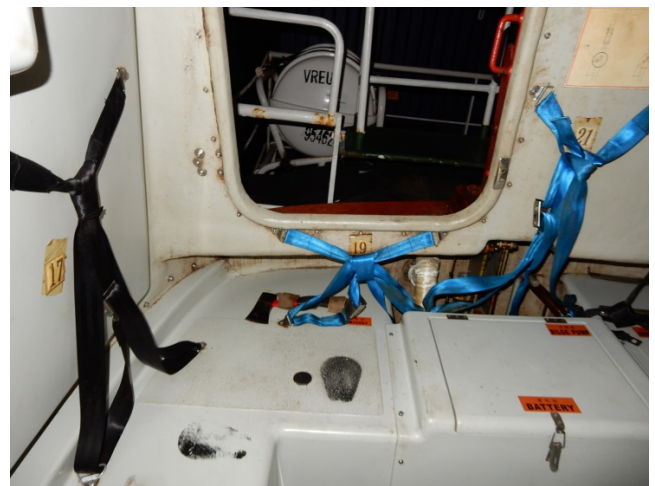
Same Color for Seat Belts for Adjacent Seats in Lifeboat

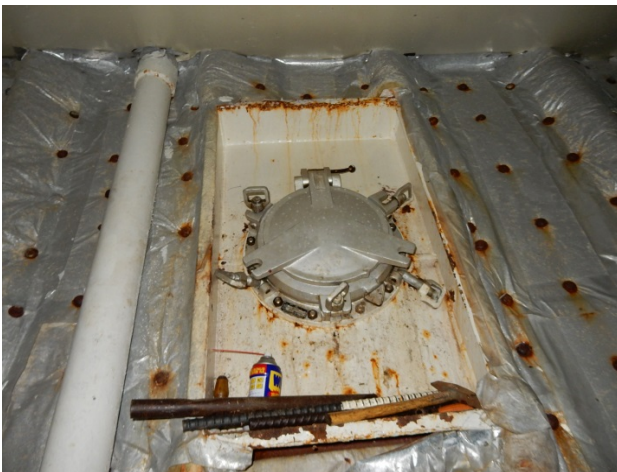
Failure to Close Storeroom Deadlight due to Rusting

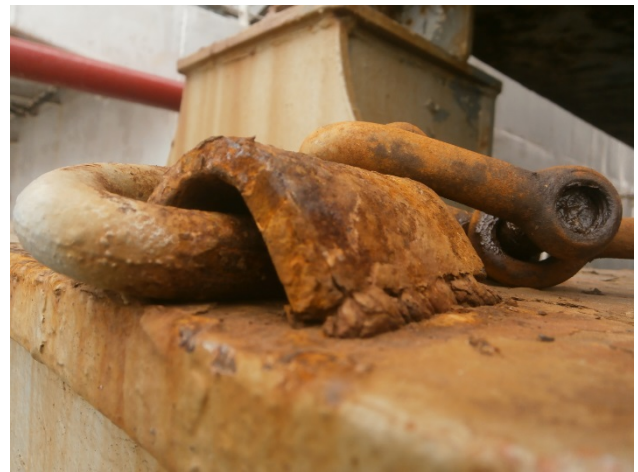
Serious Corrosion and Damage of Securing

- In the second quarter of this year, the temporarily positioned portable hatch covers of a ship was not effectively secured, so some hatch covers slipped into the sea and crashed other ships, causing the strict inspection and detention by PSC. The deficiencies include corrosion and damage of securing equipment, securing not meeting requirements, missing of securing parts and components, and serious insufficiency in implementation of ISM rules. During September to November 2016, the TOKYO MOU member countries will perform the Concentrated Inspection Campaign (CIC) of ship securing. Therefore, various companies shall prepare for the inspections in advance. The ships shall pay attention to the requirements of the Concentrated Inspection Campaign (CIC), pay close attention whether the ship securing manual is on the ship and properly approved, whether the securing equipment and relevant parts and components are complete and intact, and whether the crew members are familiar with the securing requirements and the implementation status. Any problem shall be solved timely, so as to prevent any ship deficiencies or even detention during the Concentrated Inspection Campaign (CIC).

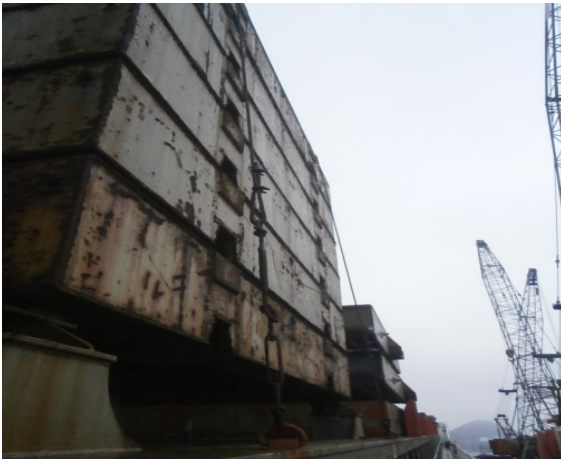
Lashing Eye

Portable Covers Securing Not Meeting Requirements

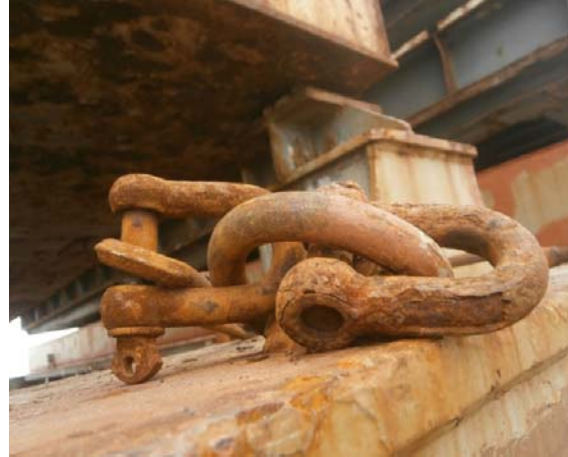
Serious Corrosion and Damage of Securing Parts and Components
