Safety Bulletin for Vessels Operating in Australian Waters

CCS Australian Office, No.106, 2026 Issue 005

Technical Alert on Recent PSC Detentions Related to Ballast Tank Air Pipe Heads

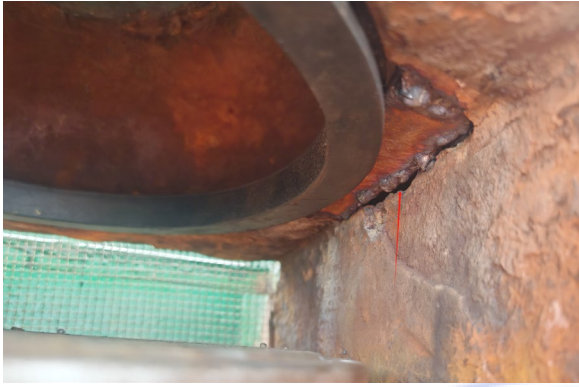
Due to a prolonged lack of maintenance, the internal structure of the ballast tank air vent heads had severely deteriorated. The sealing ring groove at the top was heavily corroded, deformed and, in some cases, cracked. Several sealing bolts on the cover plate were missing and had not been replaced for an extended period.

Cracking of the internal structure adjacent to the top sealing ring

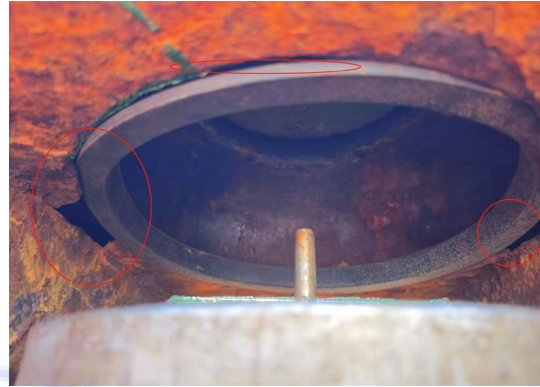
Corrosion and cracking of the top sealing ring groove

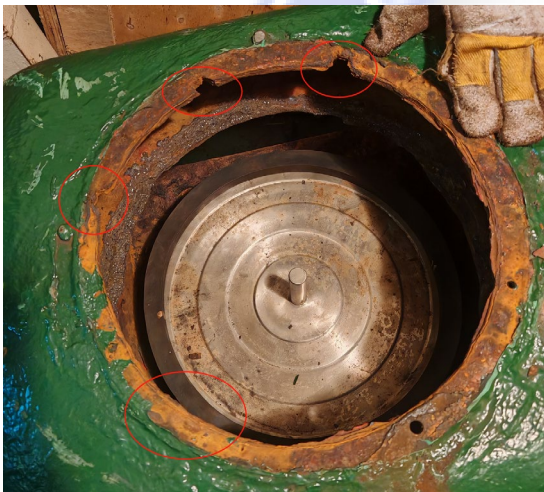
Cover plate bolt holes wasted due to corrosion

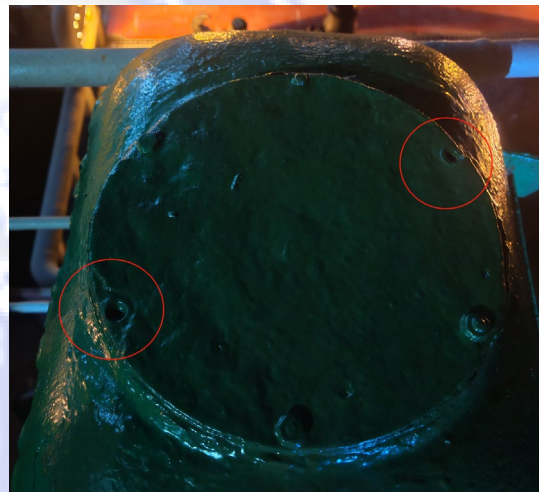
Cover plate sealing bolts missing for an extended period

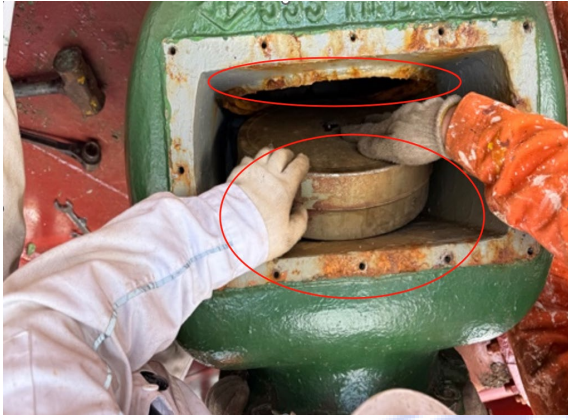
During the PSC inspection, the air vent heads located in the forepart of the vessel were selected for inspection. Two air vent heads serving the forepeak tank were found with detached float discs. PSC subsequently required a third air vent head to be opened for examination, revealing that the internal float mechanism had completely disintegrated. The inspection was then expanded to other air vent heads throughout the vessel, where multiple similar serious deficiencies were identified.

Sealing rubber ring missing, detached float disc

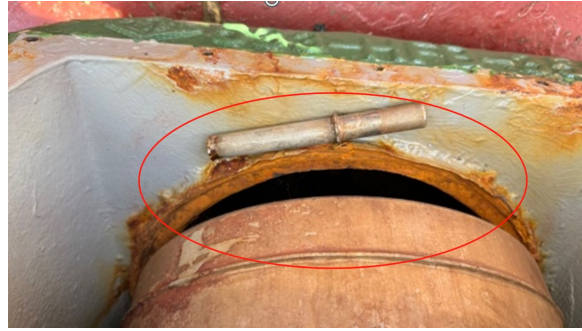
Missing sealing ring and detached float spindle

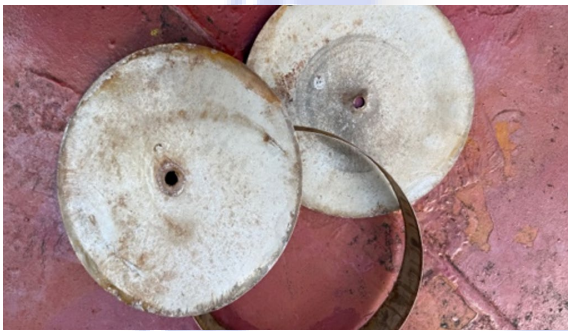
Severely damaged float disc

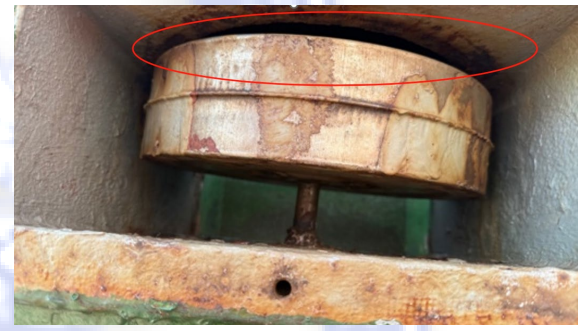
Float disc unable to achieve proper sealing

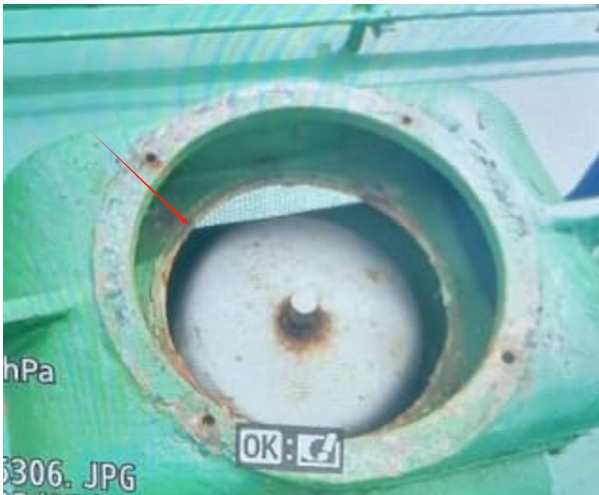
Internal examination of the air vent heads revealed missing sealing rings and damaged float spindle arrangements, resulting in detached float discs. Further inspection identified similar deficiencies in several additional air vent heads. In some cases, damaged float discs had allowed water ingress into the float chambers, affecting the buoyancy and proper functioning of the closing arrangements.

Top sealing ring missing

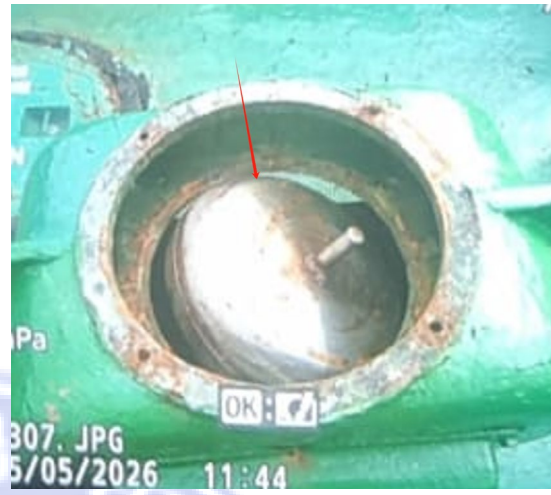
Missing sealing ring and detached float disc
