# Periodic Brief Report on PSC Information

## for the First Quarter of 2018

(Data as of June 30, 2018)

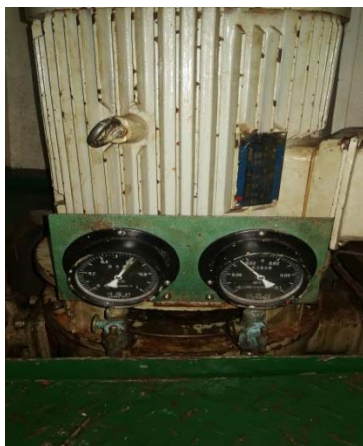
Emergency fire pump damaged

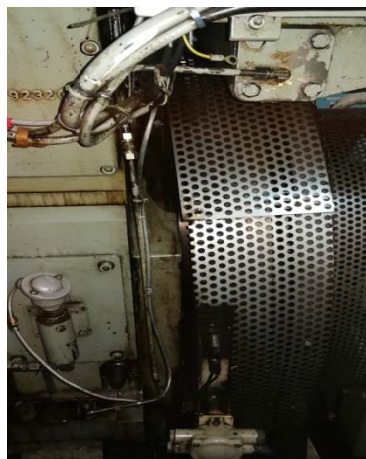
Using illegal rubber pipe in E.R.

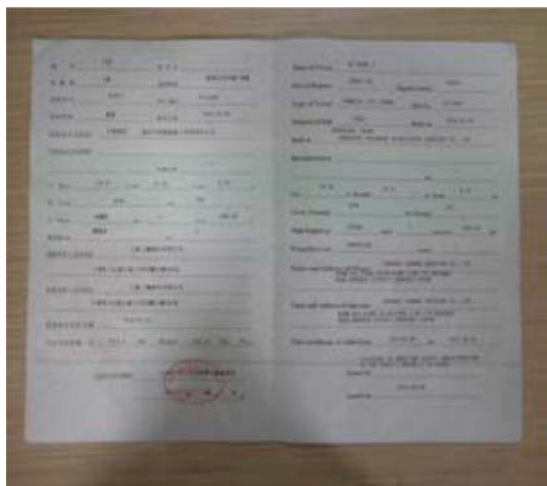
Ship's registry certificate not on board.

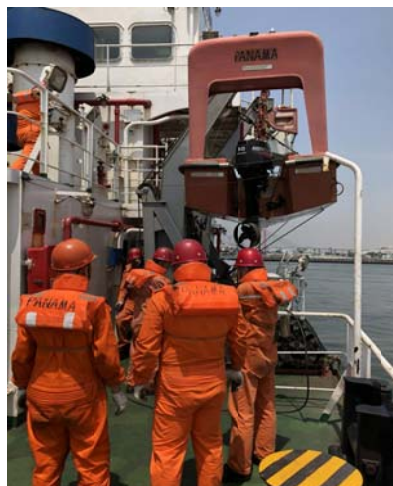
Crew members are unfamiliar with rescue boat operation.

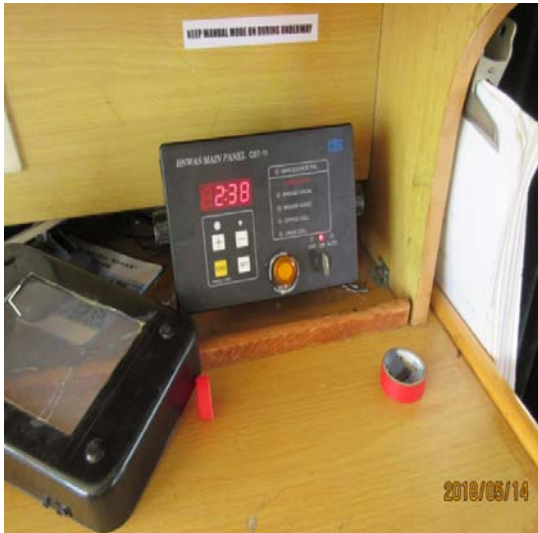
Crew members are unfamiliar with BNWAS operation.

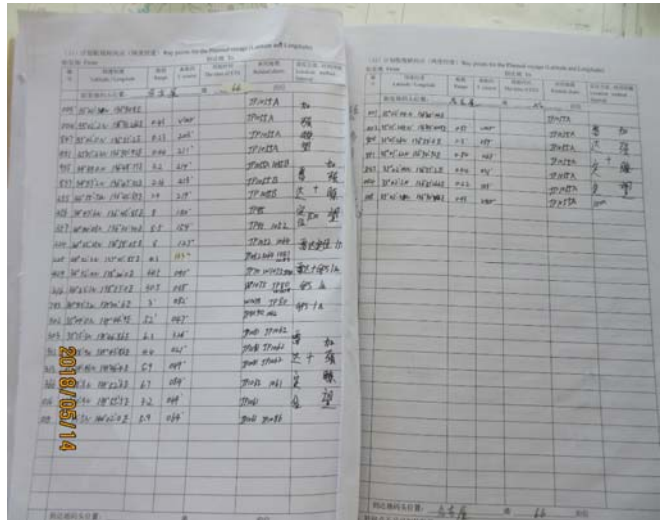
Sea charts in voyage plan are not enough.

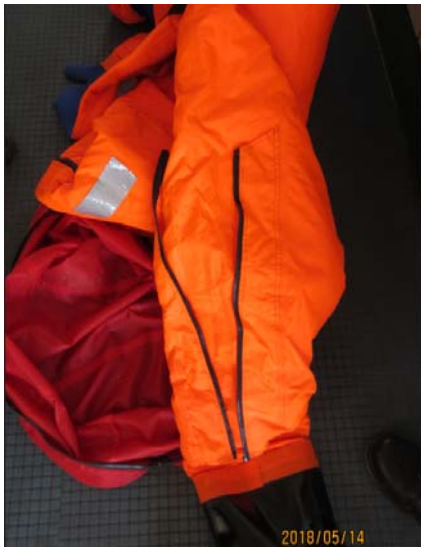
Slide fastener on life jacket damaged.

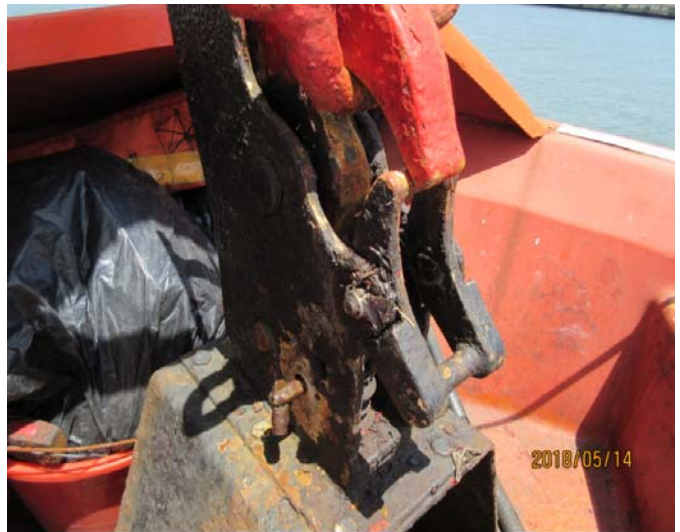
Hook on rescue boat seized.

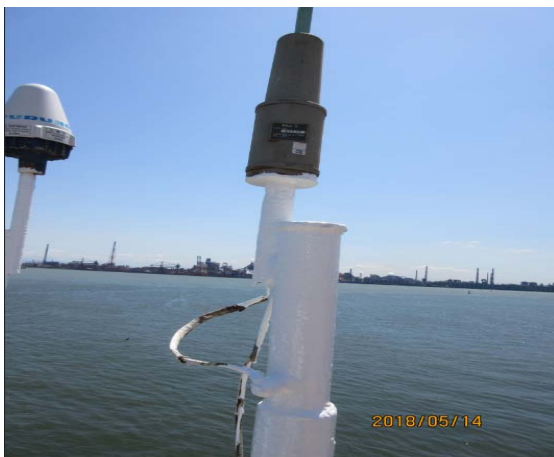
Antenna support post corroded

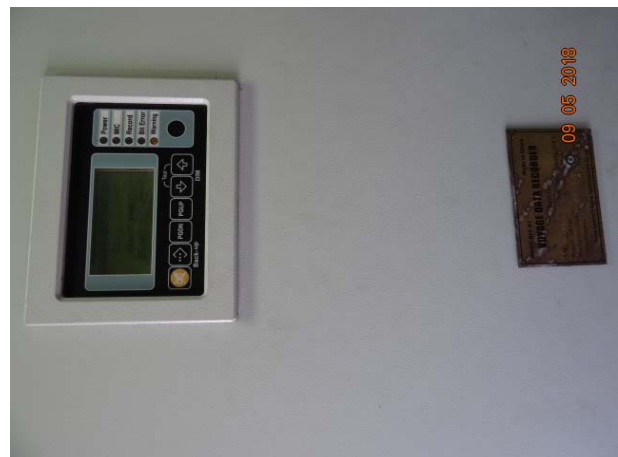
VDR damaged

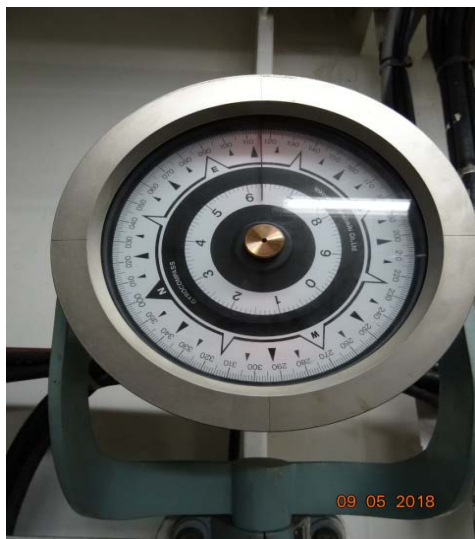
Gyro repeater in steer gear room failure.

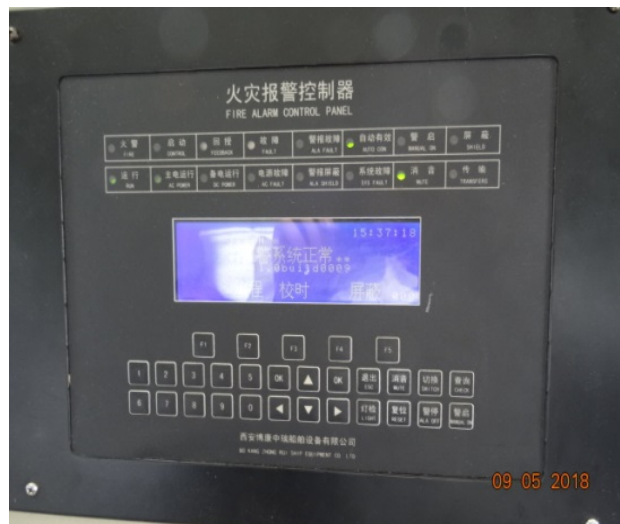
Fire detection alarm system damaged (rectified)

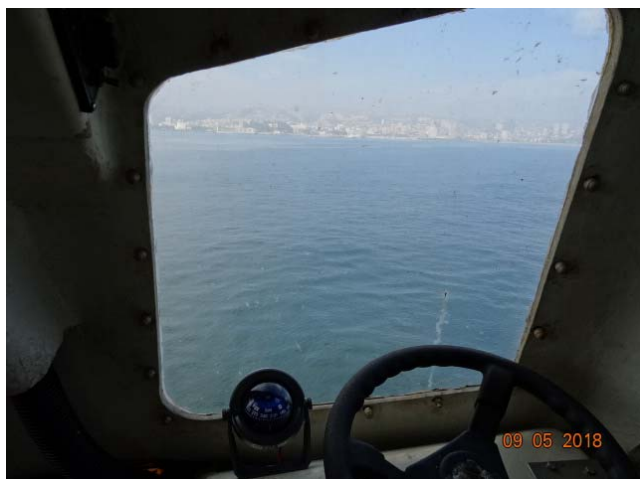
Window glass on life boat dirty (renewed)

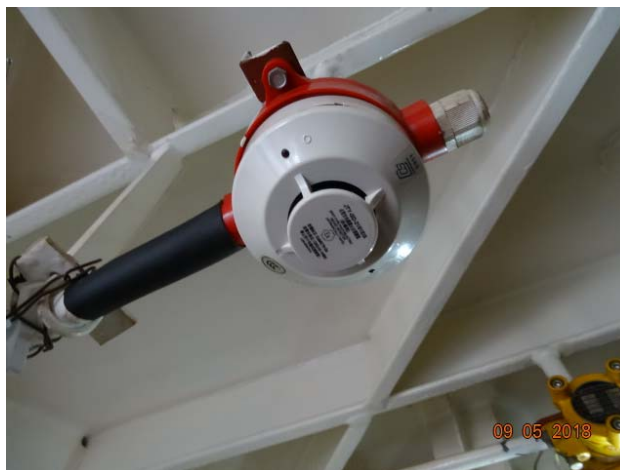
Fire detector in paint store damaged.

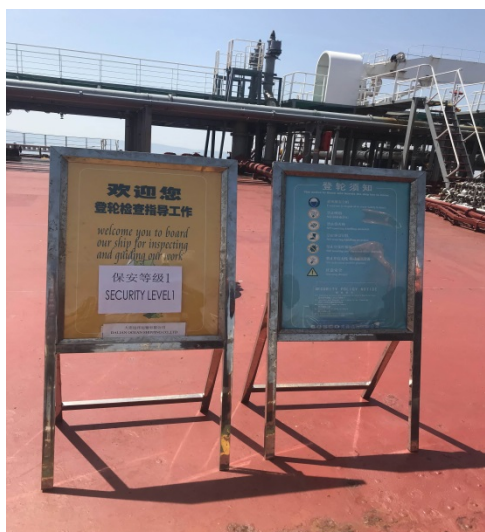
Security level notice not put at near ship entrance (rectified)

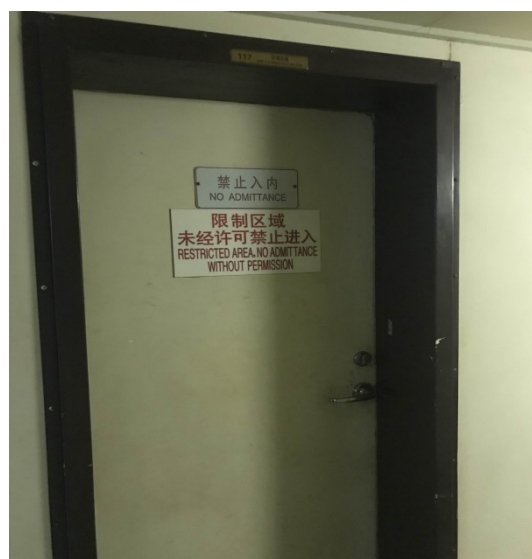
Self-closing fire door failure (rectified)

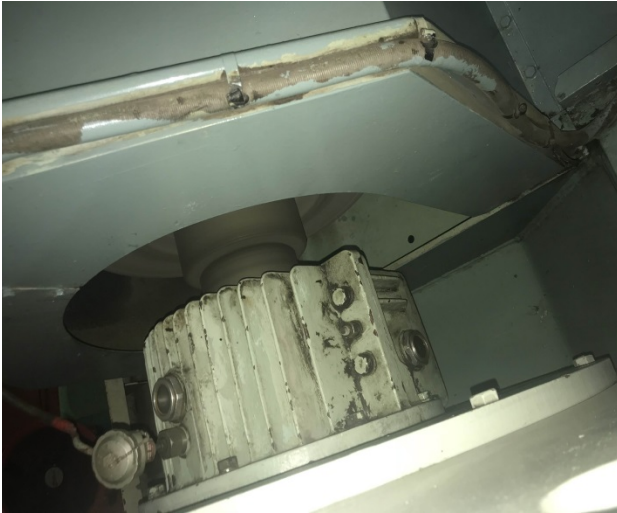
Aux. engine bottom oily (rectified)

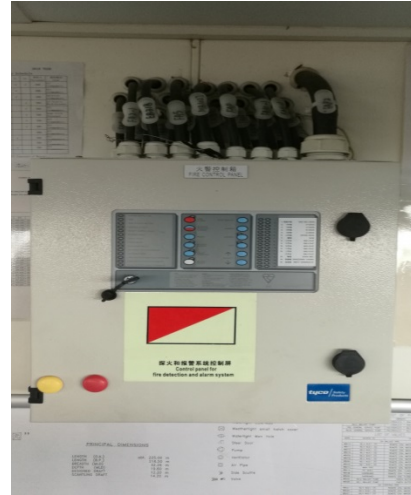
Cargo holds fire detecting system failure.

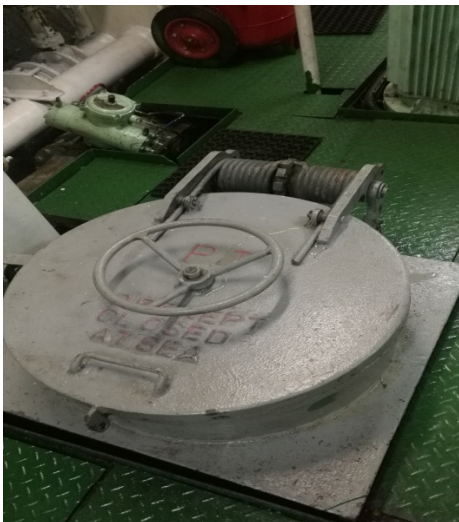
Pipe tunnel cover could not be open (water ingress)

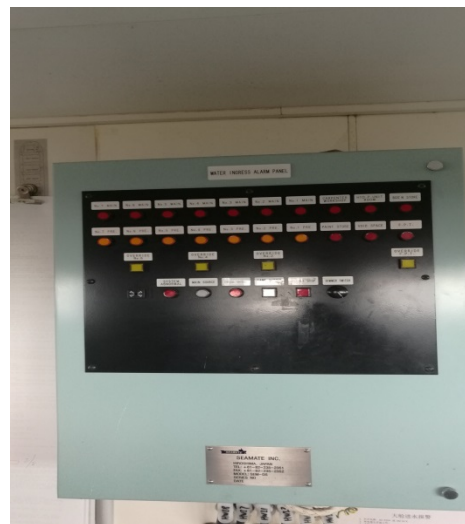
Water ingress alarm failure.

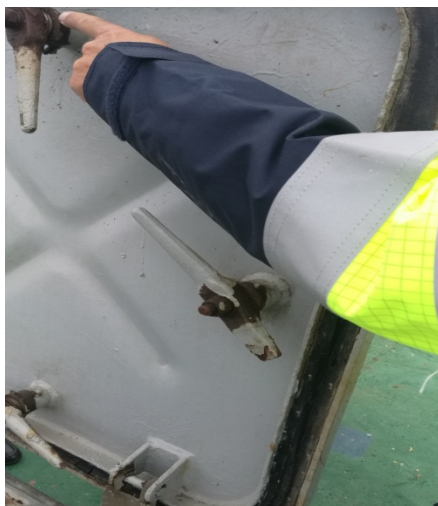
Small hatch cover for cargo hold could not be closed tightly

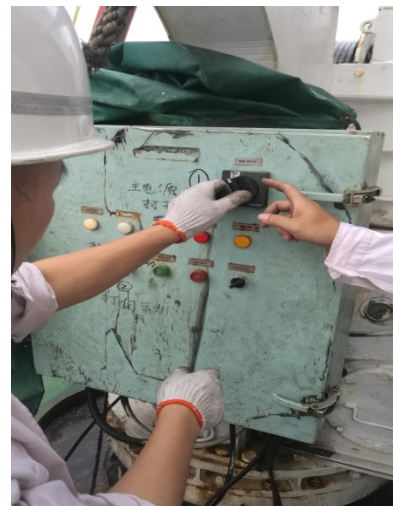
Crew members are unfamiliar with rescue boat release operation.

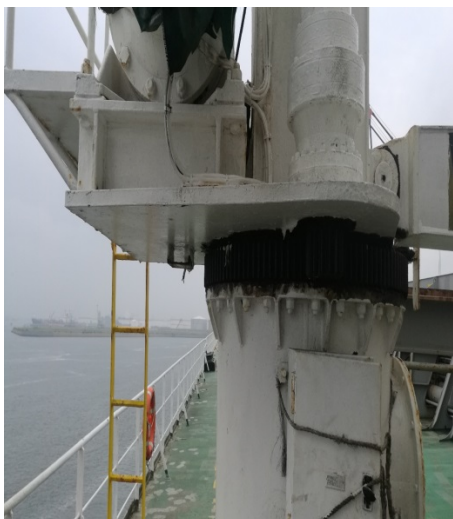
Limit switch on oil pipe crane missing

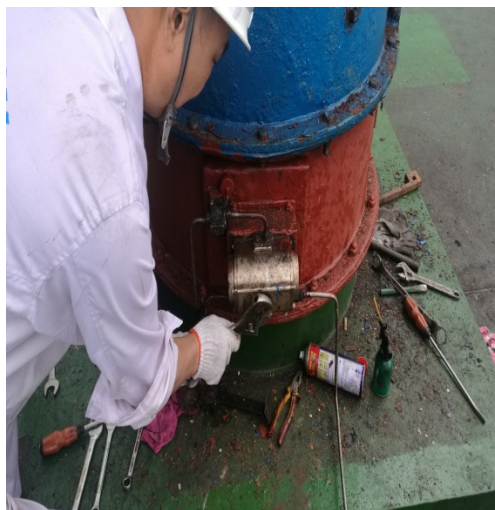
Fire damper on E.R. ventilator seized.

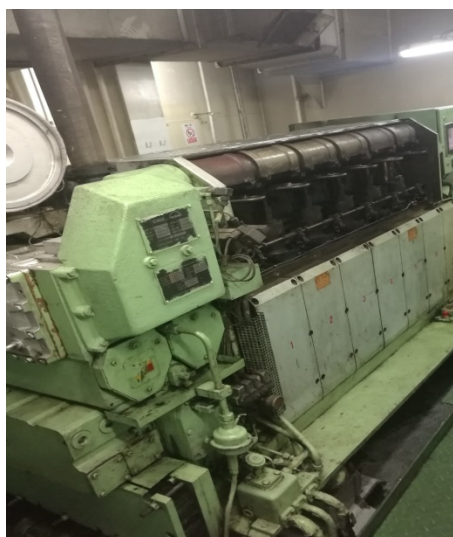
No.3 Aux. engine could not be started easily.

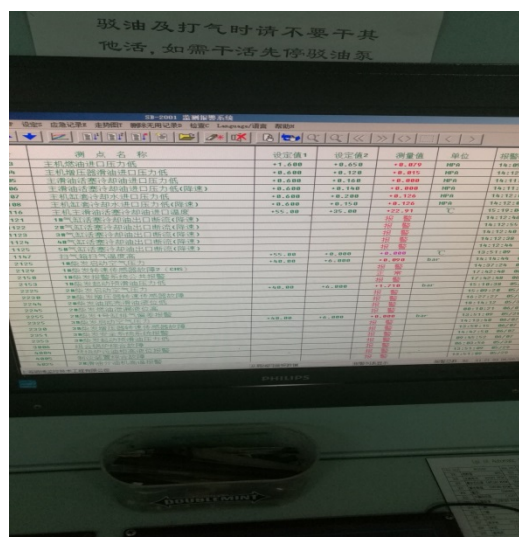
A lot of engine alarms were incorrect.

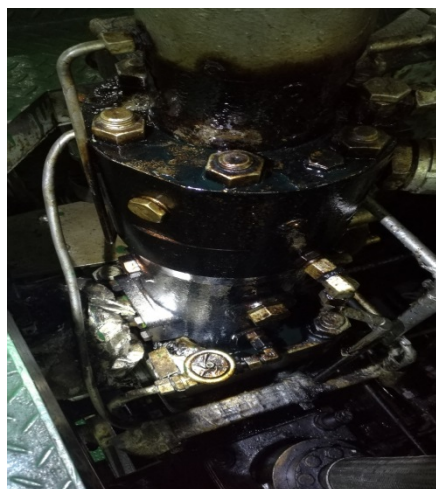
Oil leakage found from high pressure pumps.

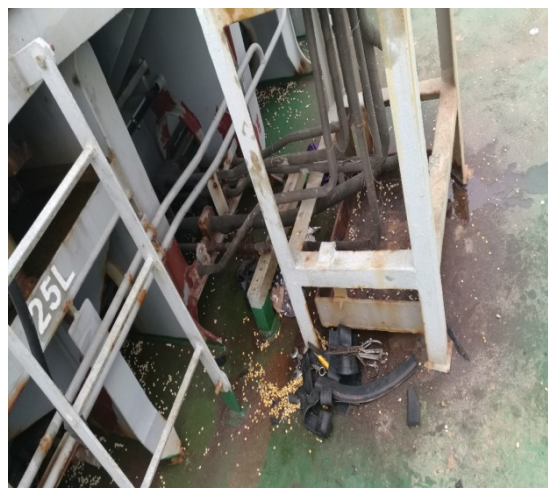
### Oil leakage found from hydraulic oil pipe on deck

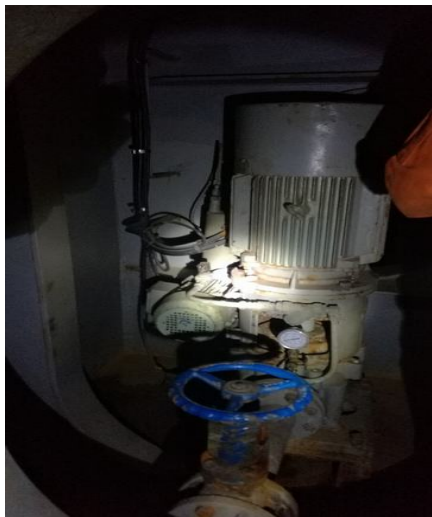
Emergency fire pump damaged.

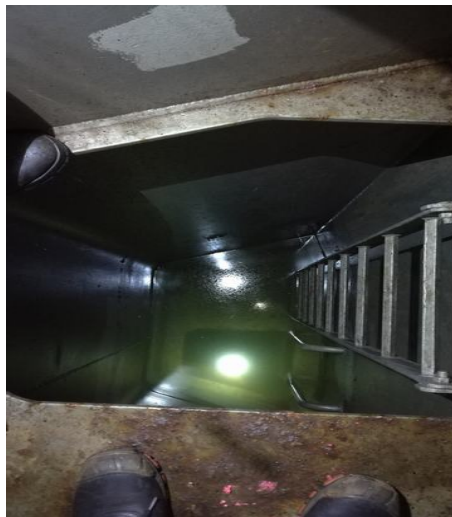
Pipe tunnel and cargo holds ingress due to ballast pipe broken.
