Bulletin

CCS Australian Office, No. 048, 2015 Issue 008

AMSA Ship Safety Information

--- Free fall Lifeboat Safety

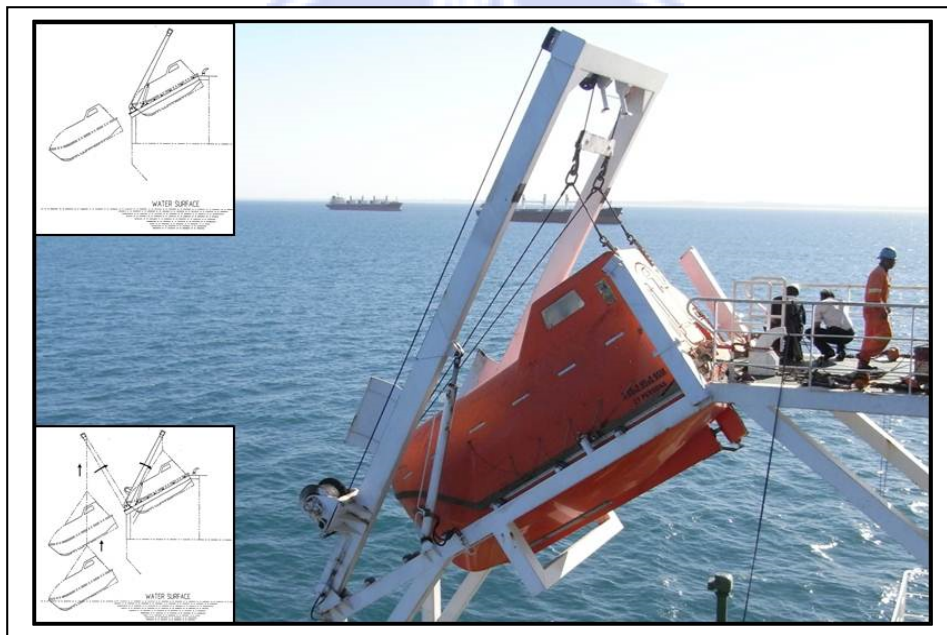
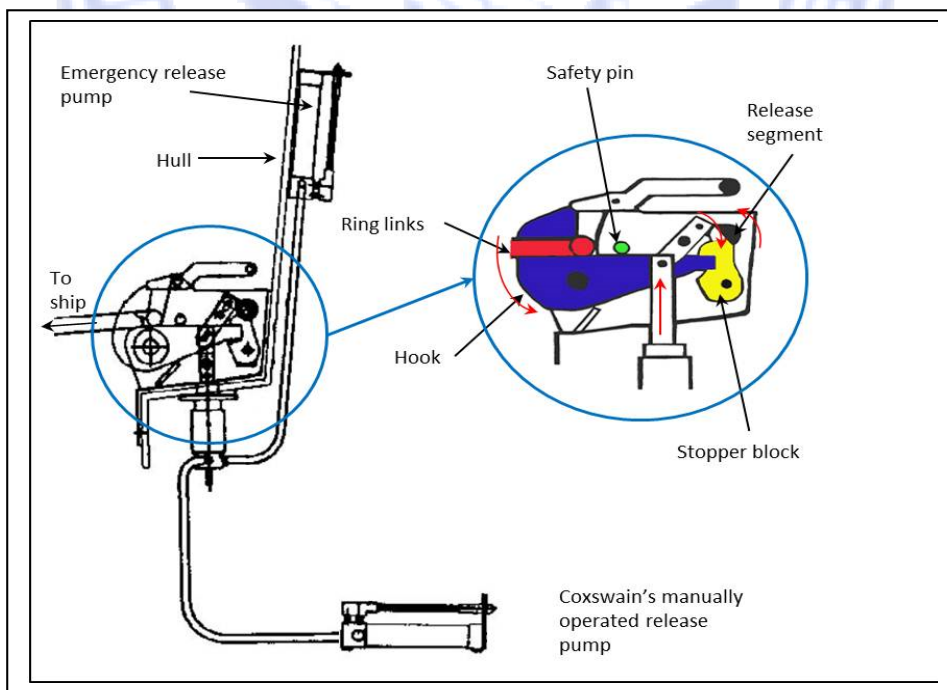
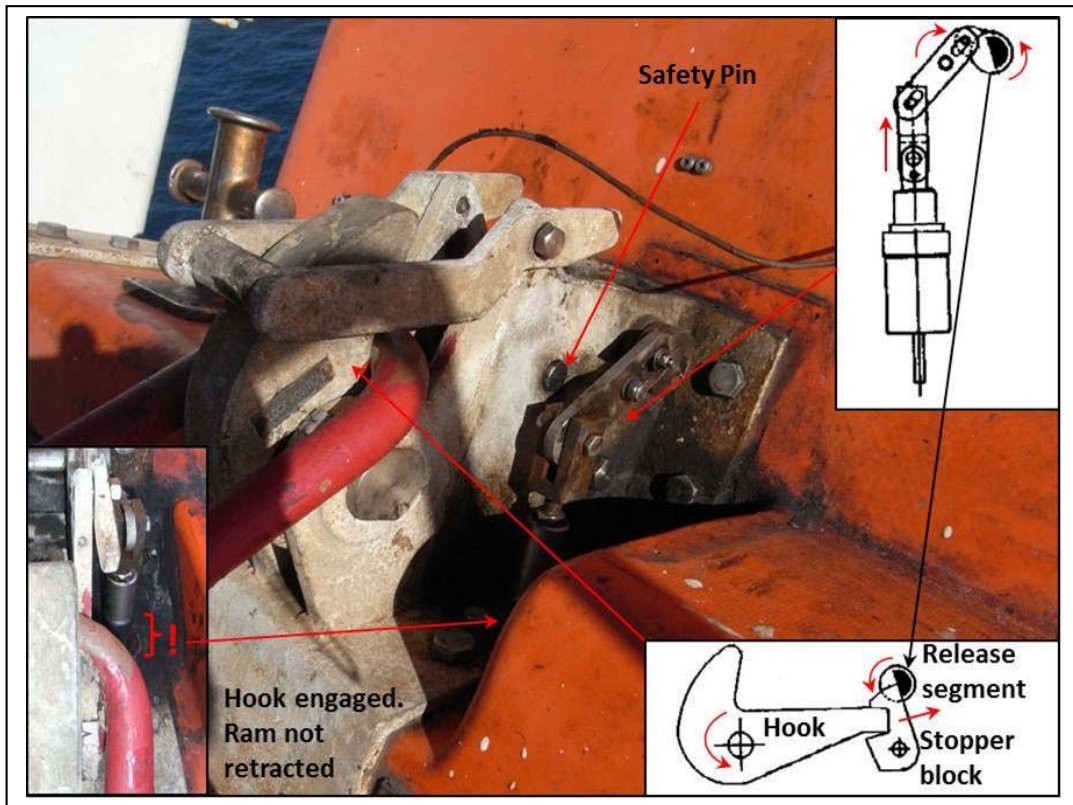
In “Case 1”, as demonstrated by picture on next page, the lifeboat on-load release system comprised the **hook device** located at the stern of the lifeboat, **the hook hydraulic activating cylinder** and **two hand-operated pumps**. One pump was adjacent to the coxswain’s position. The second, emergency pump to be used in case the coxswain’s pump failed, was located within arm’s reach of the aft-most port-side seating position. A safety

pin was fitted through the on-load release's cheek plates and sat over the tail of the hook to prevent the hook from opening and the unintentional release of the lifeboat. The on-load release could still trip but the hook could not rotate far enough for the ring links to be let go, thus preventing the launch of the lifeboat. The safety pin was attached by a lanyard to the entrance door of the lifeboat, such that the pin had to be removed before the door could be opened. Therefore, its removal could not be forgotten in an emergency.

The operation of the hydraulic pump extended the activating cylinder ram which released the stopper block via a series of linkages. The hook was then free to rotate and release the ring links connecting the lifeboat to the ship.

Resetting the on-load release and securing the lifeboat in place required the ring link to be positioned over the hook and then rotating it until its tail engaged in the stopper block. The **release segment** then had to be rotated into position, locking the stopper block in place.

The ATSB found that the hydrostatic on-load release mechanism hydraulic cylinder ram had not fully retracted after use, preventing the stopper block from resetting correctly. This left the release hook in a partially disengaged position.

The ATSB noted that the design of the release mechanism with a **cover plate** (NOTE: the cover plate was already removed from its original mounting position in above the third picture) prevented visual confirmation that the hook was correctly reset.

A). For the same design of hook device on your vessel, it was strongly suggested to remove aforementioned cover plate for double check whether all essential parts are already reset correctly as required by Manufacturer Manual.

B). Risk assessment should be carried out satisfactorily before entering free lifeboat each time. A tool box talk or job safety analysis should be carried out beforehand.

C). Personnel intending to inspect or maintain a lifeboat should always inform the duty watch keeping officer of their plans.

D). The lever of the hydraulic hand pump should never be operated unless launching the lifeboat or as part of a controlled test of the release mechanism, both of which should be authorized by the Master beforehand.

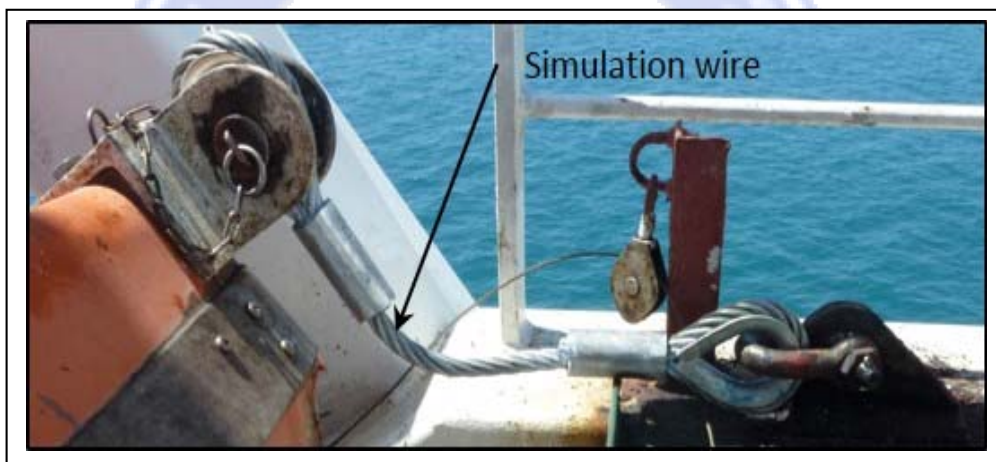
The simulation system in “Case 1” relied on two simulation wires, acting in parallel and an equal distribution of energy between them, one of which was as indicated in below picture.

Wire slings (simulation wires) were attached and secured to eye plates that were welded onto the lifeboat launching frame’s deck. When the lifeboat was in its stowed position (secured via the release hook and links) the simulation wires were slack.

In incident of “Case 1”, when hook device was inadvertently activated, the simulation wires failed, which allowing the lifeboat to move down the guide rails into the sea.

The ATSB found that the simulation wires failed due to a combination of incorrect installation and cumulative internal wear from numerous shock loading events that resulted from previous lifeboat launching drills. The further investigation indicated the longer simulation wires and additional shackle attached to the wire high impact the simulation wire safety.

The wire rope used for the simulation wires was a rotation-resistant wire. The use of an extra shackle meant that when the boat’s travel down the ramp was arrested, a twist of about 90° was forced into the wires. This another affect the simulation wire safety.

A). Duty crew **MUST** maintain the simulation equipment timely as required. More attention should be paid to concealed wire sling (simulation wire) after removing the plastic sheathing .

B).To ensure the length and connection of simulation wire comply with Manufacturer Manual.

C).The length and mechanical performance of both simulation wires **MUST** be consistent with each other.

D).The simulation wires to be replaced with genuine spare parts of rotation-resistant wire from Manufacturer, certificate for which should be provided simultaneously indicating satisfied break load.

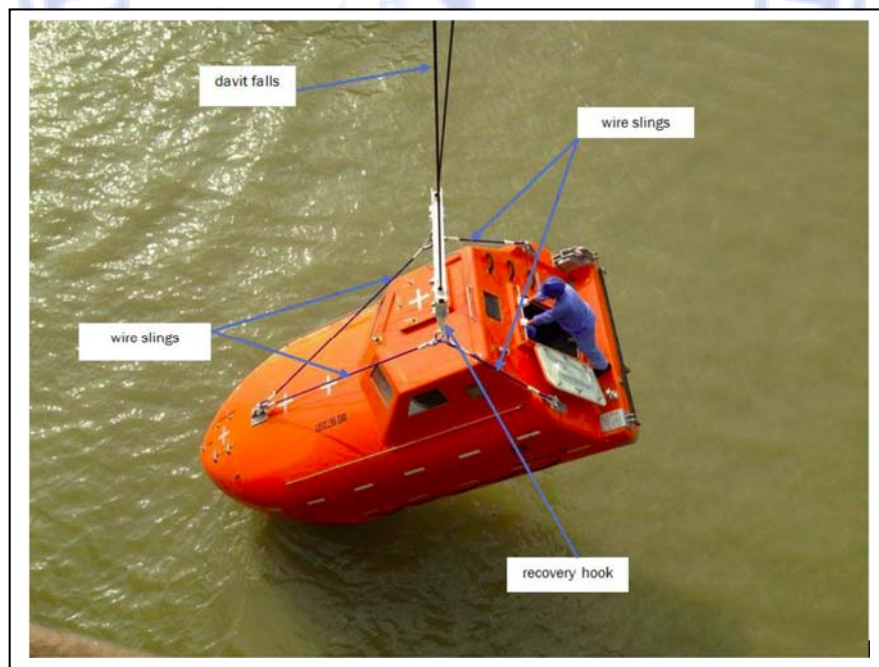
The wire slings will become stretched tight and effective when launching lifeboat by means of the secondary means of launching, or in course of lifeboat recovering, as demonstrated in below picture.

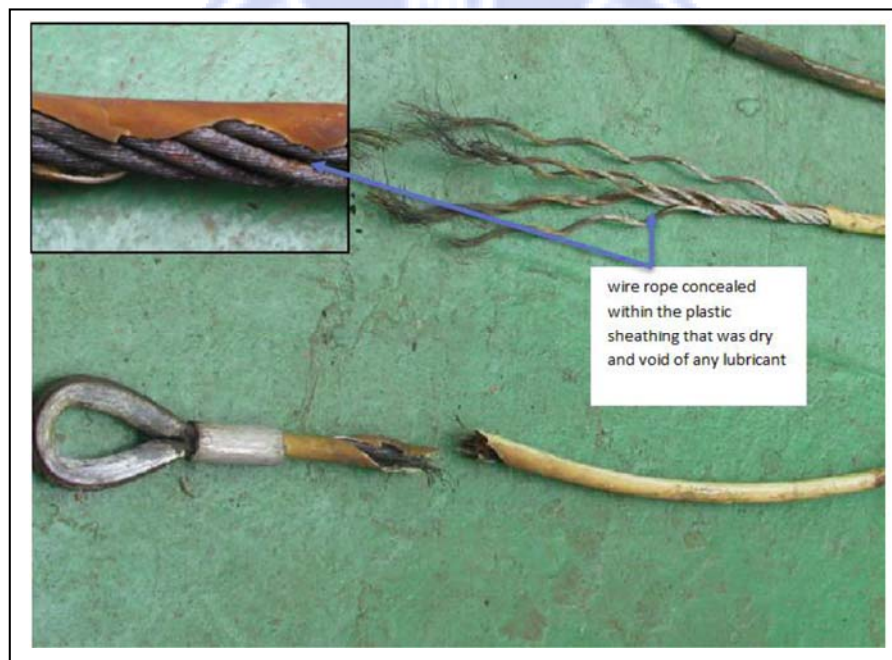
TAIC identified that the wire pennants parted under tensile overload. Subsequent testing confirmed that the sling wires had been significantly weakened by severe corrosion. This corrosion had gone undetected inside a plastic sheathing that the manufacturer had fitted to the wire.

The sheathing prevented the crew from identifying the corrosion and did not allow for lubrication or the application of other corrosion-inhibiting substances. The crew were also unaware of the necessity for greater vigilance and the application of anticorrosive substances during inspections.

A).With restriction of wire sling mounting location, it is very hard for duty crew to do routine maintenance to free fall lifeboat wire sling. Crew **MUST** pay more attention when conducting routine maintenance.

B).Company should always ensure timely renewal to lifeboat wire slings as required.

Genuine and rotation-resistant sling wire **MUST** be utilized with supporting certificate.

C). For sling wire concealed in plastic sheathing, it is suggested to remove plastic for easy maintenance. Once abnormal detected, sling wire should be renewed immediately.

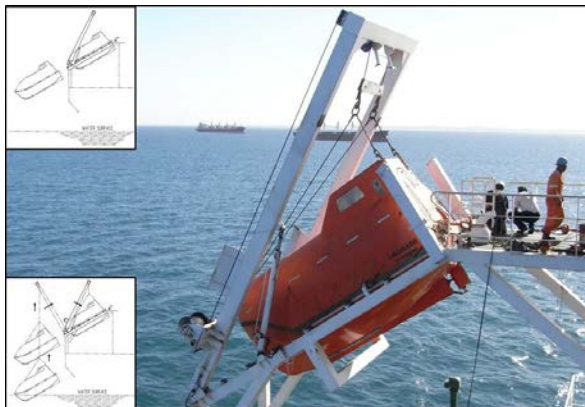
Aquarosa's Free-fall Lifeboat arrangement

Aquarosa (IMO No. 9506708) - On 1 March 2014, Aquarosa's free-fall lifeboat was inadvertently released during a routine maintenance inspection while the ship was en route to Fremantle, Western Australia. One crew member was injured in the incident and it took 5 hours for the crew to recover the lifeboat.

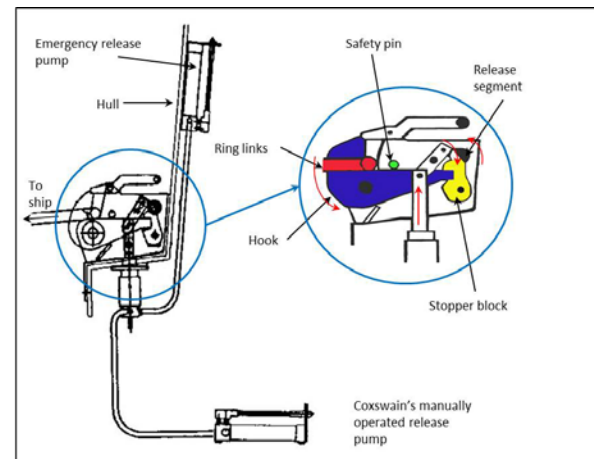
Aquarosa's free-fall lifeboat release system

The ATSB identified that the Second Engineer accidentally activated the lifeboat's on-load release mechanism while carrying out a test procedure. When the Second Engineer cycled the hydraulic system, the retaining hook was released allowing the lifeboat to move down the launch ramp.

The ATSB found that the hydrostatic on-load release mechanism hydraulic cylinder ram had not fully retracted after use, preventing the stopper block from resetting correctly. This left the release hook in a partially disengaged position.

The ATSB noted that the design of the release mechanism cover plate prevented visual confirmation that the hook was correctly reset.

The lifeboat was fitted with simulation wires to prevent it from launching under these circumstances. However, on this occasion, the simulation wires failed allowing the lifeboat to move down the guide rails into the sea. The ATSB found that the simulation wires failed due to a combination of incorrect installation and cumulative internal wear from numerous shock loading events that resulted from previous lifeboat launching drills.

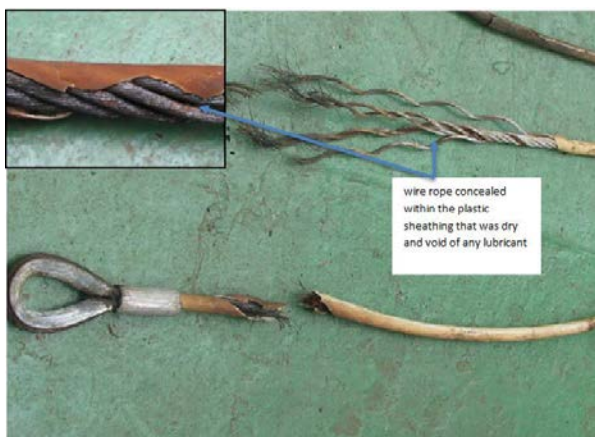
TAIC identified that the wire pennants parted under tensile overload. Subsequent testing confirmed that the sling wires had been significantly weakened by severe corrosion. This corrosion had gone undetected inside a plastic sheathing that the manufacturer had fitted to the wire.

The sheathing prevented the crew from identifying the corrosion and did not allow for lubrication or the application of other corrosion-inhibiting substances. The crew were also unaware of the necessity for greater vigilance and the application of anticorrosive substances during inspections.

Examples of the damage to *Da Dan Xia*'s wire slings after failure (Courtesy TAIC)

TAIC found that the wires were of adequate strength when manufactured, but that the sheathing allowed saltwater ingress, aiding corrosion by retaining water, and prevented external observation.
