AMSA PSC Information

---Inspection for Hatch Cover of Bulk Carrier

CCS Australia Office

August 10, 2016

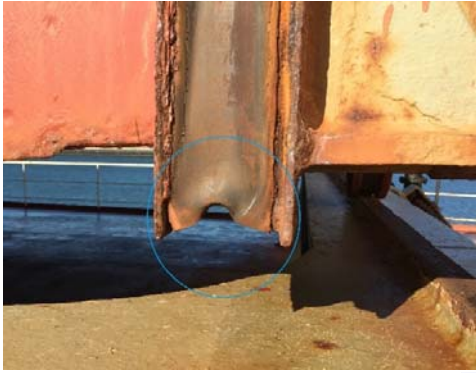
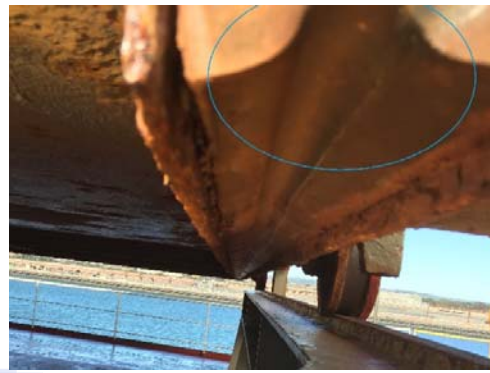
1. The cargo hold cannot kept in weather tight condition after hatch cover closed.
2. Excessive permanent set of the rubber packing and failed to recover to its normal condition due to the failure of the elasticity of the rubber packing. If necessary, the PSCO would check the Hatch Cover Manual provided by the manufacturer for rubber packing renewal standard.

(The permanent set of rubber packing shown in above photos was not accepted by Class and PSCO)

1. To check the hatch cover rubber packing condition and ensure no excessive permanent set exist. Normally, the information related to the standard compression margin and/or minimum renewal compression margin for rubber packing were included in Hatch Cover Manual. Crew staff was required to take measurement to the actual compression of the rubber packing, to make sure all rubber packing compression is complied with the requirement of Hatch Cover Manual. If no packing rubber renewal requirement in the Hatch Cover Manual, ship company should contact with the manufacturer for their technical supporting.

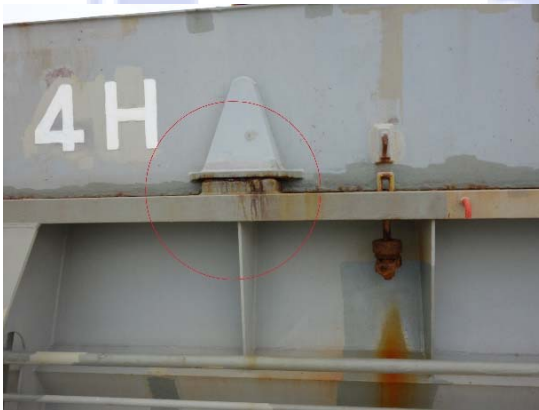
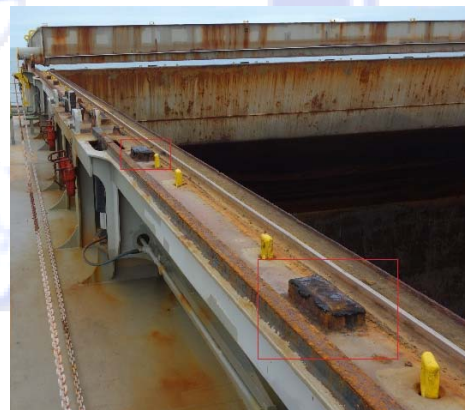
2. To check the top side surface wear and tear condition for hatch cover support foundation (bearing pad) located on the cargo hold hatch coaming face plate and corresponding bottom side surface wear and tear condition for resting pad located on the hatch cover. Excessive wear and tear will continuously cause hatch cover weight on the rubber packing and duly its elasticity failure, for which it could be determined by measuring the clearance between the lower edge of hatch cover and the face plate of the hatch coaming.

(The bearing pad on hatch coaming and the resting pad on cover)

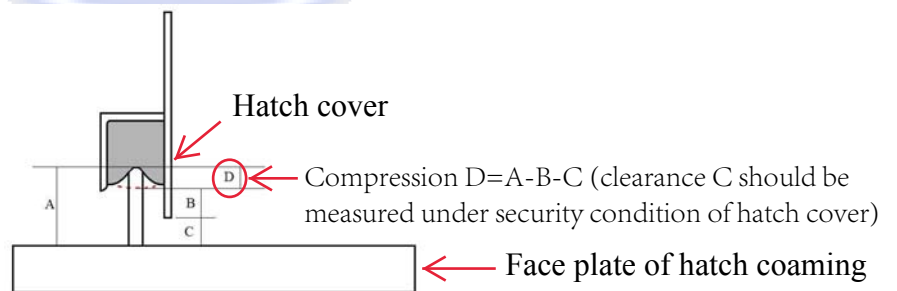
(Above diagram is for the clearance measurement)
