The First Safety Meeting of Ship Management Company,  
2018

# PSC Session

CCS Headquarters  
January 2018

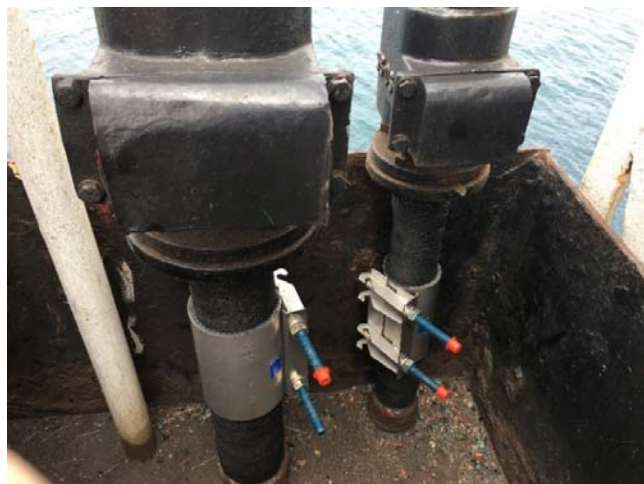
Corroded  
and holed  
air pipes

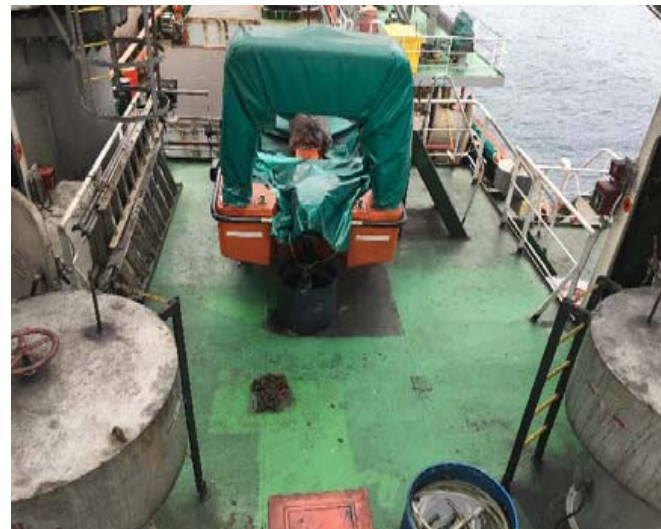
Wet and  
slippery  
deck due to  
oil leakage

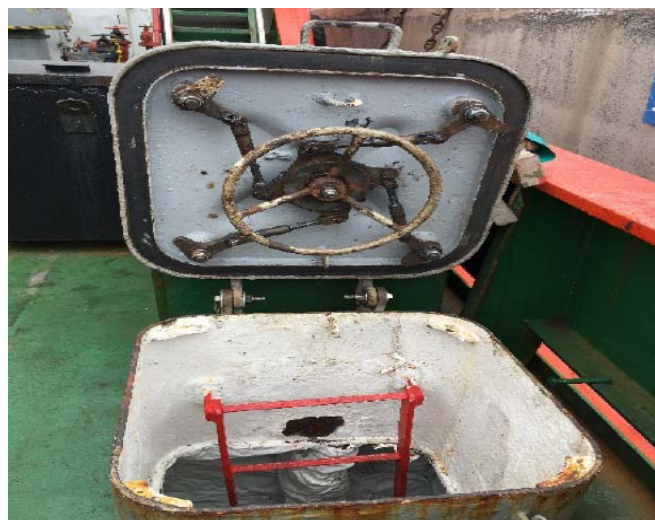
Small hatch  
cover cannot  
be closed

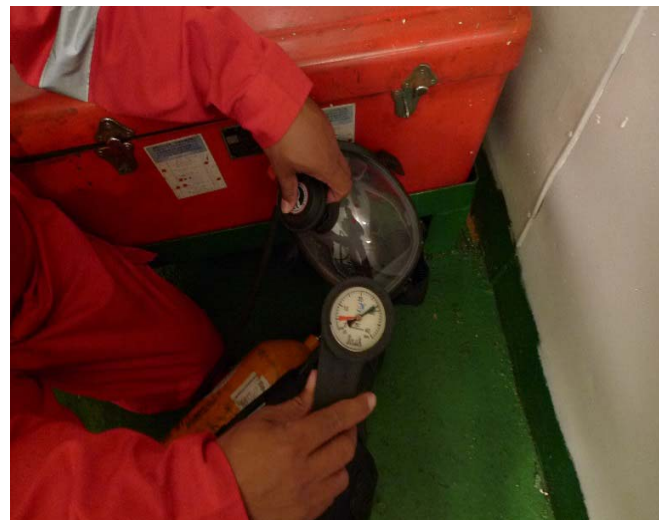
Insufficient  
pressure of  
air receiver of  
fire-control  
equipment

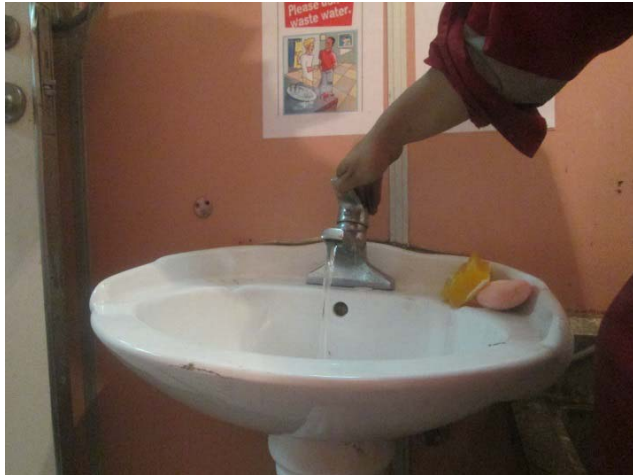
Broken tap  
of the hand  
washing  
sink

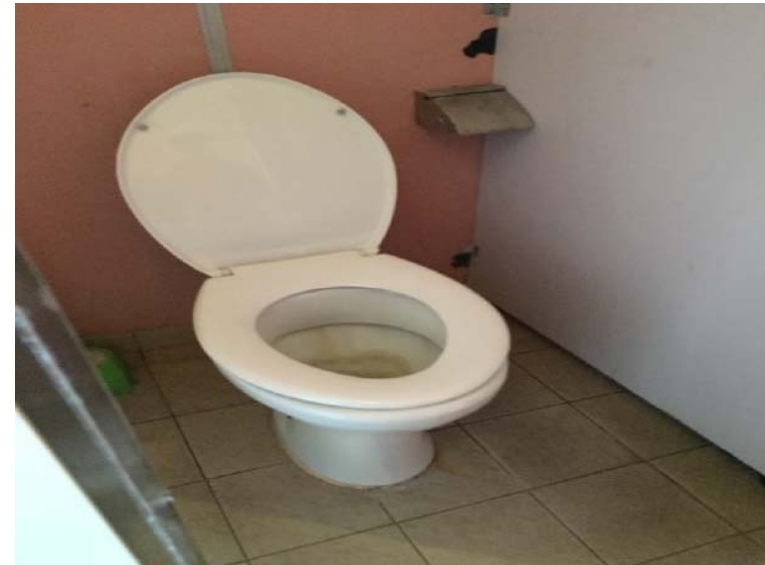
Toilet  
flushing  
doesn't  
work

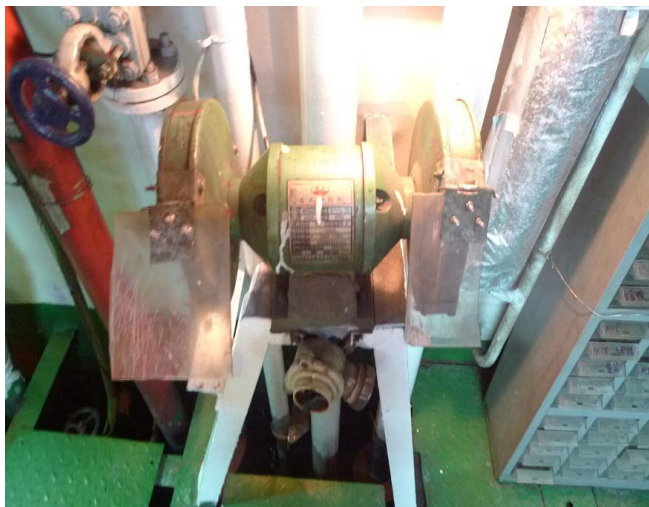
Outer guard  
of abrasive  
wheel lost

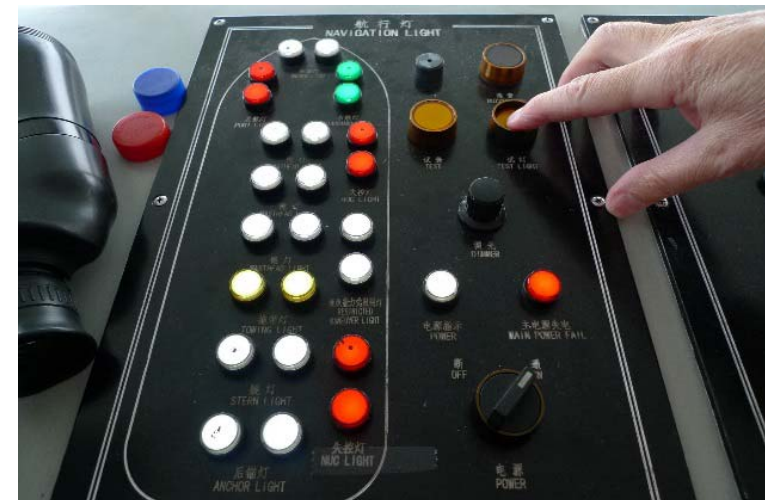
Broken  
signal  
lights

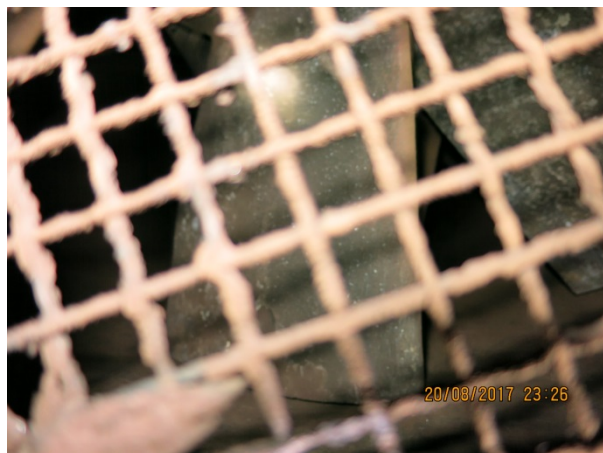
**Deficiencies for detention:** Fire damper of all ventilating fans (4 in total) in the engine room cannot be closed from outside.

Fire damper of the engine room's ventilating pipe could not be closed

- ◆ Pay attention to inspections and tests on ventilating pipes of the ship, and make sure of their sound condition;
- ◆ AMSA conducts extremely detailed and strict inspection on crew's living facilities and often propose MLC-related deficiencies; if faced with large number of deficiencies, the ship would be detained due to unsatisfactory ISM.
- ◆ Strengthen the training and education on crews, and give up the unhealthy living/working habit.

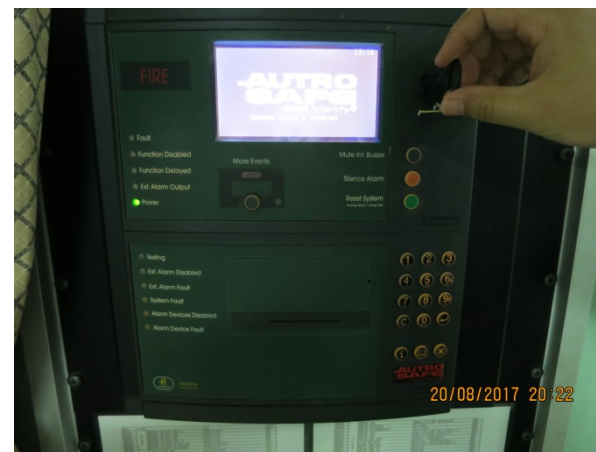
Wrong alarm released by smoke detector and alarm system

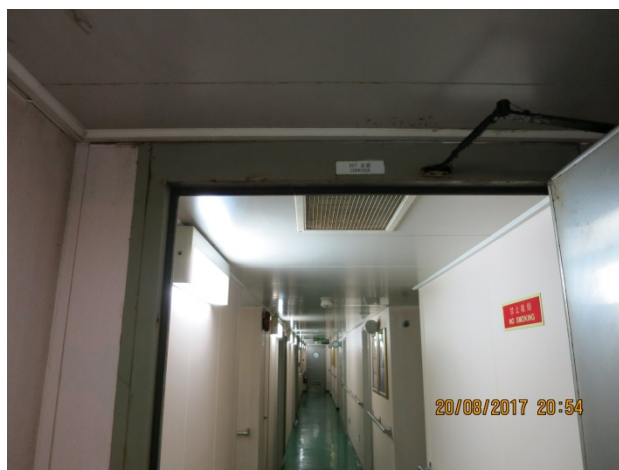
Rubber of the fire gate on deck lost

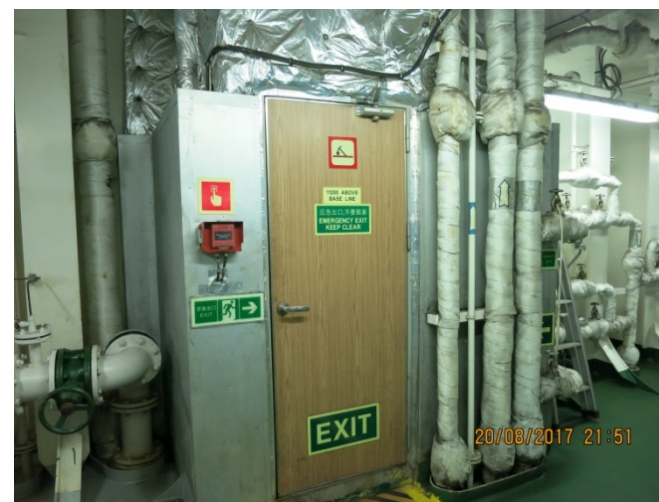
Fire gate could not be completely closed by automatic closing device

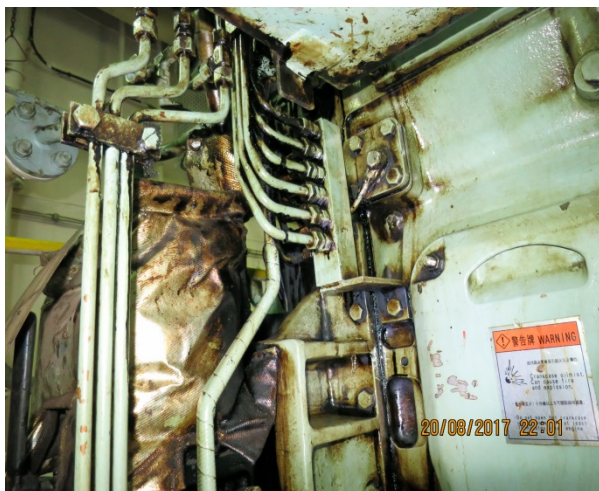
Severe oil leakage of auxiliary engine

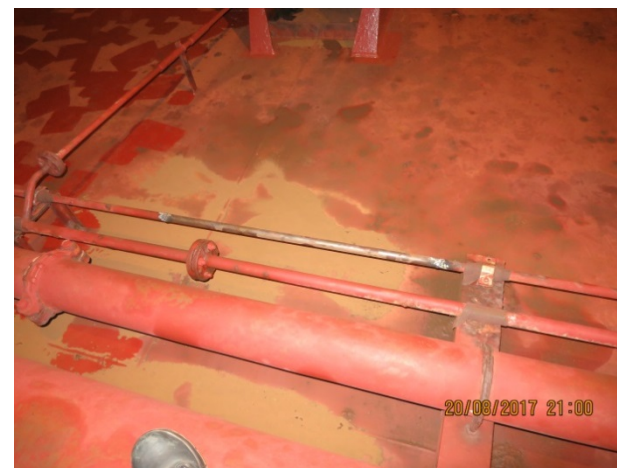
Swelling fire pipe and leaked joints

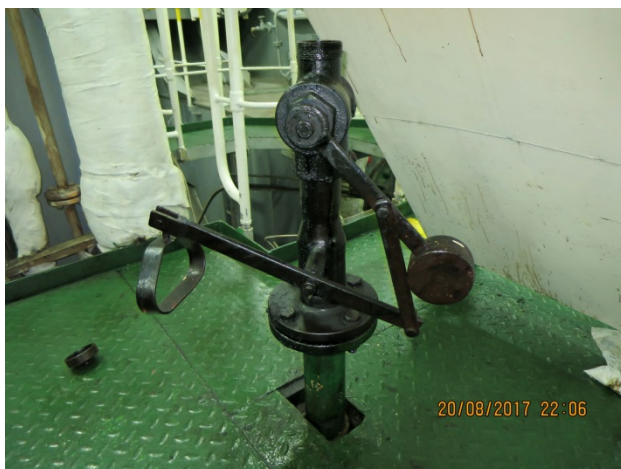
Automatic closing device of oil tank's sounding hold was tightened by steel wires and remained open

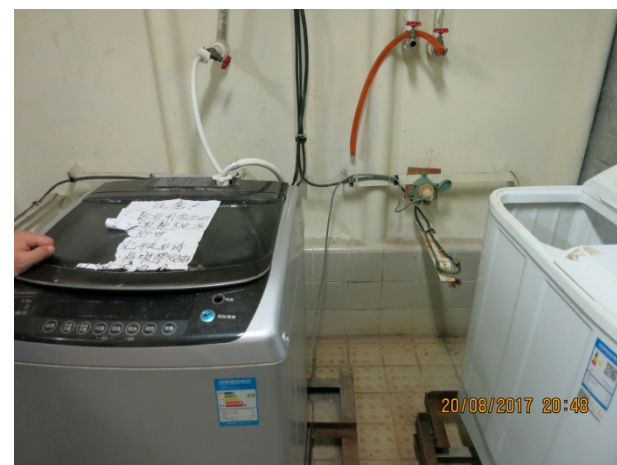
Washing machines were connected by normal power strips

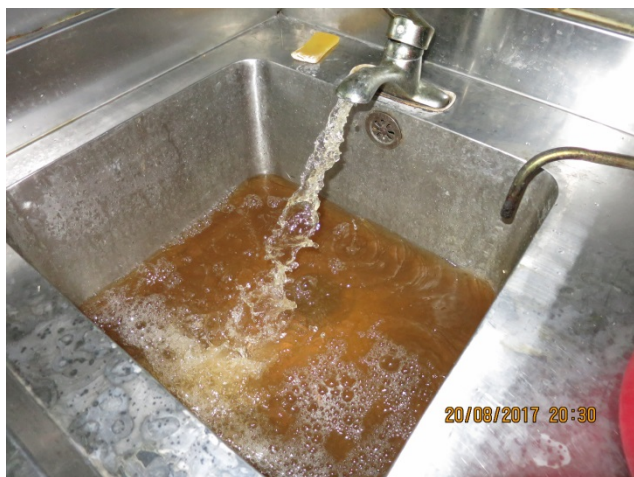
Dirty water  
from part of  
taps/in washing  
basins

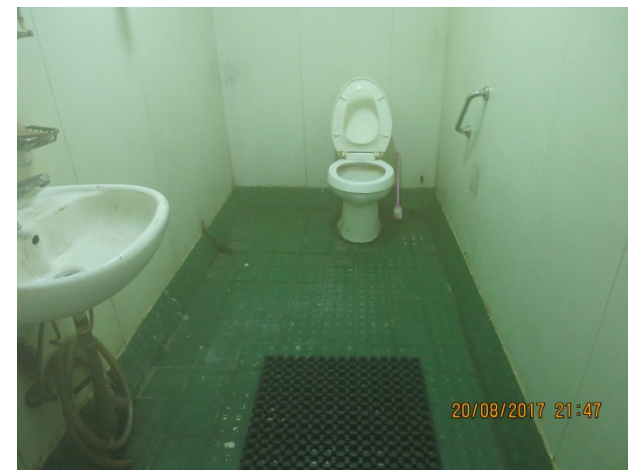
Poor sanitary  
condition inside  
restrooms

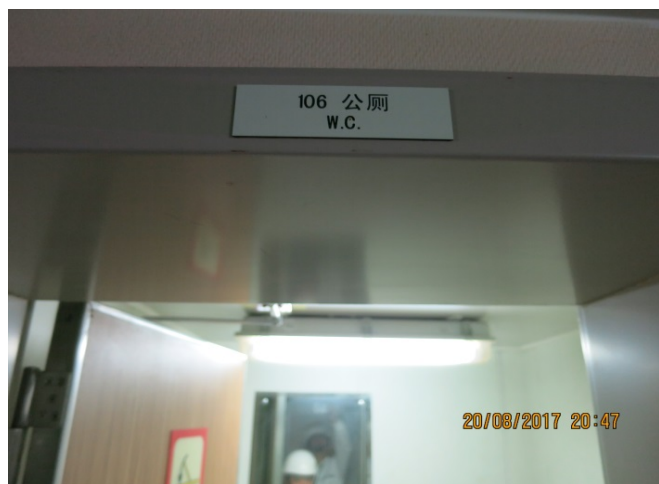
Lamp inside the  
restroom is broken,  
with lost  
lampshade

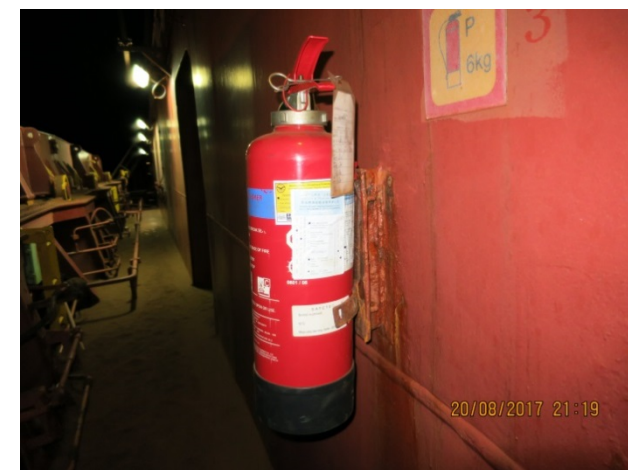
Fire extinguisher  
was moved  
inside the paint  
room (rectified)

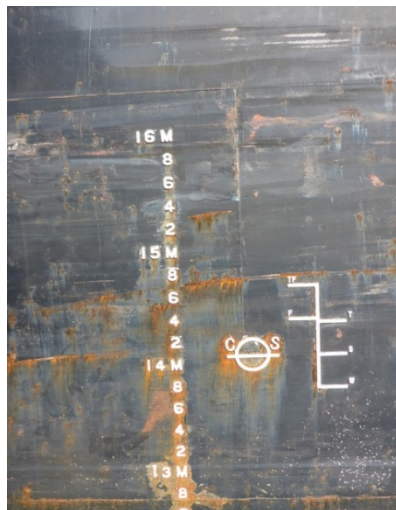
Blurry loadline marks

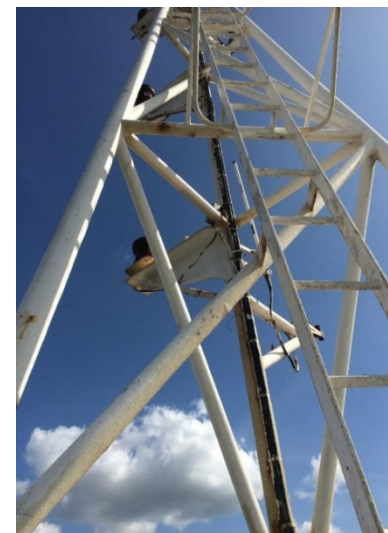
Terminal box of mast light was fixed to the max using lashing band; broken cable

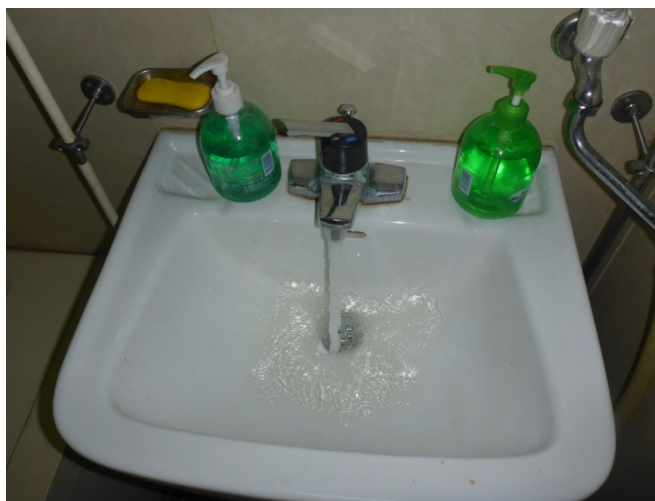
Water from taps appeared color of yellow rust

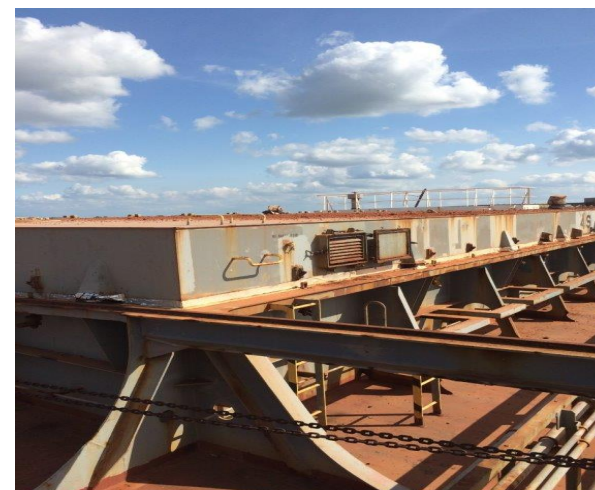
Ventilation covers at holds' two sides cannot be closed

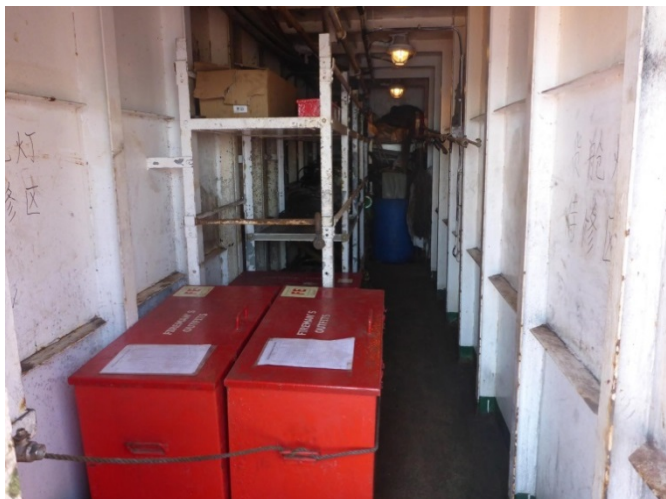
Separate storage of fire axe and other fire equipment, which affects the actual use

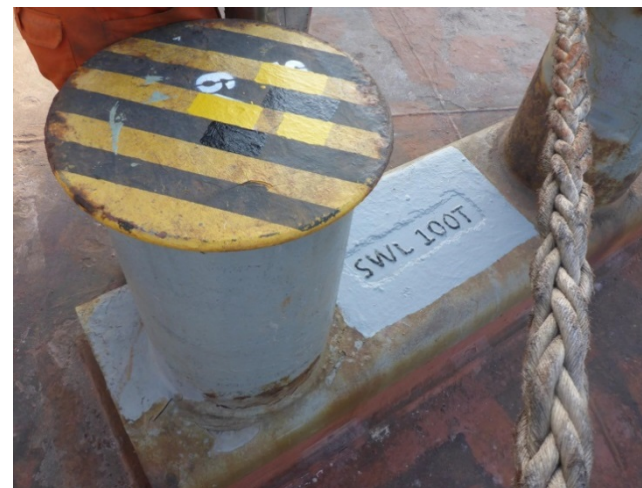
Rated load not marked on bollard (rectified)

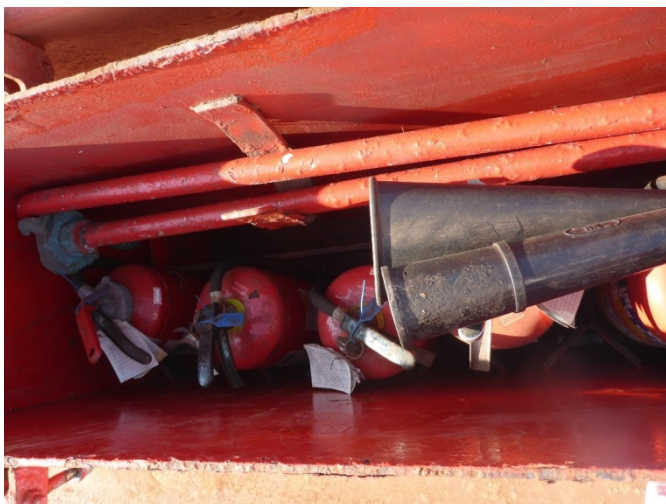
Rubber hose of fire extinguisher deteriorated and cracked open

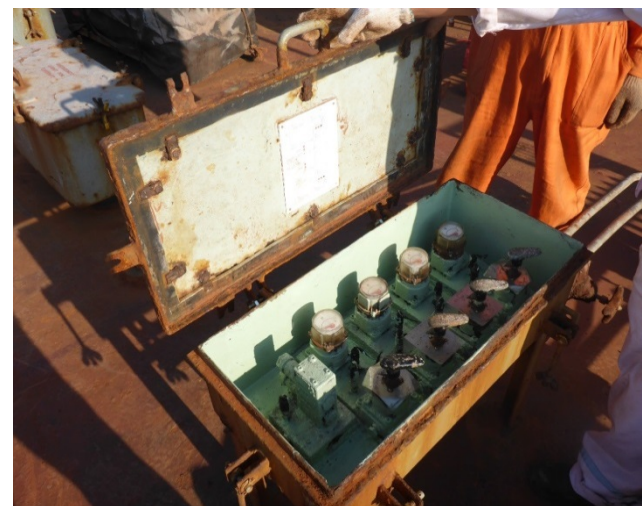
Leakage of main deck's hydraulic valve

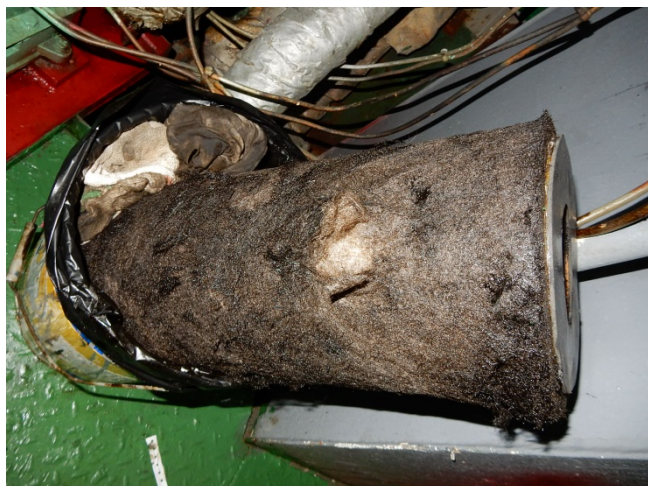
**Deficiencies for detention:** ineffective oil water separator

During the voyage that the oil water separator was used to dispose the bilge in slop/bilge tanks, the engineer on watch did not noticed that after a while, the bilge level was too low that large amount of dirty oil and bilge with high oil density entered into the oil water separator, which caused the severe pollution of filter catridge, coarse filter of primary separator, and filter element of second-stage separator; crews did not clean and maintain the separator after, which caused the oil water separator out of operation. When the PSCO carried inspection, large amount of oil stain were found in the bilge sample, and was determined deficiency for detention.

Sever  
pollution  
on filter  
element

All countries demonstrate serious attention on pollution prevention, and implement strict punishment. When the ship is using oil water separator to drain the bilge and dirty oil, close attention on bilge level and contained oil quantity shall be paid. Therefore can avoid water with obvious amount of oil sucked into oil water separator and clotted the filter and contaminate equipment and pipes. In addition, dismantlement to the oil water separator shall be carried out often, with inside parts and relative pipes cleaned; filter element shall be replaced in time as well.

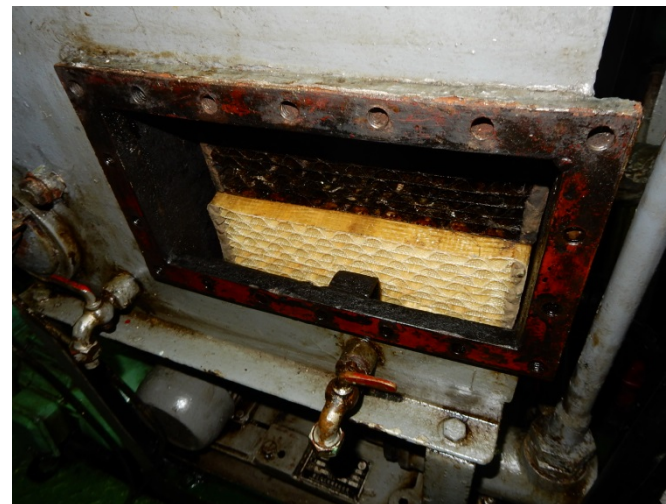
Severe  
pollution  
inside oil  
water  
separator

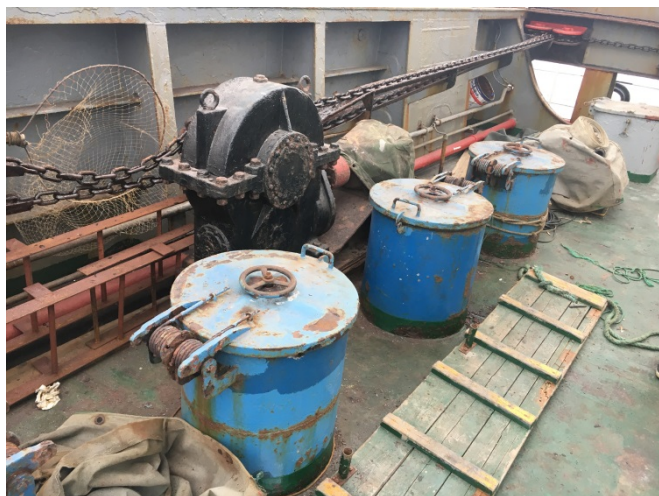
Small  
hatches of  
cargo holds  
unable to  
close

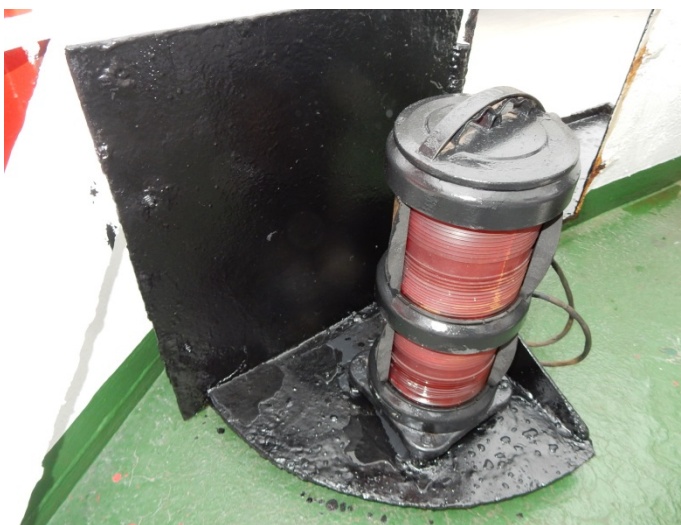
Back plate of  
side light was  
not painted with  
black matte  
(rectified)
