The Second Safety Meeting of Shipowner/ Ship  
Management Company, 2018

# PSC Session

CCS Headquarters  
August 2018

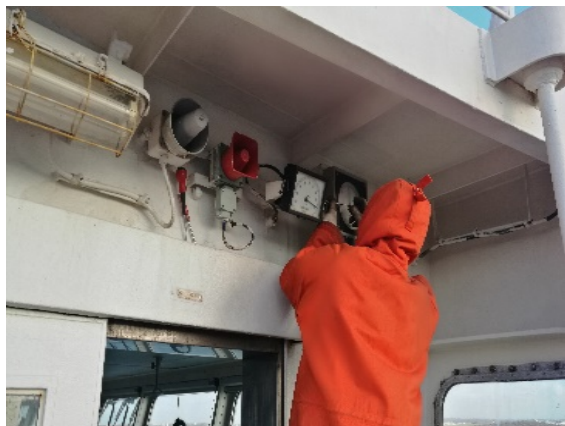
Rudder angle and speed indicator in abnormal condition

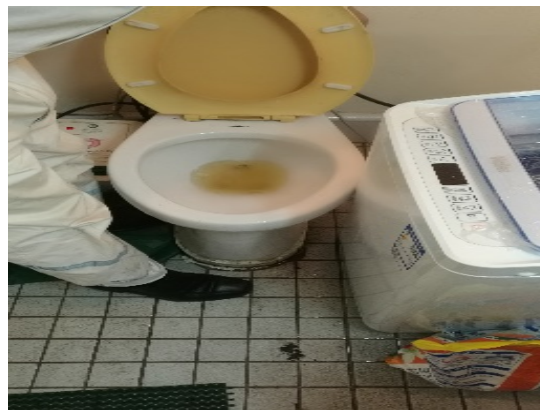
Untidy restroom, invalid flushing system

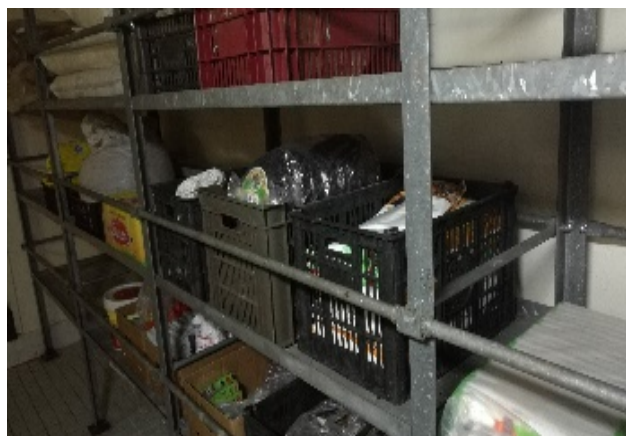
Deteriorate vegetable, and lack of dry food

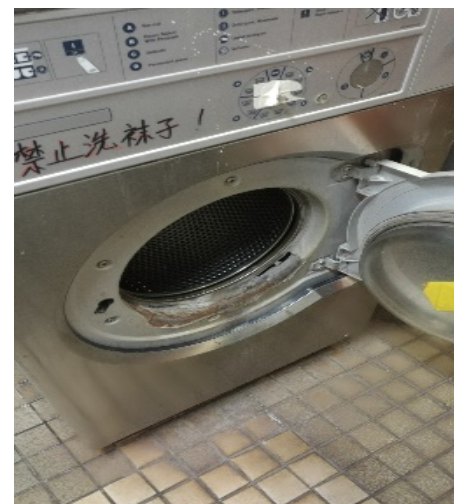
Washing machine doesn't function

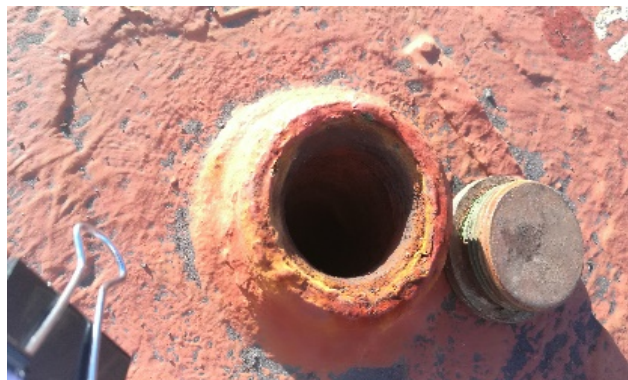
The cap for sounding pipe cannot be closed

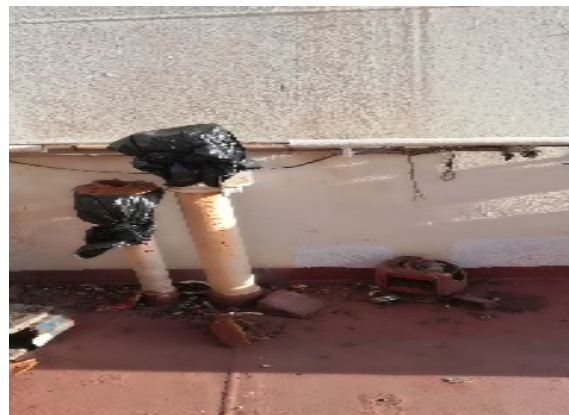
Poor condition of air pipe head

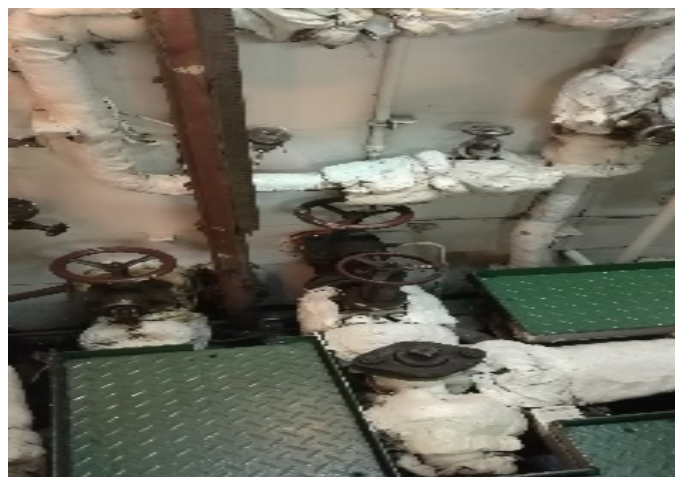
Low pressure of controlled air, and the quick closing valve cannot be closed

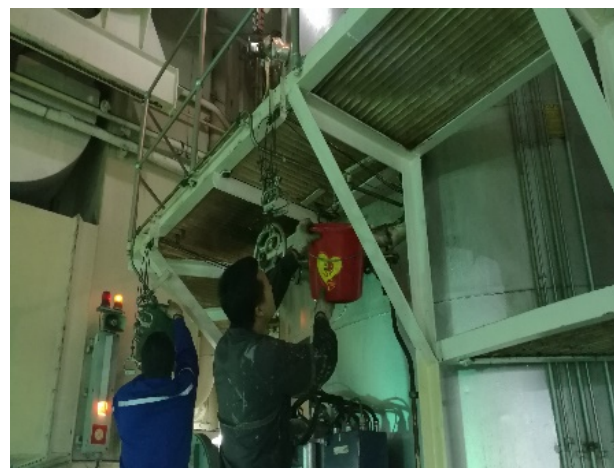
E.R. local water mist system failed

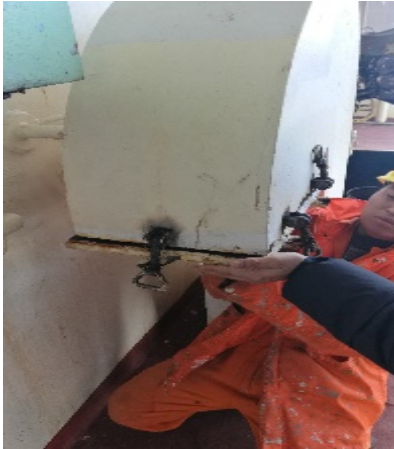
Gooseneck ventilator cannot be closed

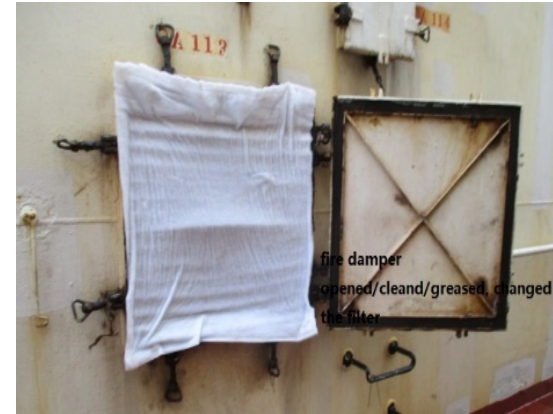
Shutter for ventilation opening in engine room cannot be closed

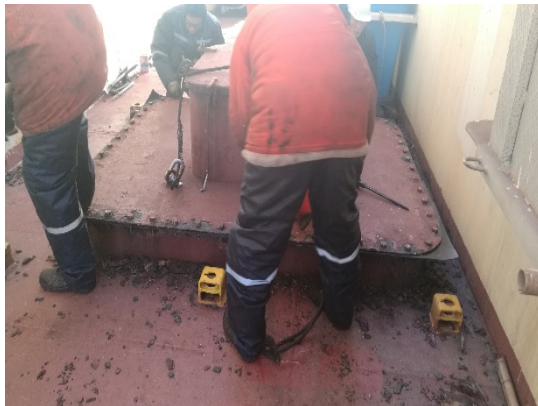
Set pin for small hatches of engine room casting missed

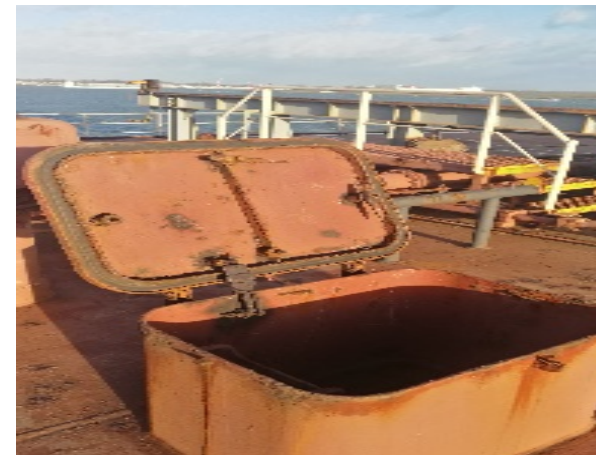
Manhole cover of cargo hold cannot be closed

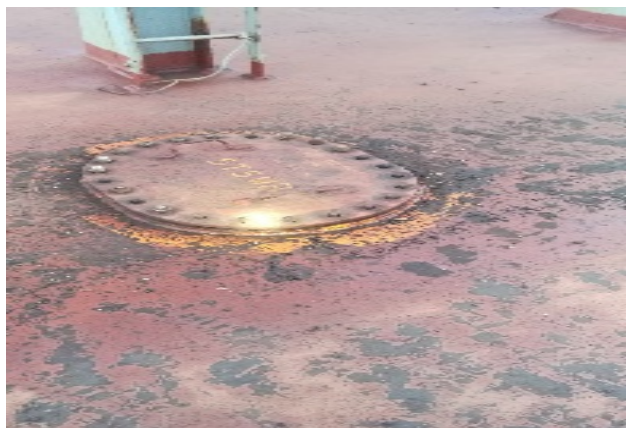
Invalid water tightness of manhole cover of ballast tank

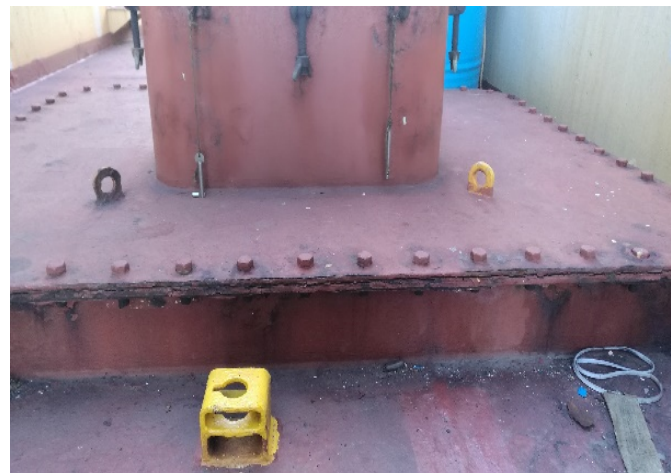
Sealing rubber gasket of engine room casting failure

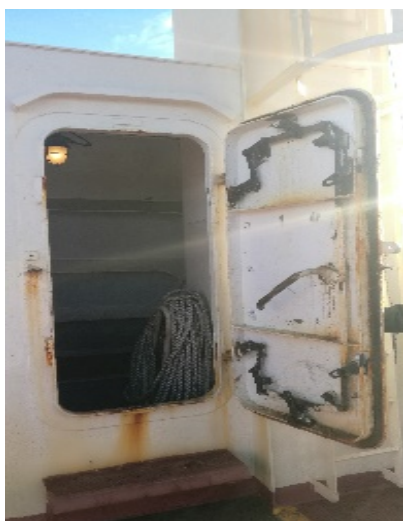
The store room door at forecastle can not be closed properly

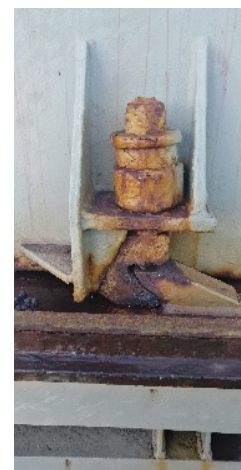
Clamming device of cargo hold hatch cover-malfunction

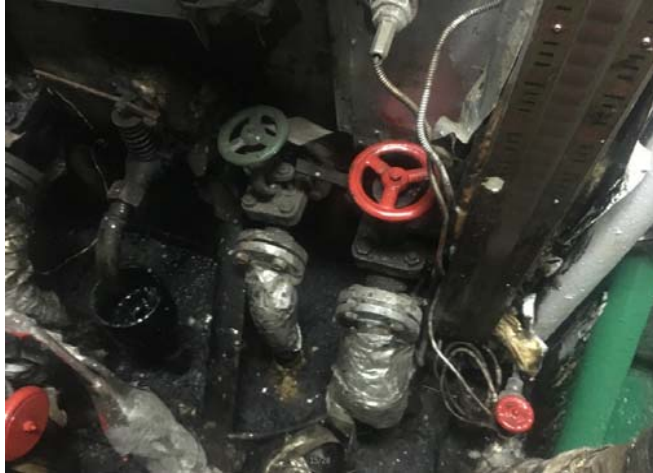
Quick closing valve of fuel oil tank did not work

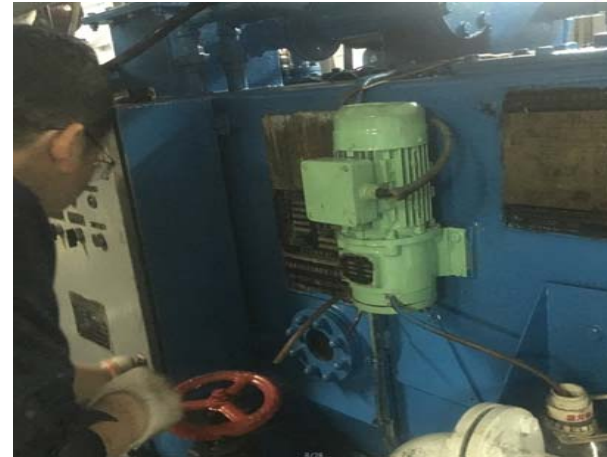
- **Investigation:** During PSC inspection, the Chemicals supply pump of sewage water treatment plant was found failed, and could neither be solved immediately nor reported to RO or Flag State; lack of attention on implementation of MLC Convention; the ship's implementation of ISM did not include ship's maintenance, and lack of training to the crews.

Chemicals supply pump of sewage water treatment plant failed

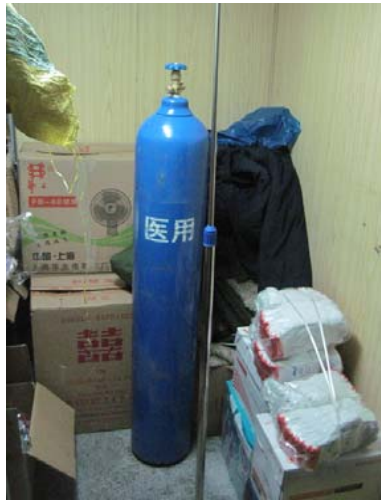
No medical-used oxygen cylinder (already equipped)

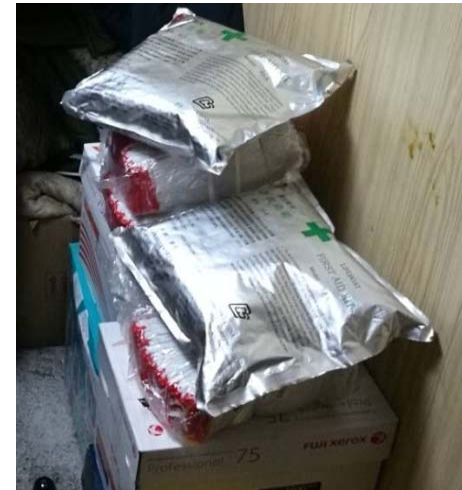
No first-aid kit in engine control room (already equipped)

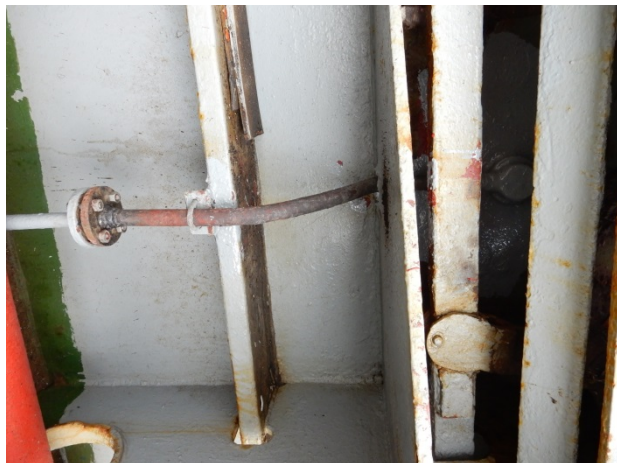
- **Investigation:** The steering gear of the ship failed during port arrival and the time spent on repairing in the sea-lane was longer. So, caused PSCO attended onboard for PSC inspection. PSCO found the CO<sup>2</sup> of the No. 2 cargo hold was holed, which led to the detention.

CO<sup>2</sup> pipe of cargo hold was hold (renewed)

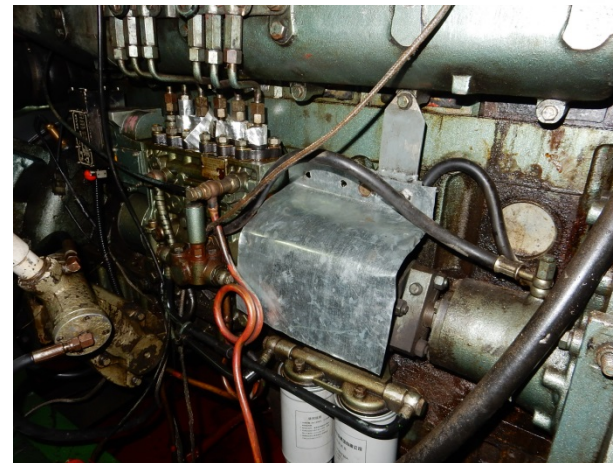
Protection cover of generator shaft lost  
(temporarily installed)

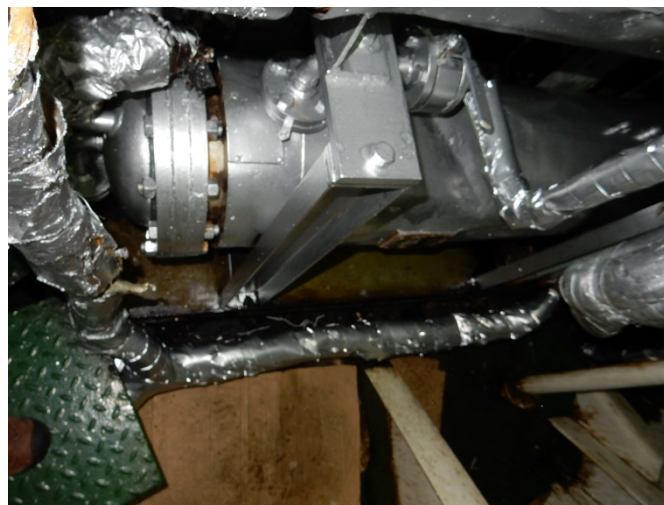
Steam heating tube of oil supply  
unit - after oil dirt removed

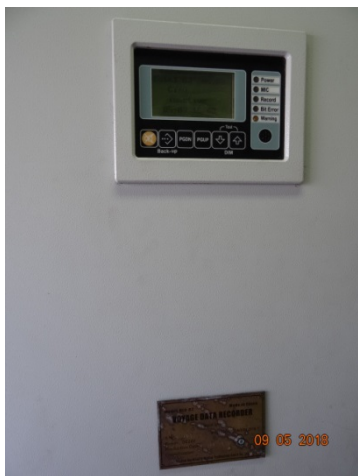
- **Investigation:** When PSC checked VDR, it showed "SYSTEM ABNORMITY". The Master explained to PSCO that it was already reported to the company, who had contacted the local service agent, but relevant document had not been able to be submitted to the flag state, class society and local PSC in advance; however the PSCO insisted on detention. After immediate repair by local service agent, VDR was able to function normally and passed tests; the detention was removed.

VDR damaged (already repaired)

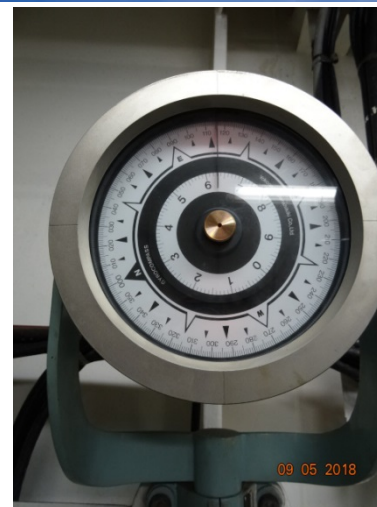
Repeater of gyro compass in steering gear room failed

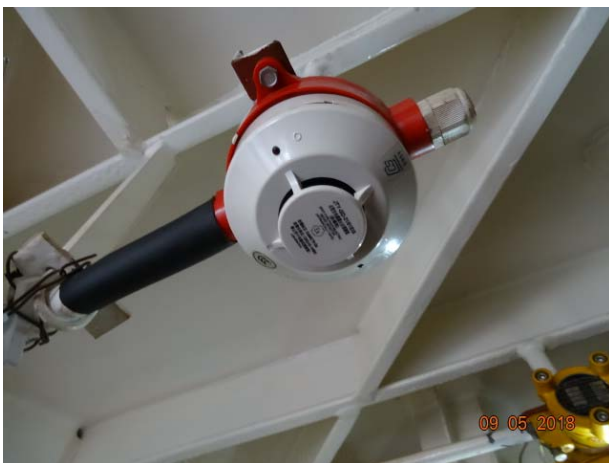
Fire detector in paint room damaged (already replaced)

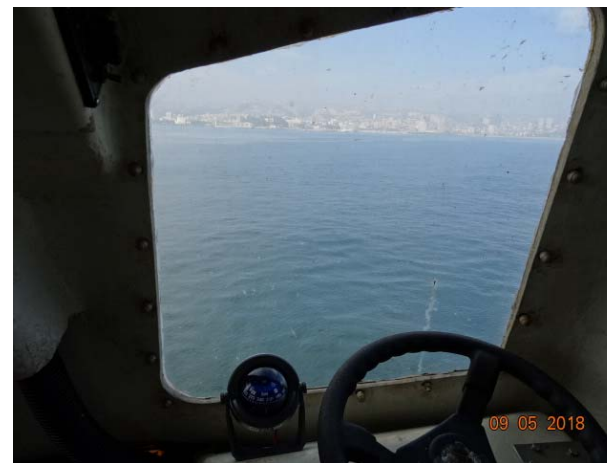
The window of the free fall lifeboat not clear (already replaced)

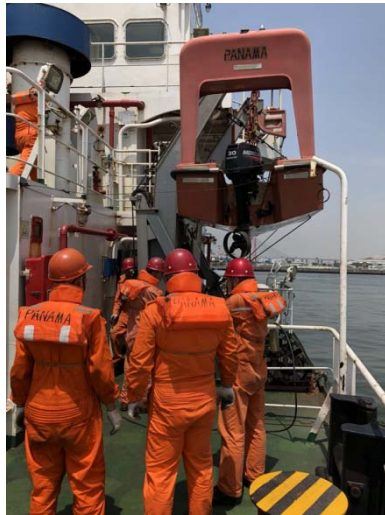
- **Investigation:** Unskilled practice of man-overboard drill—poor cooperation of crew members and unskilled boat operation; the crews began unlock the fixed steel rope even before rescue boat was ready; over long time to retrieve rescue boat, and the boat could not be placed under the davit, which caused the PSCO to consider a drill failure and accused crew members not familiar with responsibilities, and finally caused detention.

Ship's crews were not familiar with releasing/recovering rescue boat

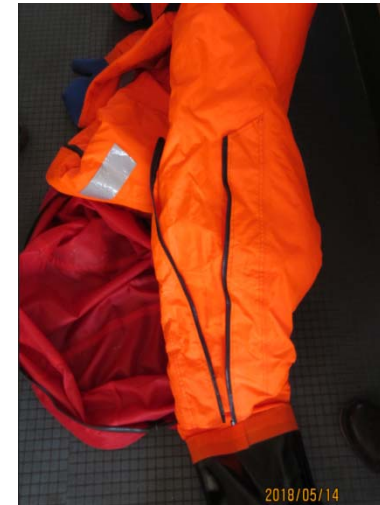
Damaged zip on immersion suit

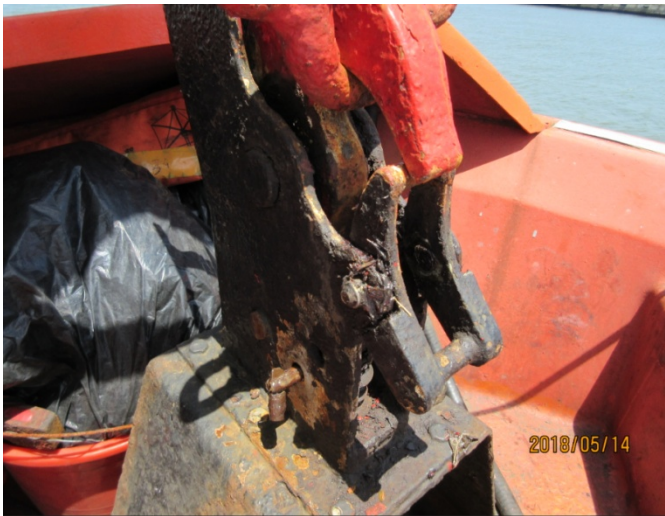
Hook of rescue boat seized

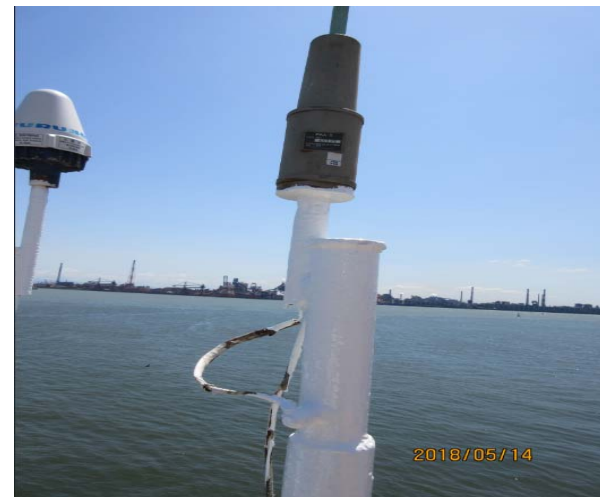
The antenna fixed rod is seriously corroded(already repaired)

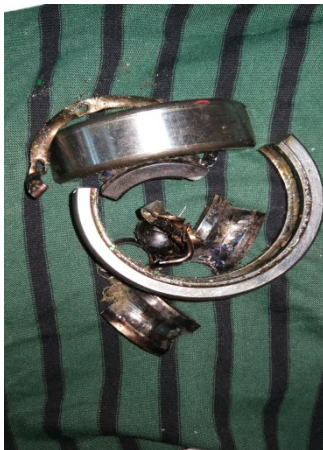
Bearings of emergency fire pump damaged

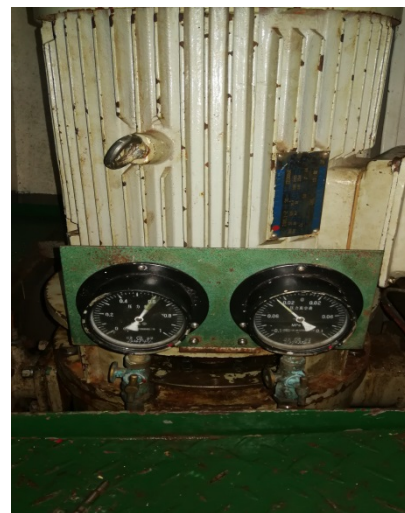
Test after restoration of emergency fire pump

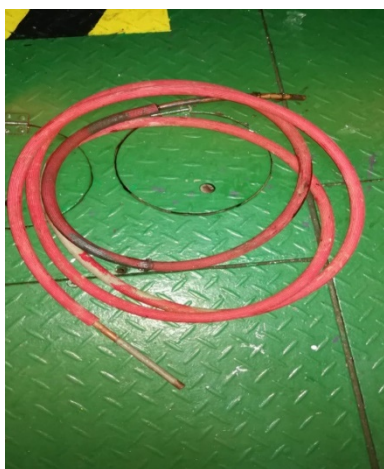
Dismantled rubber tube

- Conduct ship's maintenance and safety inspection effectively, and rectify latent defects of fire emergency equipment;
  - Copper tube was originally used as releasing tube for cooling water of air cooler for main engine; yet the crew member replaced it with rubber tube for convenience. Combustible materials such as rubber or plastic tube shall not be used in engine room to keep equipment sound and intact.

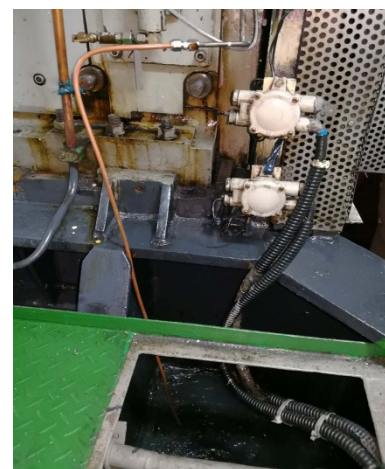
Copper tube replaced

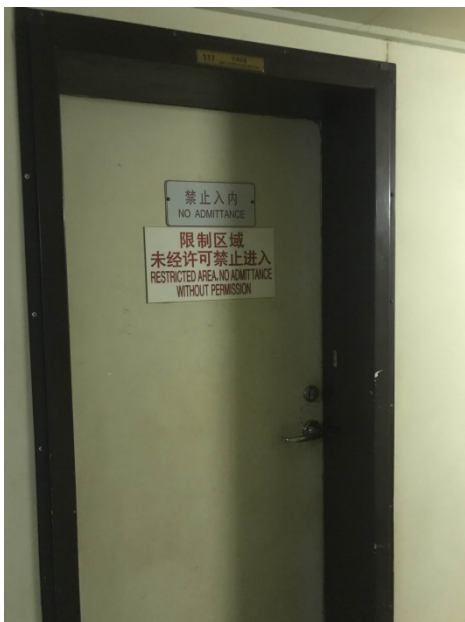
Automatic closing fire door (after rectification)

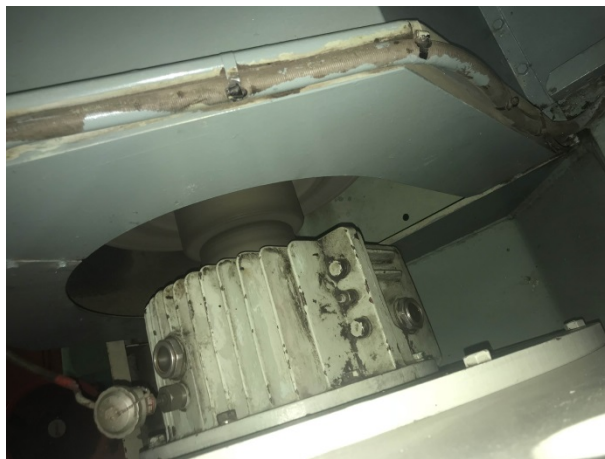
Cleaned bottom of auxiliary engine

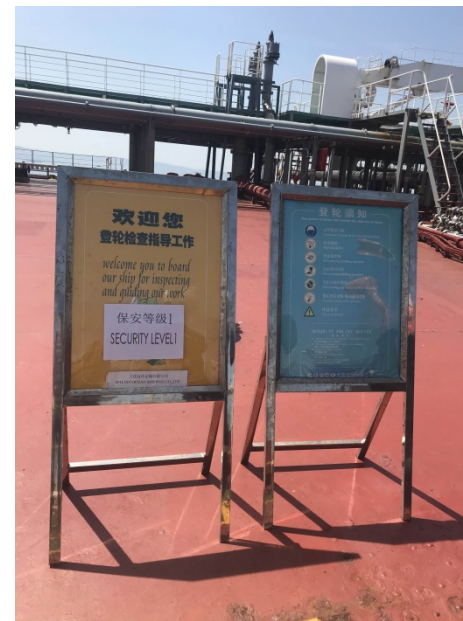
Security bulletin board (after rectification)

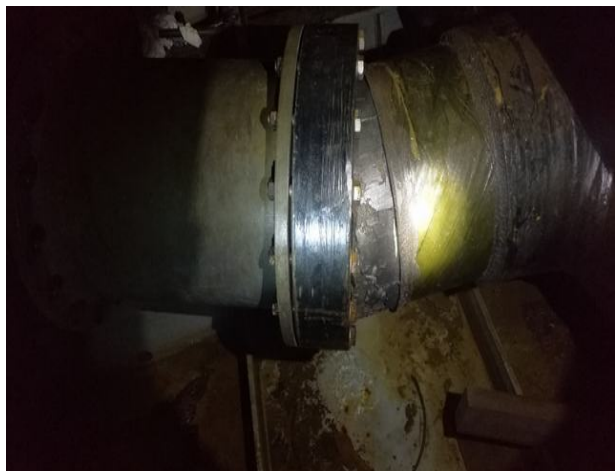
- **Investigation:** Water leaked from the joining area of ballast pipe (FRP material) in pipe tunnel, which caused the immersion of pipe tunnel and inability to open tunnel cover, further caused the fire detecting alarm, water ingress alarm and emergency fire pump that connected to it were immersed by water and could not function. After the accident, the company and ship did not report to local PSC, and flag state or class society with explanation; also, the fact that the small hatch cover and fire damper could not be closed and with other non-detention deficiencies, PSCO considered lack of validity of system operation and determined to detain the ship.

Water leakage of ballast pipe of pipe tunnel

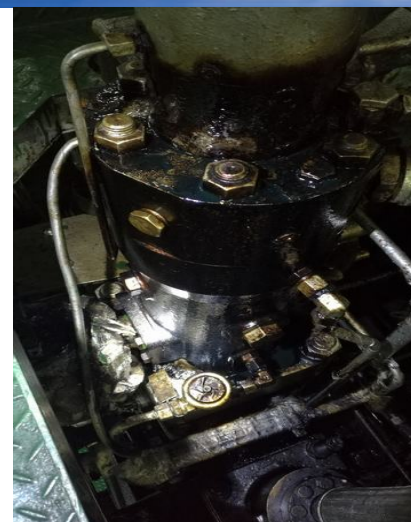
Oil leakage of high pressure oil pump

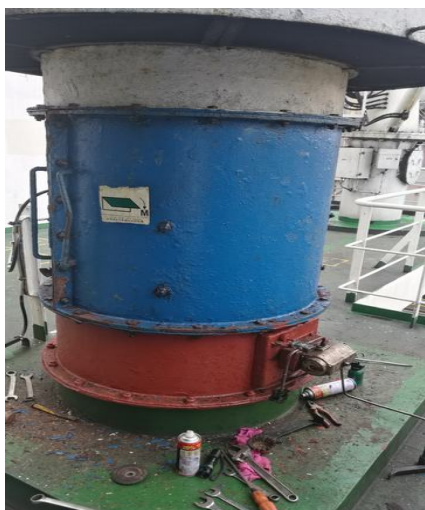
Damper of ventilator of engine room cannot be closed

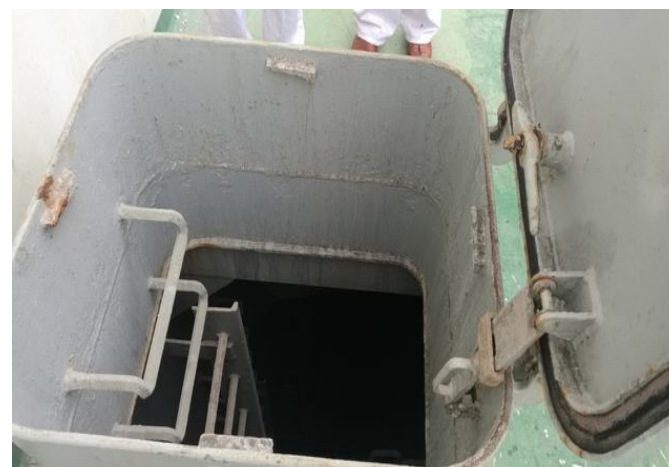
Small hatch cover cannot be closed tightly

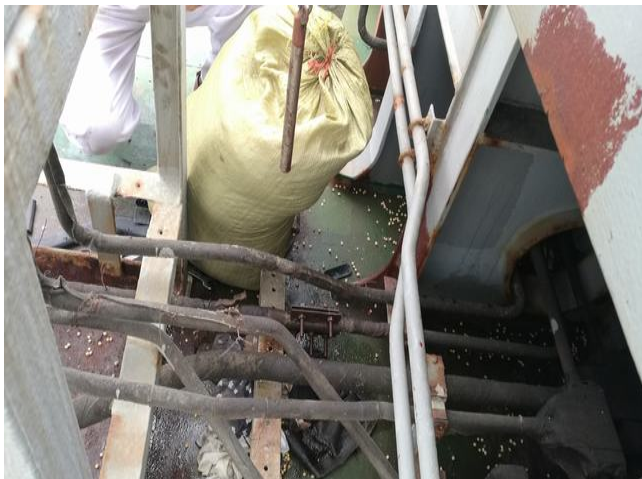
Leakage of hydraulic oil pipe on deck

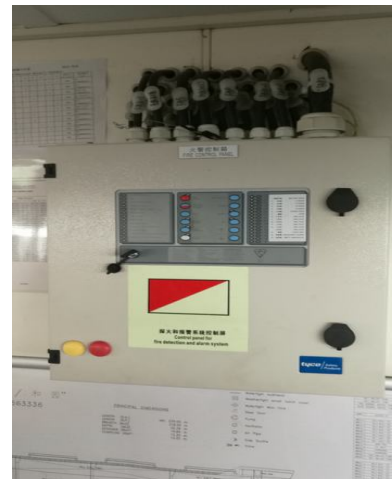
Fire detecting system in cargo hold failed

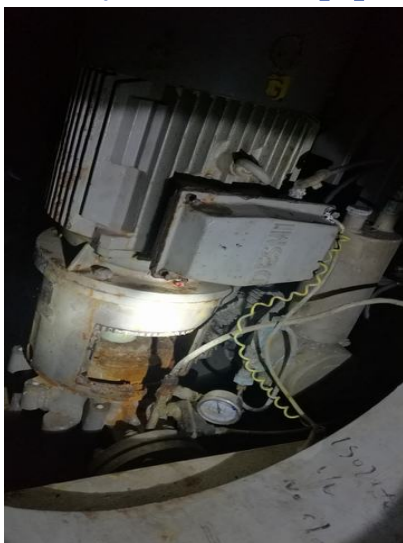
Emergency fire pump did not work

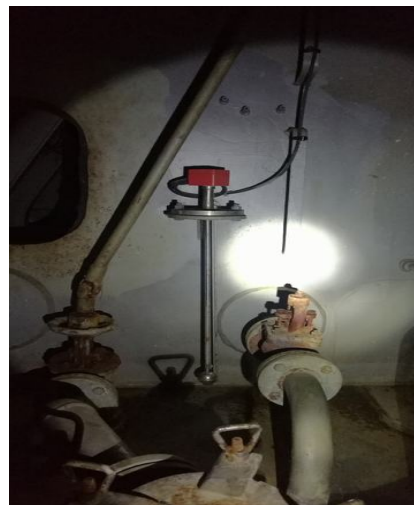
Water ingress alarm failed
