Bulletin

CCS Australian Office, No. 085, 2023 Issue 001

INSPECTION OF MAIN ISOLATION VALVE IN FIRE MAIN

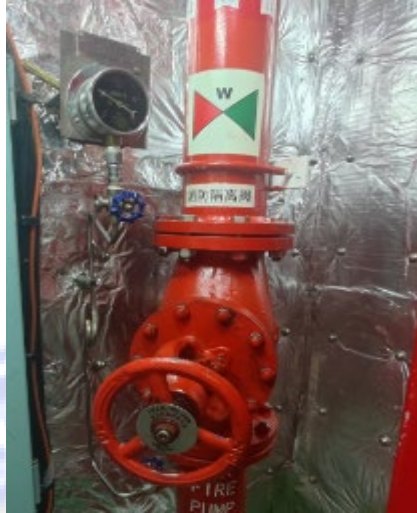
Picture 1

During an PSC inspection of said ship, the officer required the ship crew to perform operation testing of her emergency fire pump with the isolation valve in the fire main closed to the fire line from her machinery spaces. There was a pressure gauge fitted to the underside of the valve (i.e., machinery spaces side), as shown in Picture 1. After the pump was started, it was observed by the officer that there was still a pressure reading shown in the pressure gauge within the fire line from her engine room side, so the officer suspected that the valve was malfunctioning. To further confirm his assumption, he required the crew to switch the operation from the emergency fire pump to the main fire pump and audible flow sound was readily heard from the valve body upon the operation of the main pump. In the meantime, water leakage was seen at the outlet of the fire hydrant outside her deckhouse. Therefore, the officer judged that the valve was malfunctioning, and deficiency code 30 was given to the ship, requiring immediate rectification.

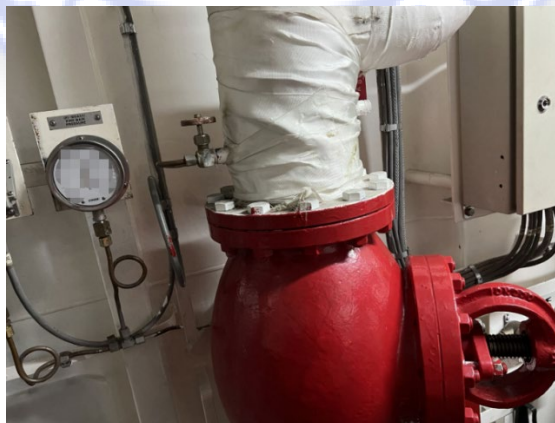
Picture 2

1. At present, some of the ships calling Australia have such pressure gauges installed at the main isolation valves at their fire control stations. The failure/malfunction of the valve can be readily identified by reading this gauge during the operation of main/emergency fire pumps. To be more specific, if the gauge is positioned to the bottom side of the valve (i.e., machinery spaces side) as shown in Picture 1, upon operation of the emergency pump, the gauge should indicate zero pressure with the valve in a closed position, which indicates there is no water pressure in the fire line from machinery spaces. Conversely, if it is position on top of the valve (the emergency fire pump side) as shown in Picture 2, upon operation of the main fire pump, the gauge should also indicate zero pressure with the valve in a closed position, which indicates there is no water pressure in the fire line from the emergency fire pump.

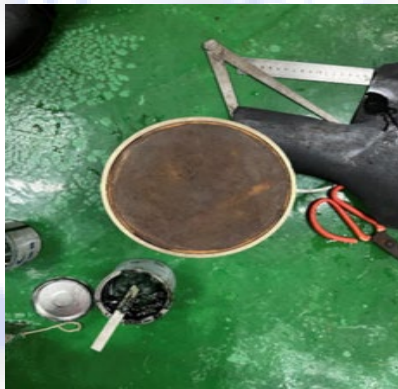
Picture 3

Through an investigation into the deficiency, it was argued that the root cause could be due to chronic corrosion of and physical fluid impact on the valve clack, which led to a reduction of its internal sealing. After the detention, the rectification was completed after the crew overhauled the valve to clean the inside of the valve body and polished/grinded the valve clack (Picture 3), which was followed by satisfactory operation testing.

1. operation testing of your emergency/main fire pumps and the main isolation valve at the fire control station is highly recommended before calling Australia, making sure they are all in good working order;
2. inspection and maintenance of the valve should be implemented on board on a regular basis, which includes but is not limited to manual turning actions/movement of the valve with bare hands (i.e., without aid of any tools).
