# Bulletin

CCS Australian Office, No. 089, 2023 Issue 005

## Notes on Recent High-Incidence Detention/Deficiency

### Items in the East Australia Region

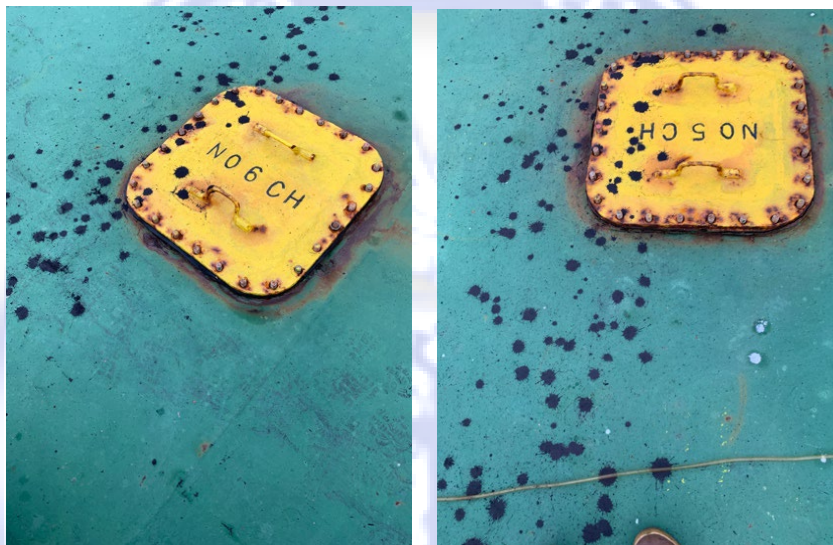
Figure 1

Taking a recently detained vessel as an example, all access hatches, including booby hatches, could not close weathertight. In some instances, numerous nuts were missing from these hatches (see Figure 1). As a result, the vessel failed to meet the watertight integrity requirements and was detained by AMSA.

"All access hatches to cargo holds not able to close weathertight. Booby hatch of cargo hold No.7 Aft not able to close weathertight."

Upon investigation, it was found that crew members had left some nuts loose to make it more convenient to access the cargo holds, leading to the loss of watertight integrity.

- 1.Strengthen the regular inspection and maintenance of Booby Hatch and related structures, components.
- 2.Enhance crew training and supervision to prevent situations where the bolts and nuts are not properly tightened at access hatches due to convenience or negligence.
- 3.Regarding the air vents for ballast tanks, adequate spares shall be

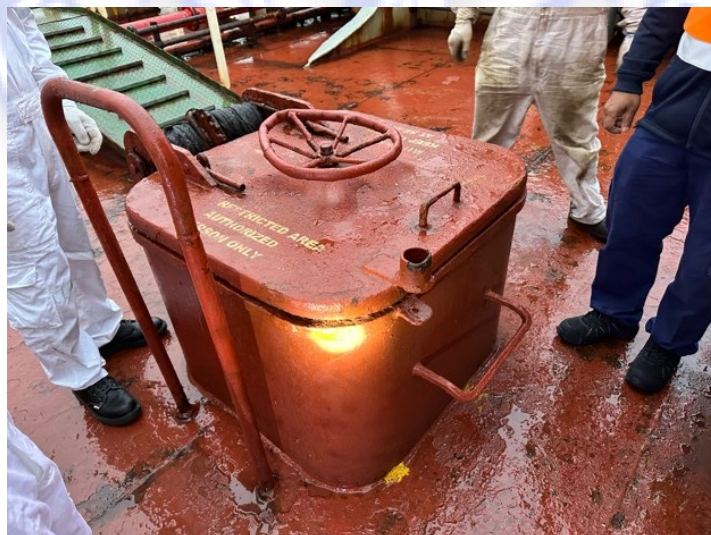
Figure 3

"Cargo hold No.2 (FWD) and No.4 (Aft) booby hatches not able to close weathertight."

During the PSC inspection, it was observed that the No.2 (FWD) and No.4 (Aft) booby hatches could not close completely, leaving gaps between the hatch and the cover (see Figure 3).

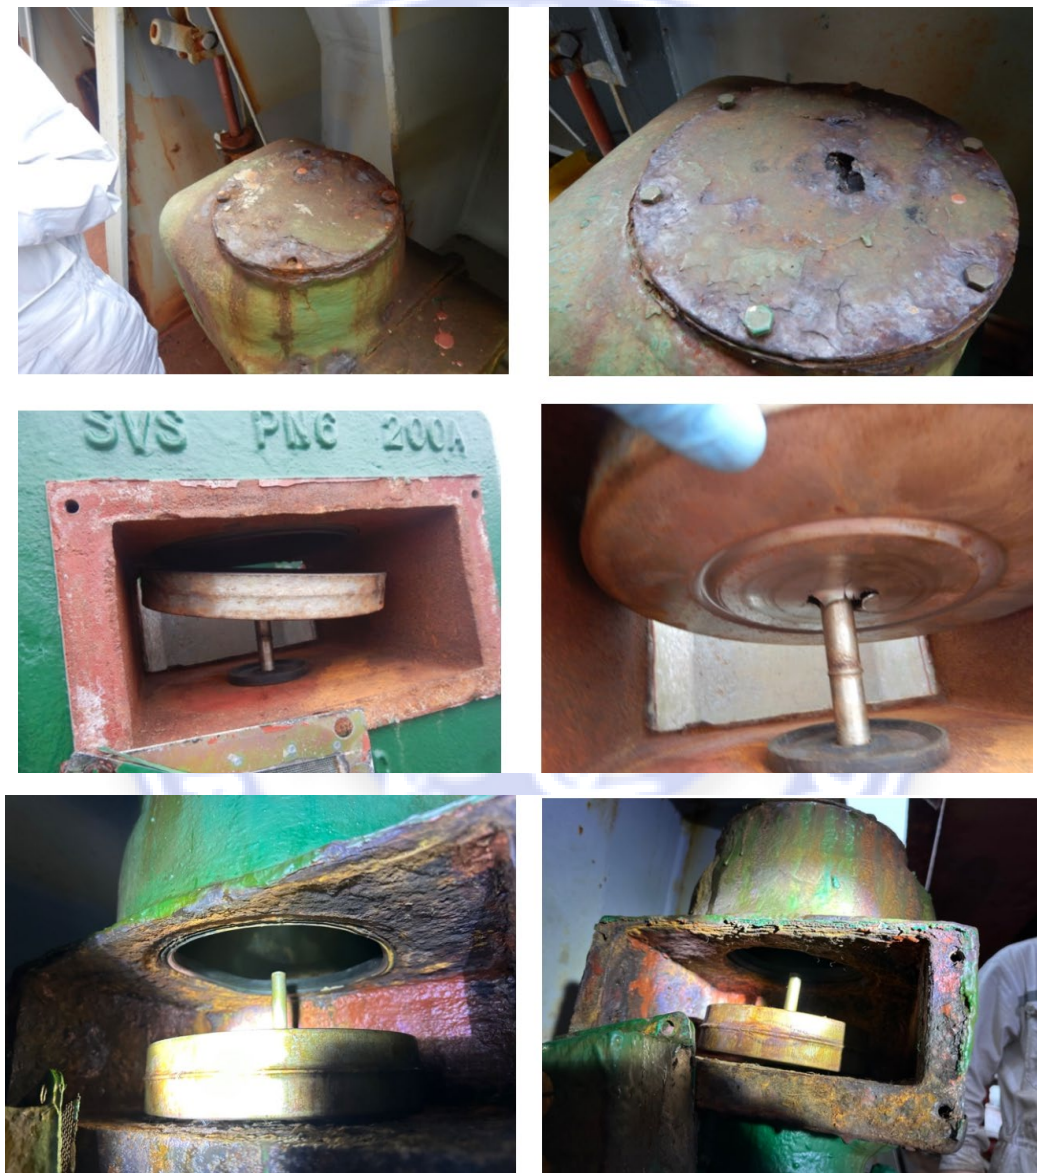
Figure 5

"Multiple ballast tanks air vent closing arrangements defective."

Due to a lack of routine maintenance, the closing arrangements for most of

the ballast tank air vents on the vessel were found to be in poor condition. During the PSC inspection, multiple ballast tank air vent closing arrangements were found defective (floats damaged, guide pin broken and air vent body damaged) at critical locations (fore peak tank, aft peak tank, etc.), as shown in Figure 5.

available onboard, including the entire bodies, floating disks/balls. guide bars and sealing rings, so the defective units can be rectified readily.
