## NOTICE ABOUT SURVEYS ON THE AGED VESSELS WITH HIGH PSC DETENTION RISKS DUE TO ELECTRICAL EQUIPMENT FAILURE

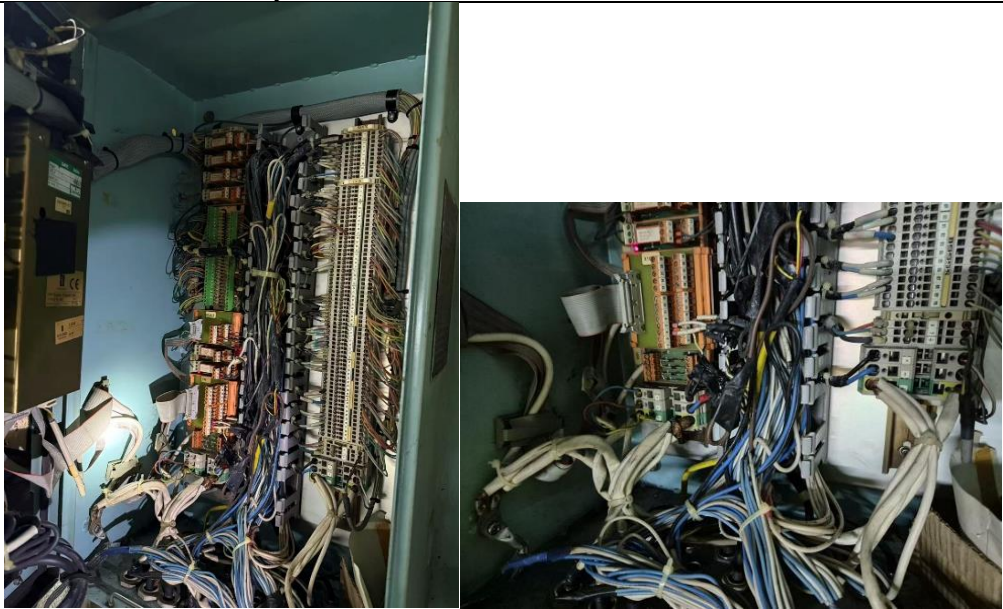
No.1	In the emergency operating box of the main engine, many cables are disconnected and bridged. An automation display is broken and completely out of order. The repair must be carried out by a specialist company. The entire emergency control box of the main engine must be inspected by an authorized company. A report from the company and the classification society must be sent to PSC-GERMANY.DE. <b>(Ground for Detention)</b>

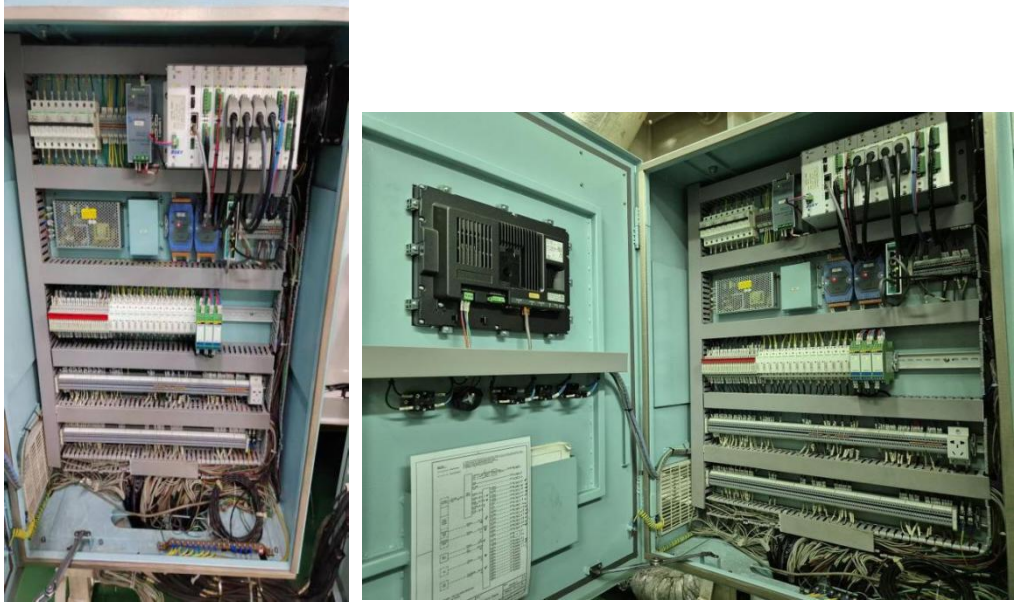
No.2	Several disconnected cables and bridges were found in the engine room inside the control box (ballast water management system). The system has been manipulated. <b>(Ground for Detention)</b>

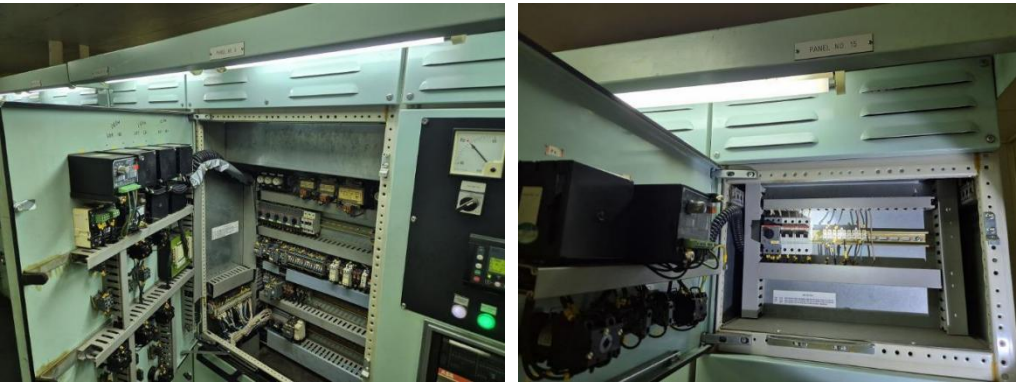
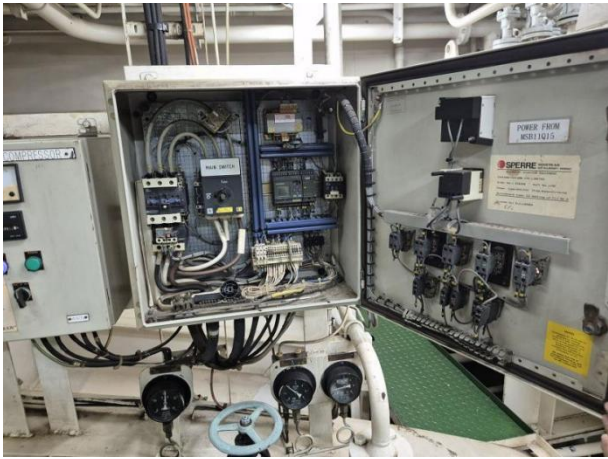
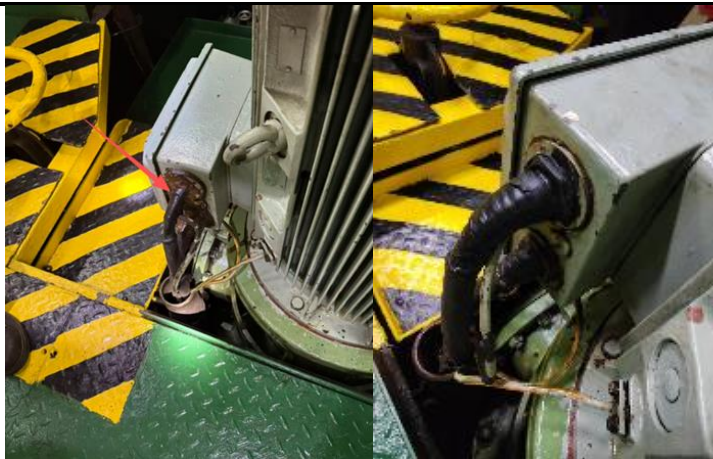
<p>No.3</p>	<ul style="list-style-type: none"> <li>-Found in main switchboard,in Panel 6 and 15 (megaohm test) unsafe cable connections and bridges.</li> <li>-Found in switchbox (main air compressor 2) unsafe cable connections and flying cables.</li> <li>-Found the cable connection of one ME lub oil pump not watertight and unsafe.</li> <li>-Found HT Calorifier leaking.</li> <li>-Found cable of remote control engine room crane stripped and damaged.</li> </ul>

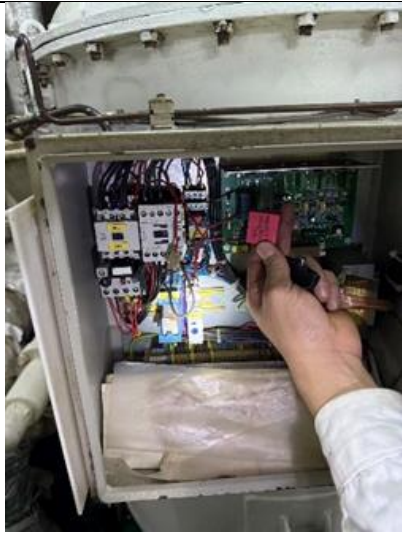
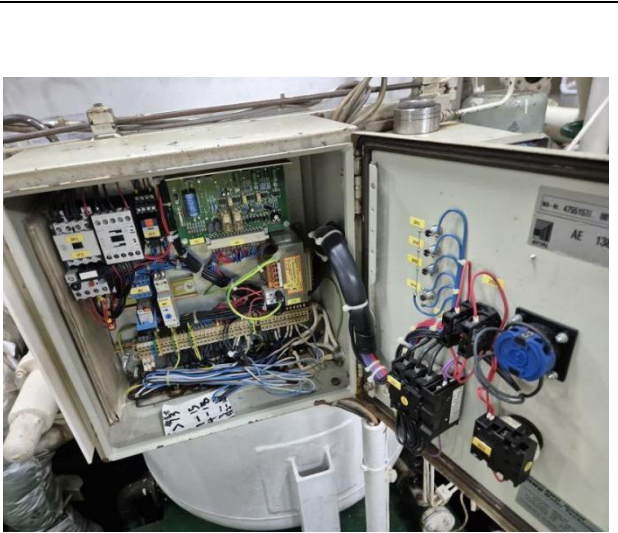
No.4	Found an manipulation (flying additional relay) in the RWO WATER TECHNOLOGY switch box.

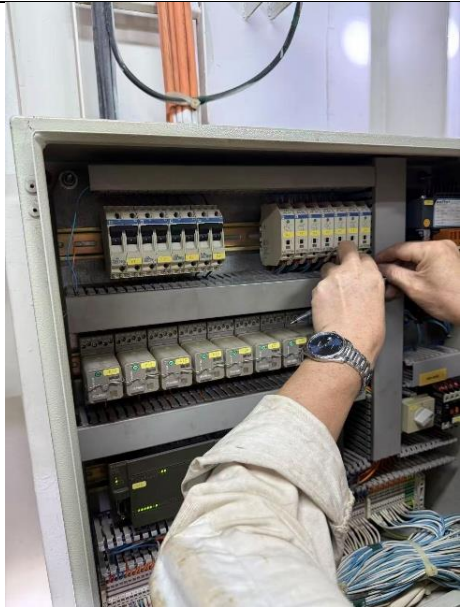
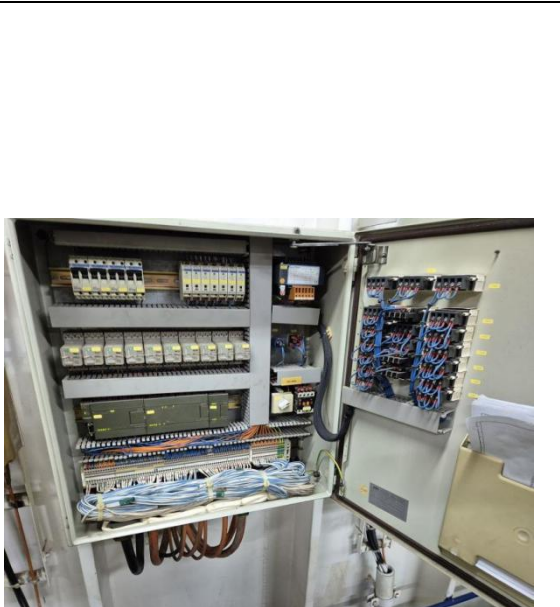
No.5	Found in steering gear (contactor cabinet warning box) a flying relay. <b>(Ground for Detention)</b>

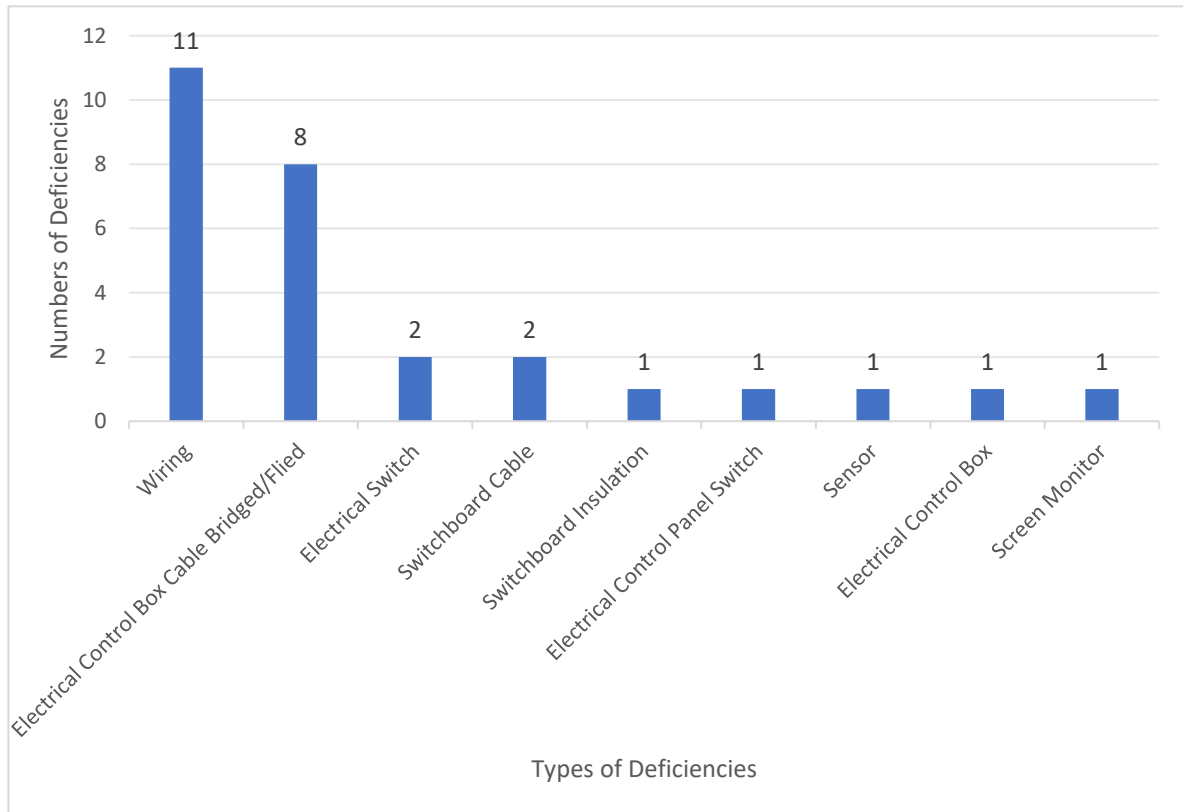
Based on inspections conducted on CCS classed vessels at this port since the beginning of this year, the main deficiencies were concentrated in areas such as cable bridging, temporary wiring, and unsafe connections, totaling items, accounting 75% of all electrical defects.
