Bulletin

CCS Australian Office, No. 104, 2026 Issue 003

Maritime Safety Awareness Bulletin Regarding AMSA Maritime Safety Bulletin 23 Pilot transfer arrangements

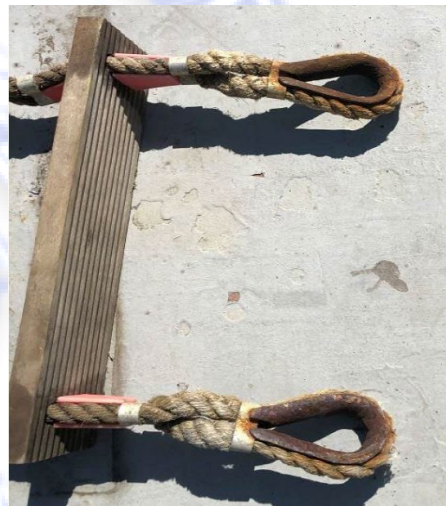
- Side ropes worn, aged, contaminated, or insufficient in strength
- Pilot ladders not complying with ISO standards or without valid certificates
- Damage caused by corrosion of end metal fittings
- Steel fixing screws embedded within the step fixtures (chocks) were observed to have chafed against the side ropes

Figure 2 Example of corroded end point thimbles (protective rings)

- A regular inspection regime shall be established under the ISM system
- Equipment exposure to ultraviolet radiation, chemicals, and other adverse environments shall be prevented
- Pilot ladders and man ropes shall be periodically replaced (according to AMSA Marine Notice 23/04 and ISO requirements, pilot ladders complying with ISO 799-1:2019 shall undergo and pass strength testing within 30 months, or otherwise be directly replaced; additionally, PORT OF PORT HEDLAND LOCAL MARINE NOTICE 14/23 (P) contains corresponding requirements)
- Man rope specifications: diameter 28–32 mm, made of Grade One Manila rope (PORT OF PORT HEDLAND LOCAL MARINE NOTICE 14/23 (P))

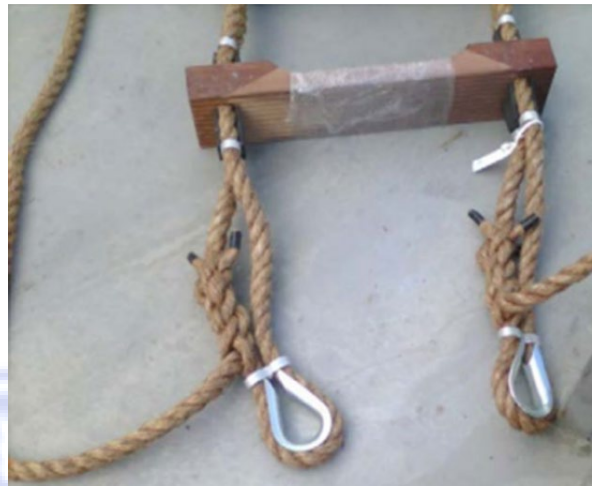
- Incorrect arrangement of combination ladders
- Pilot ladder not extended to the required length above the platform
- Unsafe embarkation/disembarkation point arrangements
- Splices found in the side ropes of pilot ladders, which are non-compliant

Figure 4 Side ropes with splices (connections)

- Manufacturer's certificate must be provided and comply with SOLAS V/23 or ISO 799-1:2019 standards
- Regular inspections shall be carried out and the ladder maintained in good condition
- Side rope splices, uneven steps, slipping hazards, or non-compliant structures shall not be present

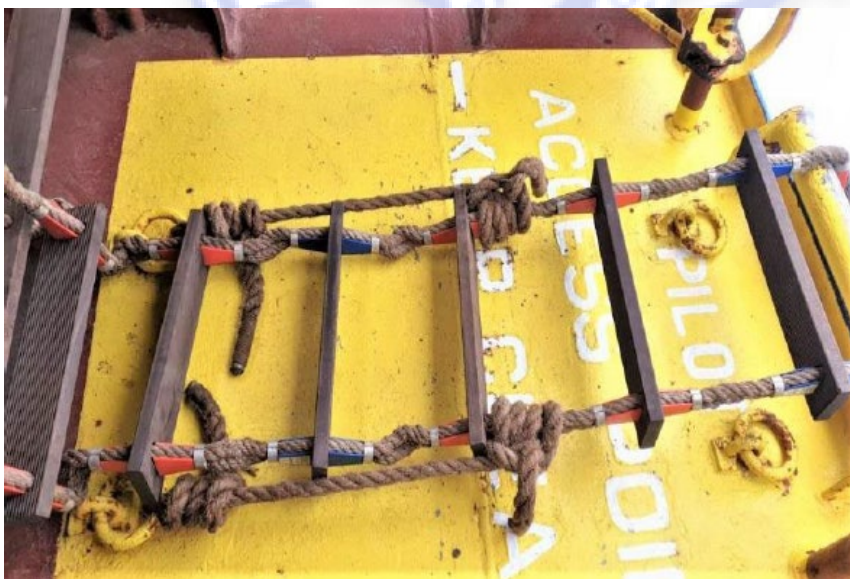
Figure 7 Pilot ladder secured to approved main deck strong points using rolling hitch knots.

- Pilot ladders shall be secured to strong points on deck
- Load shall be transferred through the side ropes and shall not be borne by steps or spreaders
- Use of rolling hitch knots for securing is recommended (AMSA Marine Notice 2023/04)
- Use of shackles or steel fittings to directly bear side rope loads is prohibited
