# Bulletin

CCS Australian Office, No. 060, 2017 Issue 002

## Australian Ship Safety Information

### --- Air Vent for Ballast Tank and Fuel Oil Tank

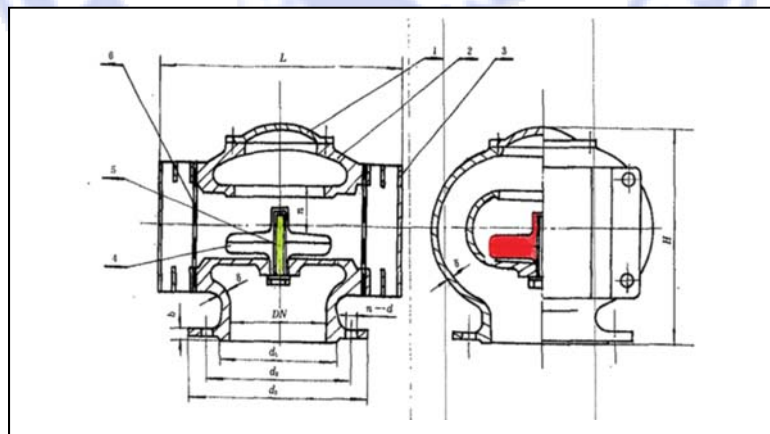
As a supplementary reminder to <CCS Bulletin (No.17) > for Float Disk Type air vent for ballast tank and fuel oil tank (as indicated in below picture) , for this type of air vent, the float disk, rubber ring inside of air vent MUST be kept in good working condition all the time, furthermore, the cover plate on the top of air vent body MUST also be kept in watertight condition.

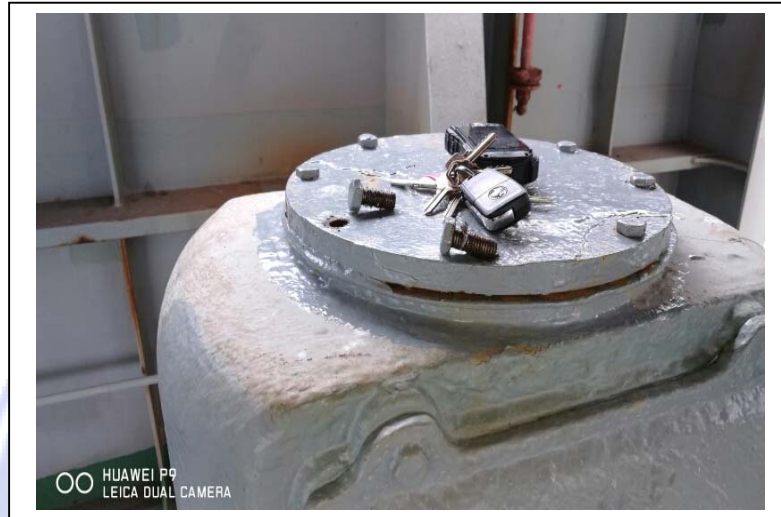
It was noted failing to kept cover plate in watertight condition will result in vessel detention for the possible reason of mounting bolt broken, cover plate deformed and/or

seriously rusted and even holed.

Following picture indicating failing to keep watertight between cover plate and air vent body, for which AMSA detained the vessel.

Hereby, your attention was drawn to make sure all the air vent for ballast tank and fuel oil tank was dismantled for checking by crew staff one by one and kept in good working conditions before vessel visiting Australia.

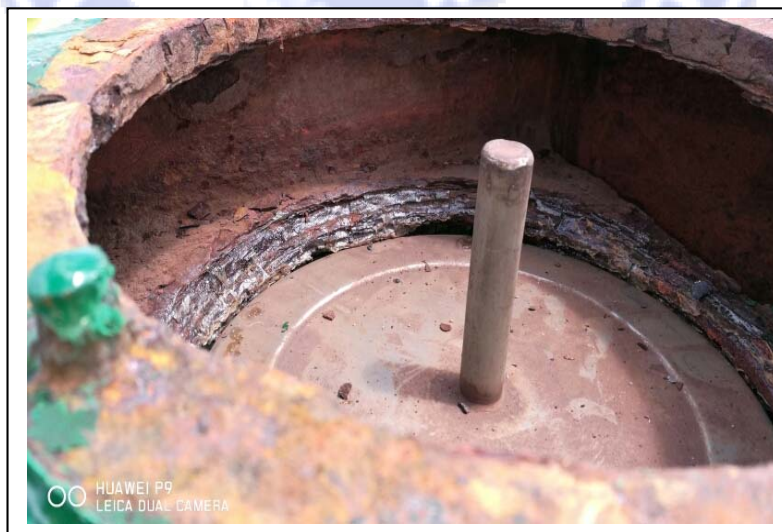
Although some float disk kept in good working condition, the inside supporting structure member rim for rubber ring rusted seriously as pictured below (noted the rubber ring was glued on the supporting structure member). In this situations, rubber ring will fall off when it encounter heavy sea water or overfilled ballast water, which will also cause vessel detention. (Please note: the rubber ring was removed off deliberately for picture purpose)

Meanwhile, Company make sure plenty of air vent spare parts always provided on board.
