# Bulletin

CCS Australian Office, No. 042, 2015 Issue 002

## AMSA PSC Information

### Engine Room Ventilation Fan Trunking Closing Appliance

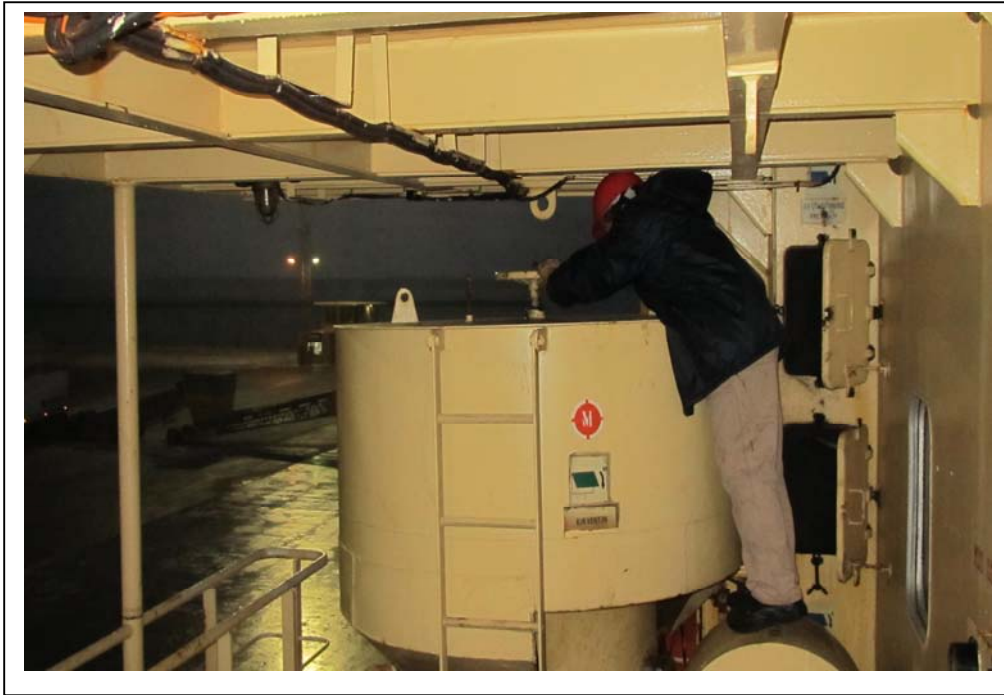
For easy and immediate access to operation of hand wheel located at the top of ventilation mushroom cover, a vertical ladder normally fitted between the trunking supporting deck and top of mushroom cover, indicated as following picture:

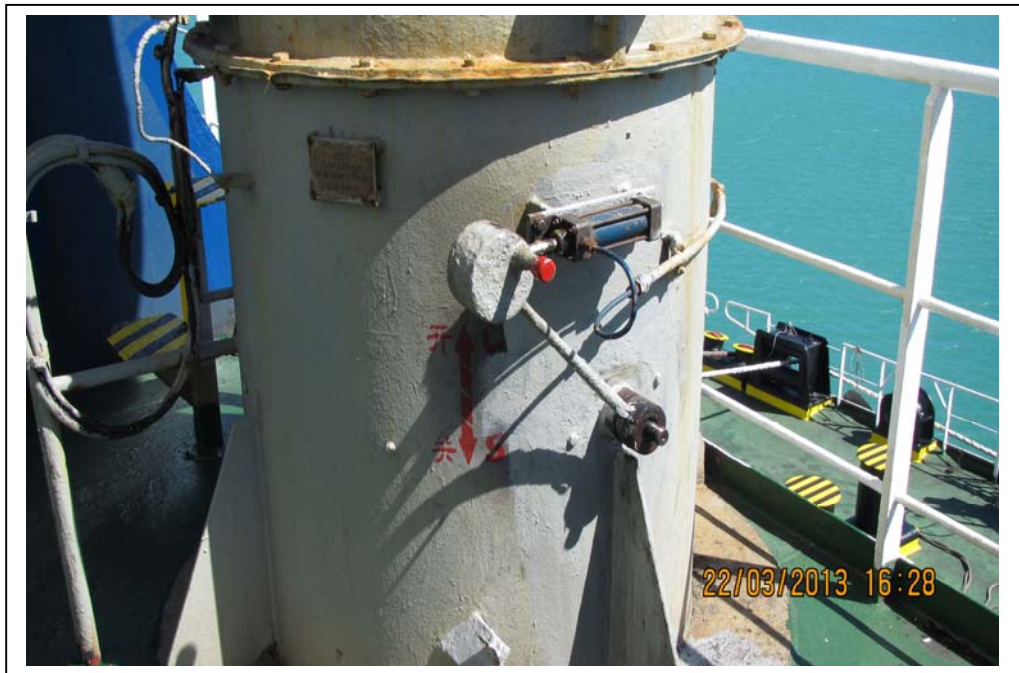
Most vessels utilized compressed air as medium to remotely controlled close to fire damper. As an example indicated in below picture, under the compressed air, the pneumatic actuator piston rod moved away from its original position which was expected to hold the fire damper in open status through attached connecting rod, and then the

weight made the connecting rod turn anticlockwise to push the round fire damper in ventilation trunk to close status.

- O-ring in pneumatic actuator defective caused the piston rod no any or requisite travel, failing to release the weight of connecting rod, resulting that round fire damper not closed immediately.
- Compressed air found leaking at fire control station, pressure pipeline, and/or connection to pneumatic actuator, no requisite piston rod travel available.
- No required maintenance and lubricating oil to the round fire damper axle bearing, made fire damper not open and closed freely.
- The fire damper attached connecting rod fixing angle to the fire damper itself not in correct position, which resulted fire damper not turned to the expected close position when the weight falling down.
- The round fire damper in ventilation trunking rusted serious, even holed, under effect of high temperature and high speed of air in the trunking, which made fire damper defective.

- The drive shaft to fire damper axle end sheared and failed, which will be very hard for crew staff to detect this deficiency during its routine work and will seriously impact expectation of fire damper remotely controlled close.
- When locally controlled close function included, to ensure all the locally controlled related function kept good operational.

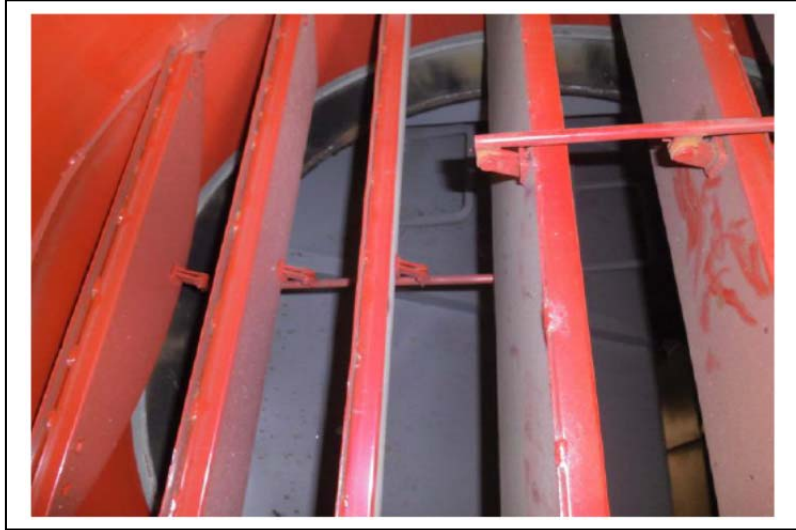
Following picture demonstrating fire damper in open status:

Normally, this type of fire damper was designed made of 5-7 louvres, among which middle louvre operated as leading louvre and the others as following louvres, all the louvres connected with each other via linkage bar. Each louvre turned around its axle end bearing fitted to the ventilation trunking coaming.

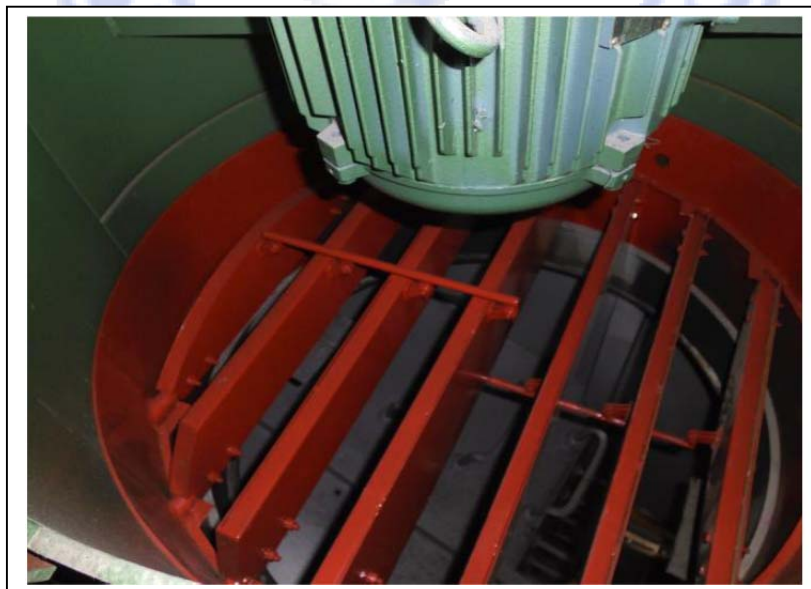
Through a newly installed inspection hole, duty crew can easily and will be happy to do inspection and maintenance to fire damper inside of trunking as demonstrated in below picture:
