Bulletin

CCS Australian Office, No. 087, 2023 Issue 003

PILOT TRANSFER ARRANGEMENT

Based on AMSA Marine Notice 23/04

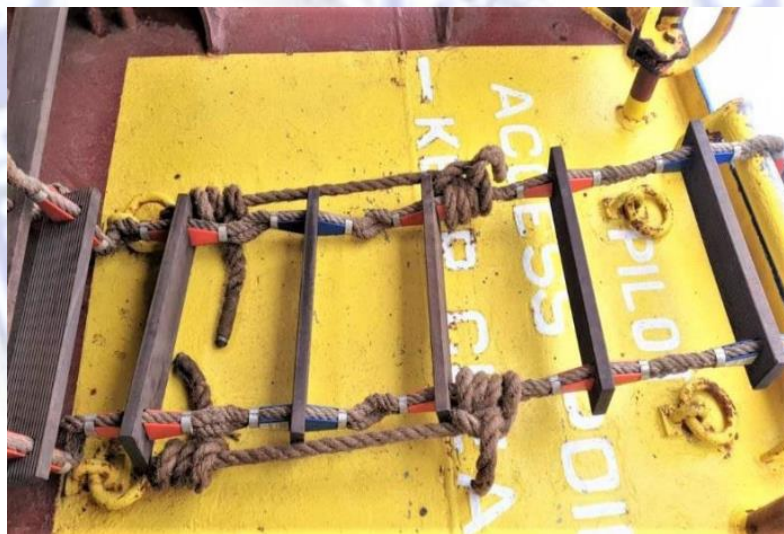
Picture 2 appropriate application of rolling hitch knot to secure a pilot ladder to a deck strong point (Source: AMSA Marine Notice 2023/04)

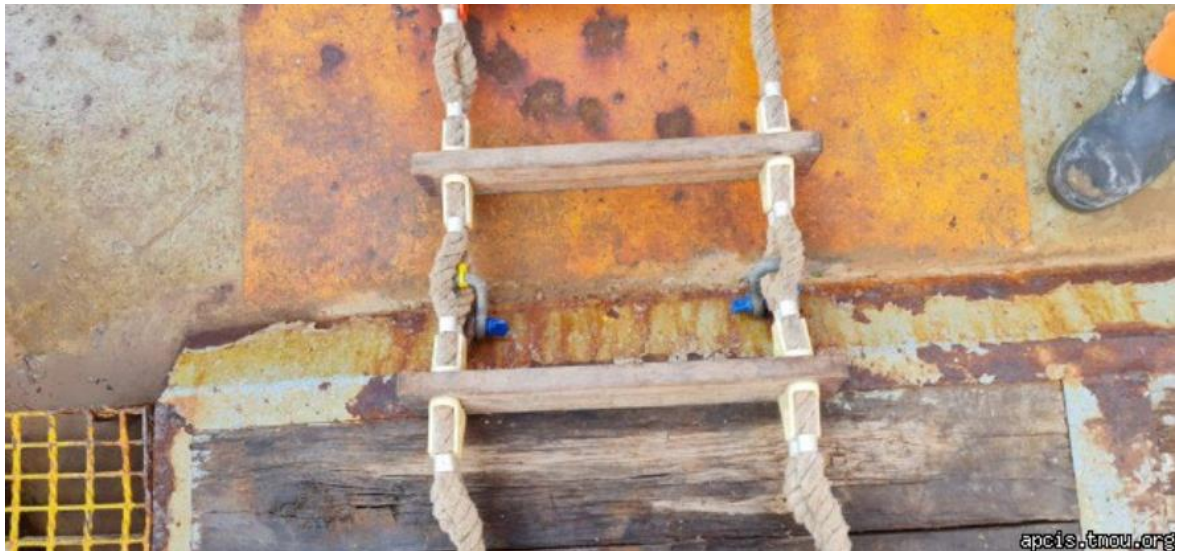
Picture 6 & 7 show examples of unsafe use of shackles to secure pilot ladders.

Picture 7 Unsafe pilot ladder securing arrangements

The pilot ladder is normally secured at its thimble end with shackles. However, due to the varying freeboard at specific loading conditions, the pilot ladder cannot always be secured at full length by the thimble ends. Under such circumstances it must be secured at an intermediate length. That can only be done in a safe way by ensuring that the weight

of the ladder is transferred from ladder' s side ropes to the approved strong point on deck directly.

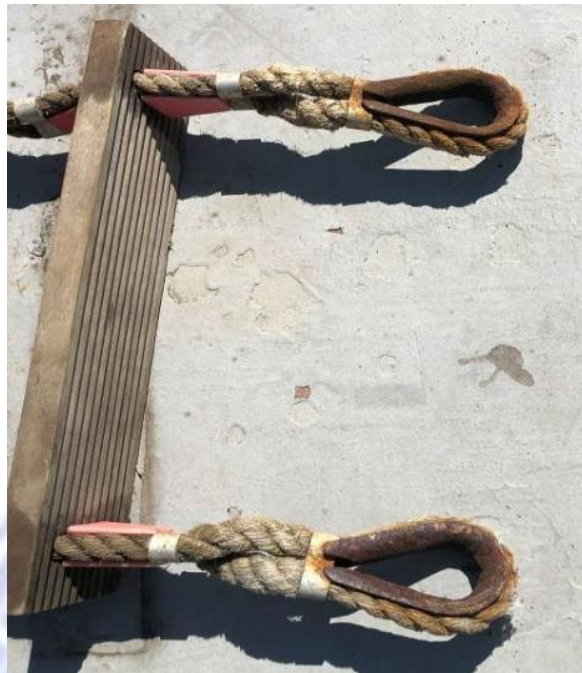
Picture 8

Common areas of defects can be the thimble ends of the pilot ladder. Corroded end point thimbles as illustrated in Picture 8, can damage the side ropes leading to failure.

Ongoing inspection and maintenance of pilot boarding arrangements are an essential part of ensuring their continued safe operation. Paragraph 10.1 of Part A of the International Safety Management Code (ISM) requires ship operators establish procedures to ensure a ship is maintained in conformity with the relevant rules and regulations, including pilot transfer arrangements. Such procedures should include regular inspections of the pilot transfer arrangements and storage to prevent damage of such equipment when not in use.

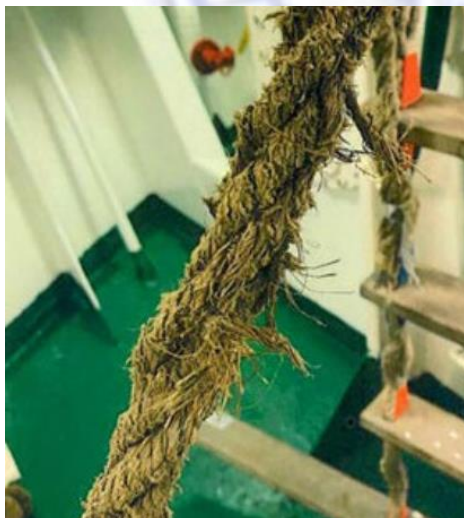
Picture 9

Another common area is the frayed or damaged side ropes as illustrated in Picture 9, and as a result, Pilot ladder where side ropes parted when in use (Picture 10). These should be detected during routine visual inspections.
