I. Description of Third Quarter 2016 PSC Inspections

1. General situation of third quarter 2016 PSC inspections of CCS classed ships

Classed Ship in Service Dept. of CCS Headquarters

October 12, 2016

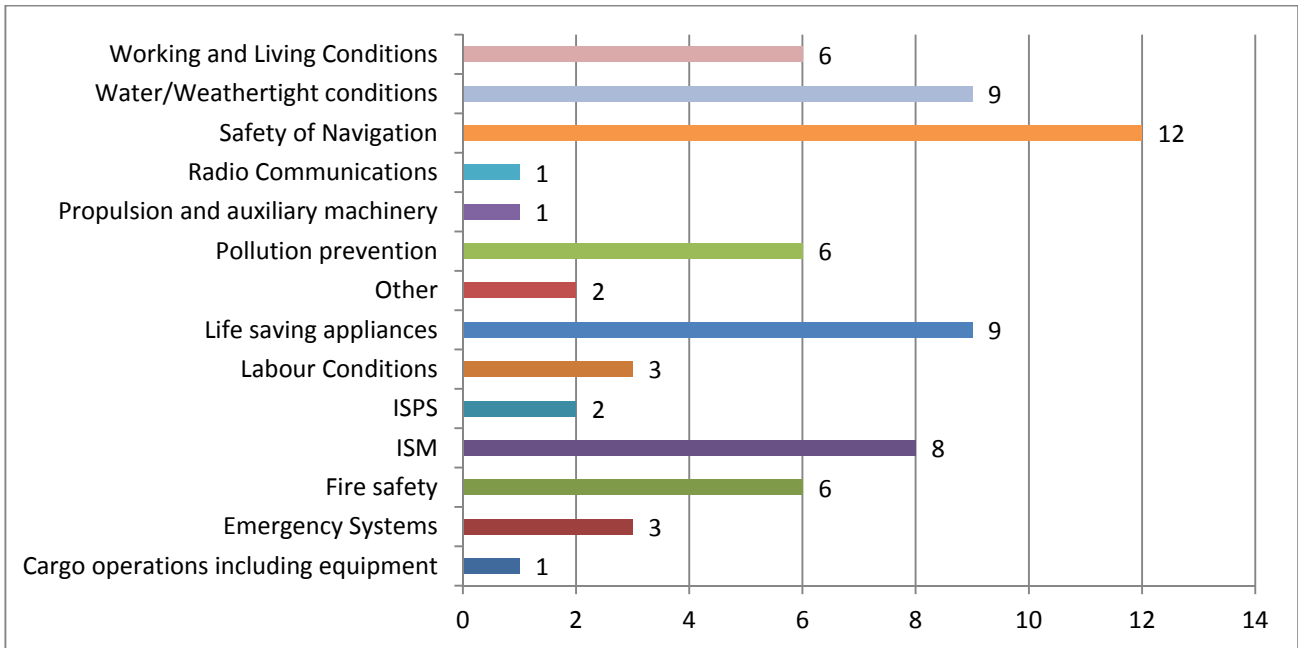
Totally 69 deficiencies were found in the 9 CCS classed ships which had received detention reports and were under inspection. The average of deficiencies of detained ships was 7.67, which was smaller than that of last quarter (8.75).

The number of deficiencies in safety of navigation, water/weather-tight conditions, lifesaving appliances, ISM and fire safety was comparatively larger. Thus, much attention shall be paid to inspection on these items to reduce deficiencies of ships.

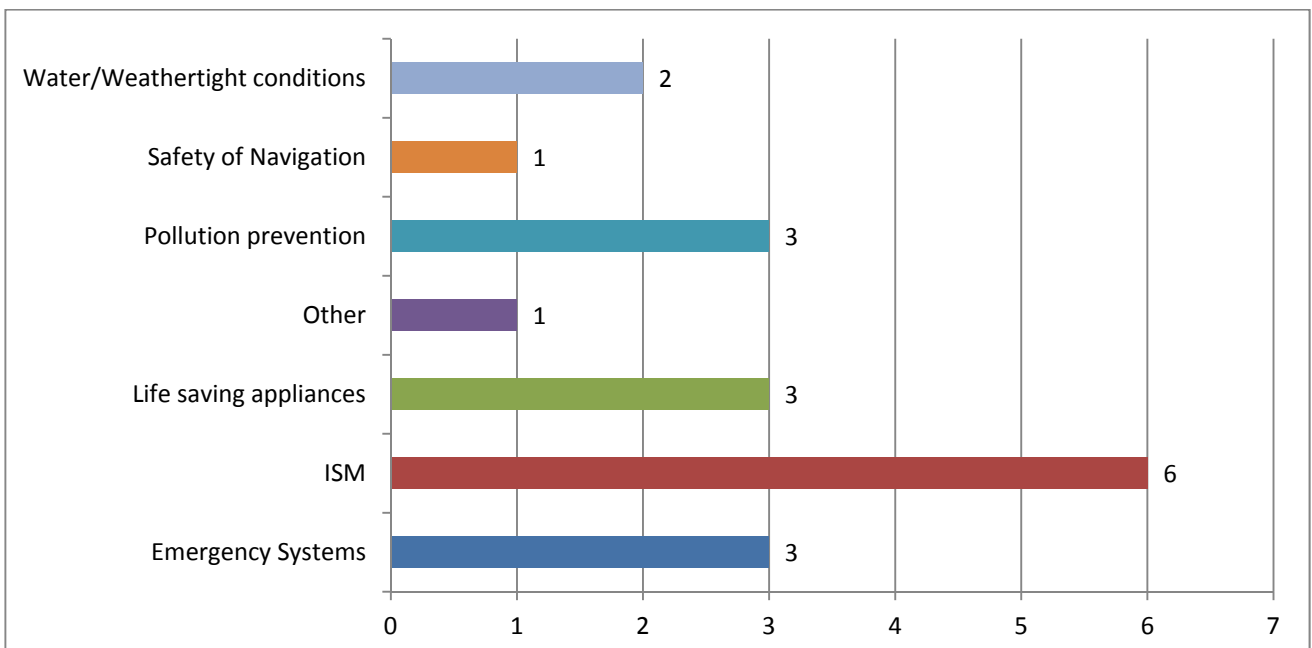
Totally 19 deficiencies were found in the 9 CCS classed ships which had received detention report and were under inspection. The average of detention-related deficiencies of detained ships was 2.11, which was lower than that of last quarter (2.5).

The number of detention-related deficiencies in ISM, emergency system, lifesaving appliances and pollution prevention was comparatively larger. Close attention shall be paid to the implementation of drills and other ISM requirements, crew's familiarity with their duties, maintenance of equipment and operation of emergency device to meet relevant requirements and reduce deficiencies and detentions.
