The First Safety Meeting of Ship Management Company,  
2018

# PSC Session

CCS Headquarters  
January 2018

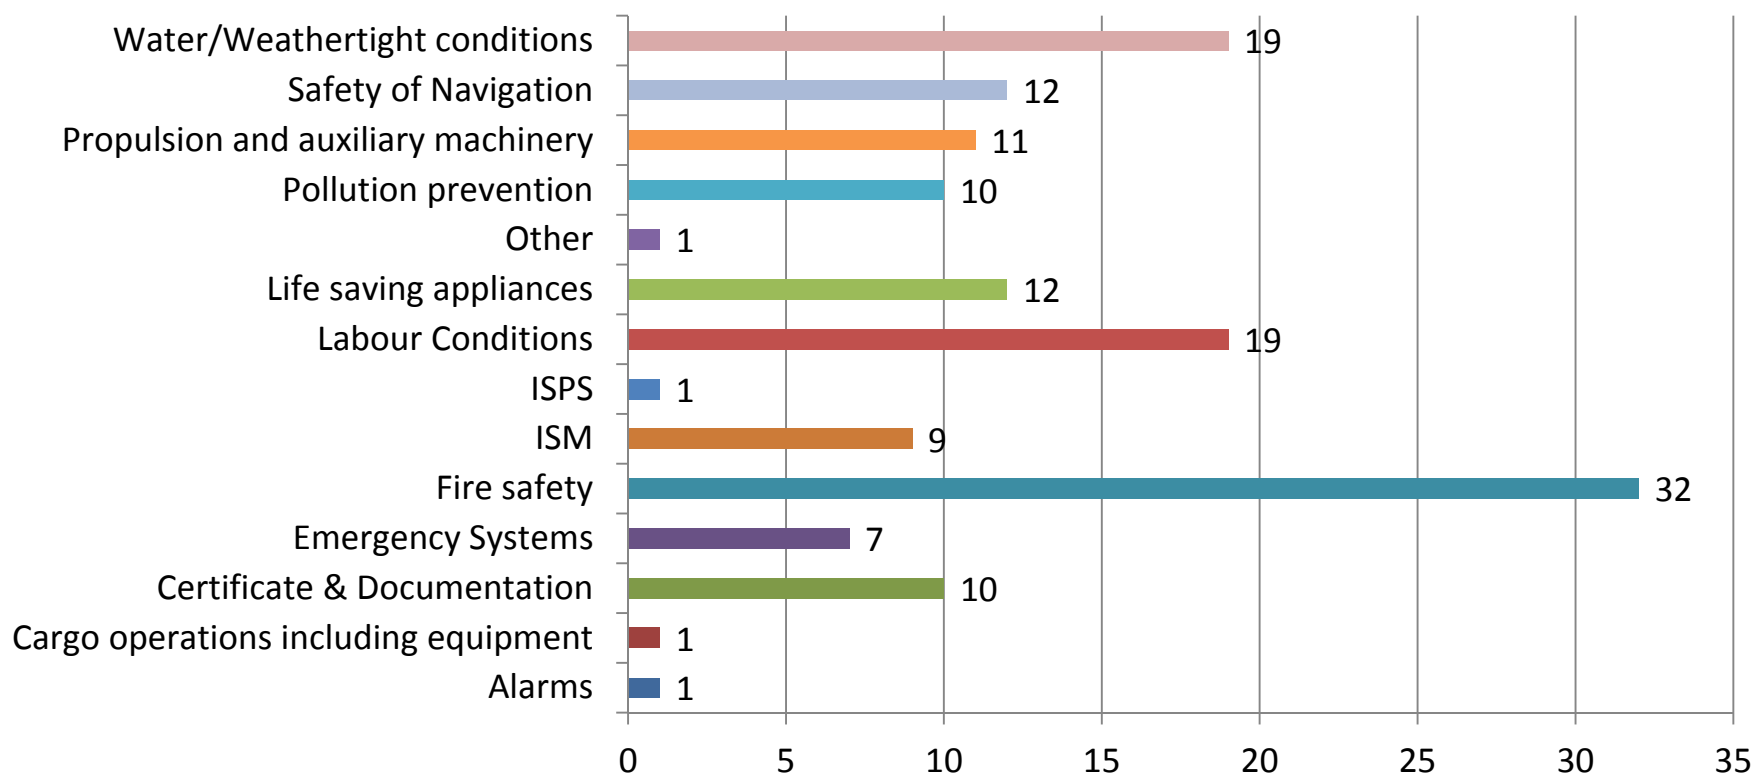
## 2. Statistics of all deficiencies

For the 15 CCS-classed ships that received detention report and carried out investigation, 145 deficiencies were detected, with the average of 9.67 deficiencies per ship, which witnessed a rising tendency compared to the average of 8.83 deficiencies per ship in 2016.

**More deficiencies were revealed related to fire safety, weather tight, working condition, navigation safety, and life-saving equipment, etc.**

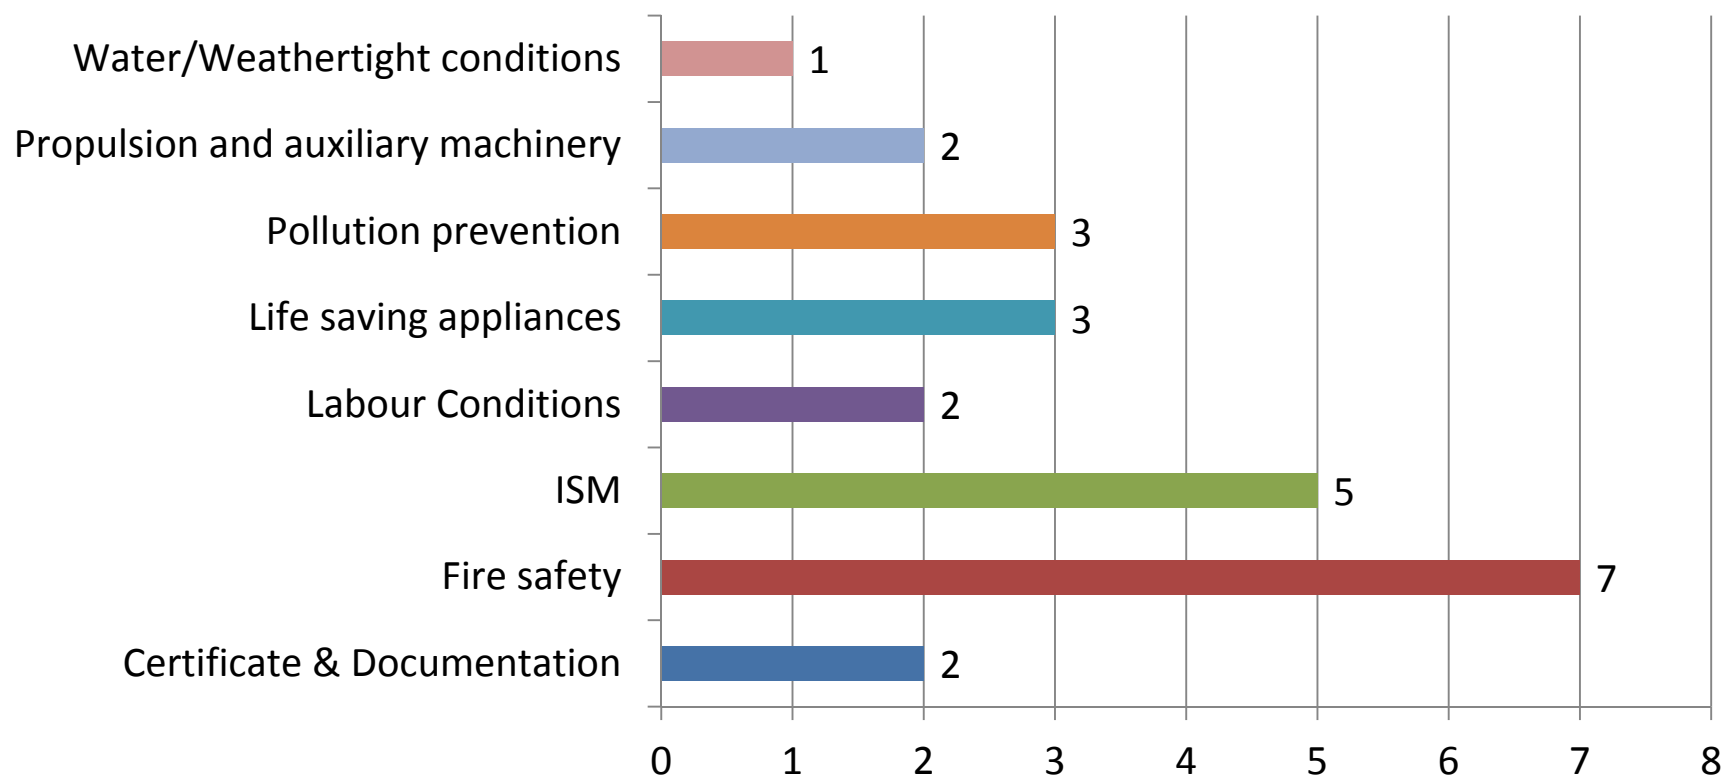
## 3. Statistics of detention deficiencies

For the 15 CCS-classed ships that received detention report and carried out investigation, 25 detention deficiencies were detected, with the average of 1.67 deficiencies per detained ship, which witnessed a decline compared to the average of 2.61 deficiencies per detained ship in 2016.

Detention deficiencies were mostly regarding fire safety, ISM, life-saving equipment, and pollution prevention, etc.

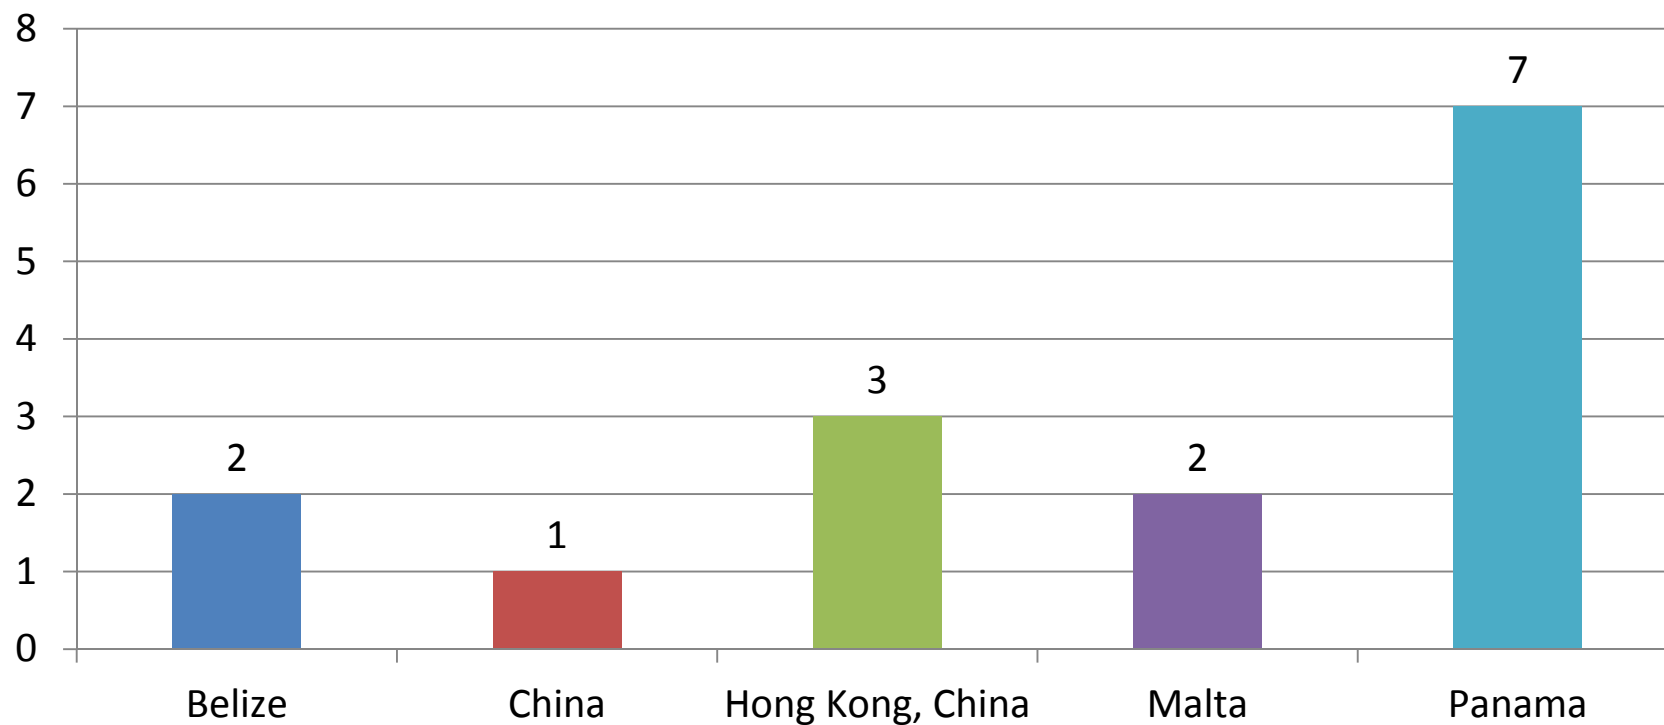
## 4. Distribution of detained ships by flags

**Detained ships include more Panama and Hong Kong ships; among CCS ships, Malta and Belize ships bore a higher detention rate.**

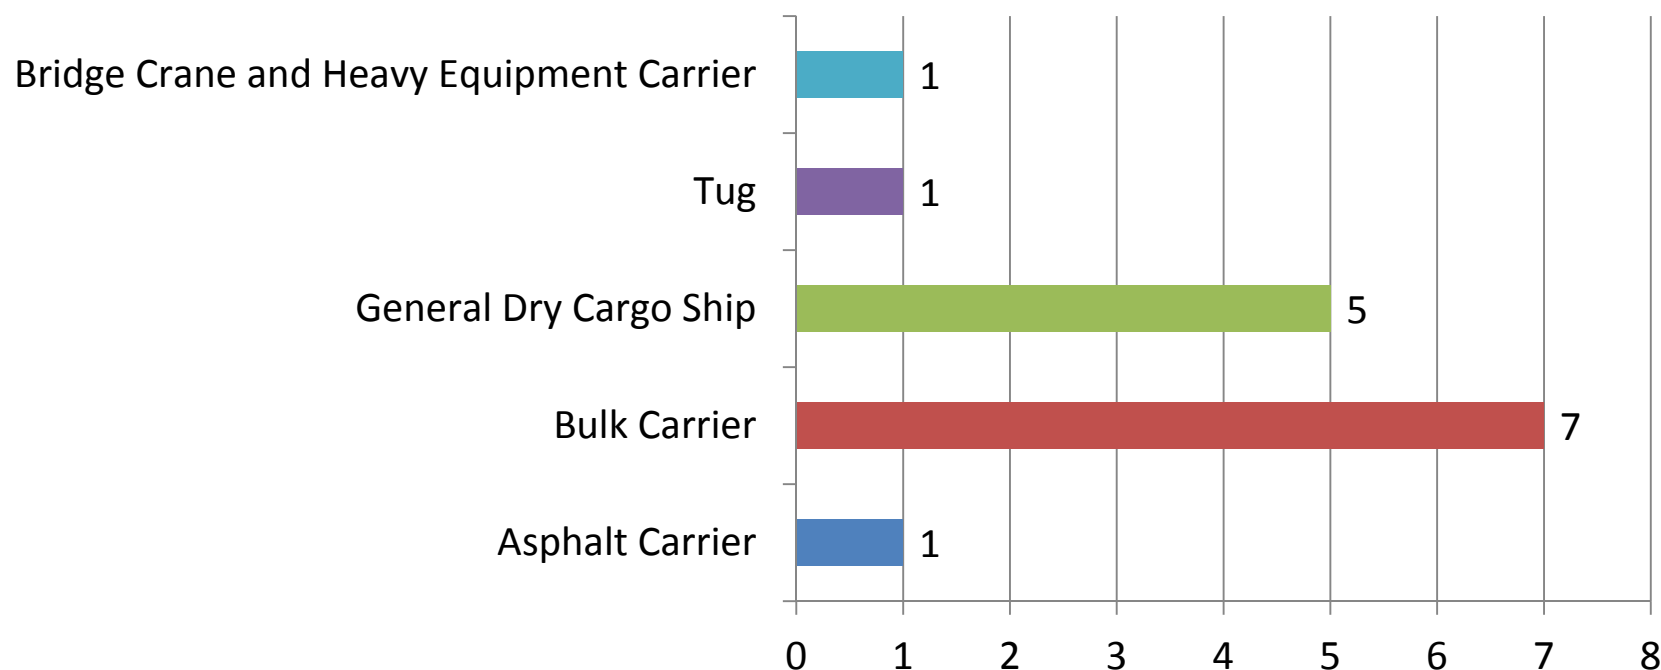
## 5. Distribution of detained ships by ship's types

There are more bulk carriers and general dry cargo ships among detained ships, occupied 47% and 33% of all detained ships respectively, and 80% altogether.

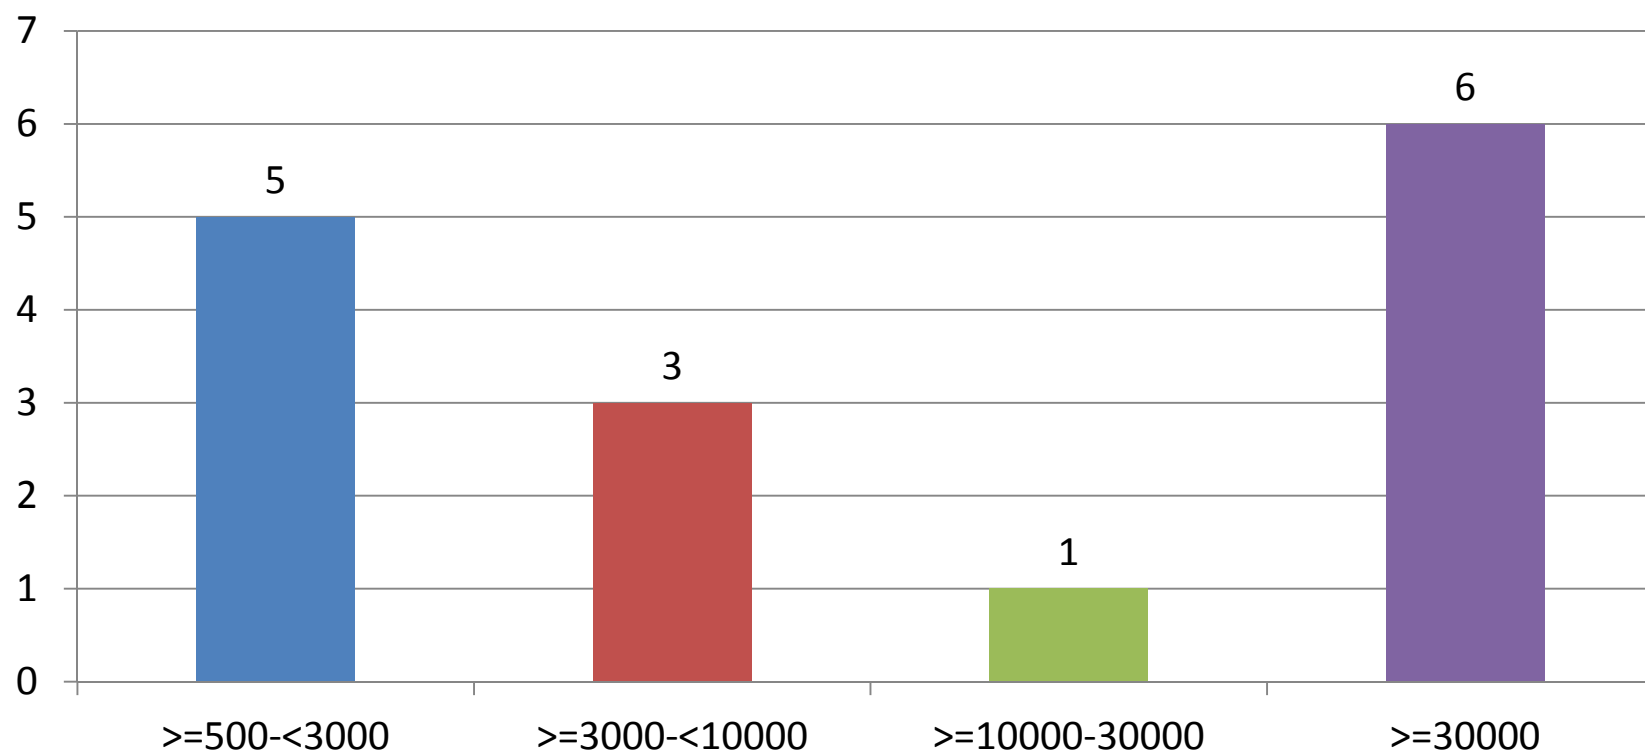
## 6. Statistics of detained ships by gross tonnage

Ships of less than 10,000 GT faced with more detentions, which occupied 53.33% of all detentions and were mainly small- and medium-sized general dry bulk carriers and tugs.

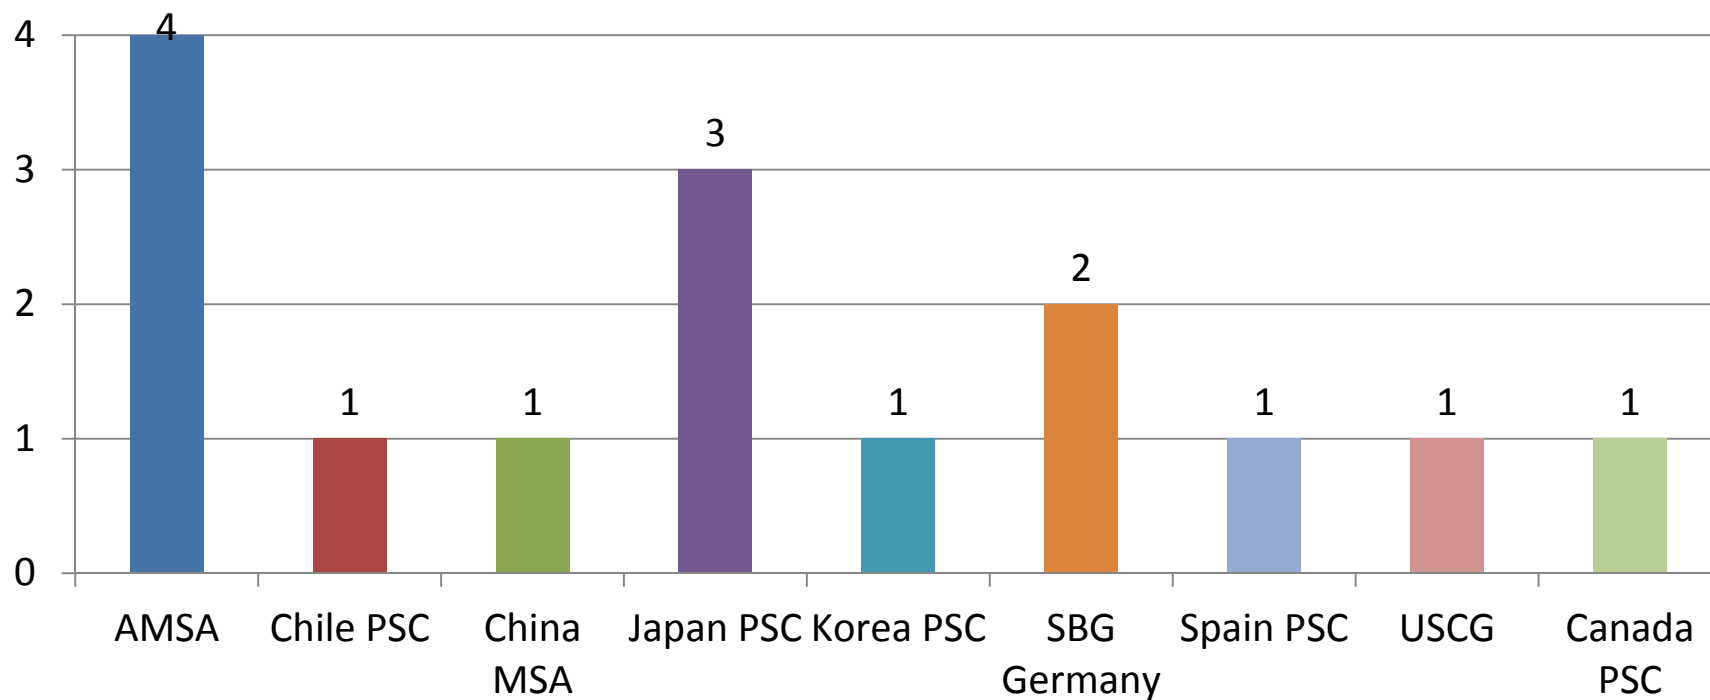
## 7. Distribution of detentions by country/region

More detentions occurred in Australia, Japan, and Germany, which occupied 60% of total detentions of CCS ships.

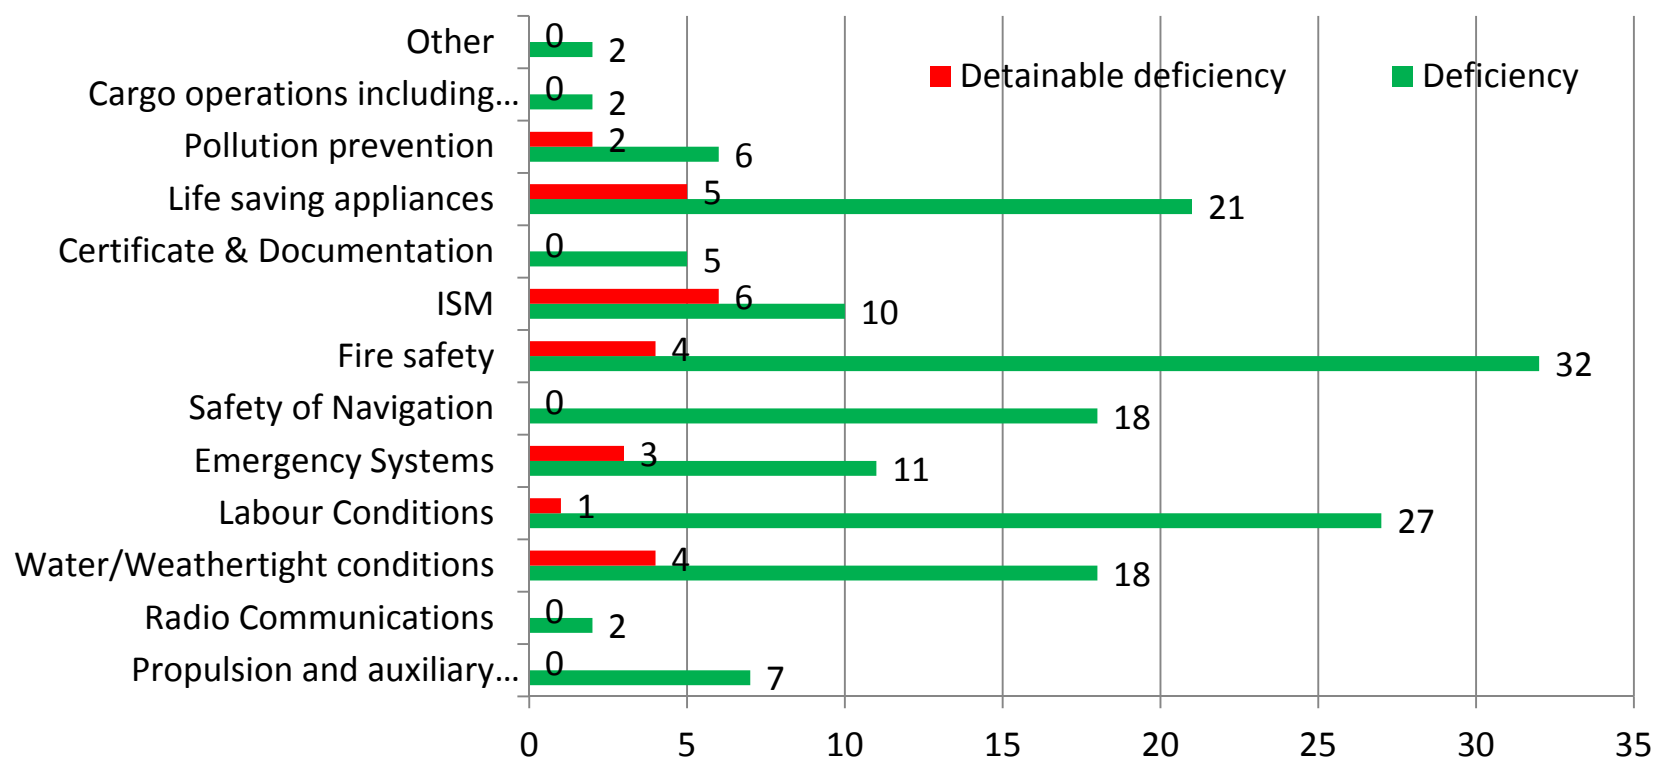
#### Key points of AMSA and PSC inspections

AMSA is famous of being strict. In recent 3 years, AMSA detected deficiencies mainly covered fire safety, labor condition, life-saving equipment, navigation safety, and wind/water tight, etc.; deficiencies for detention are mainly ISM, life-saving equipment, wind/water tight, fire safety, and emergency system, etc; ISM detention deficiencies are mainly due to poor ship's operation, drills and training, MLC deficiencies, repair and maintenance, etc.

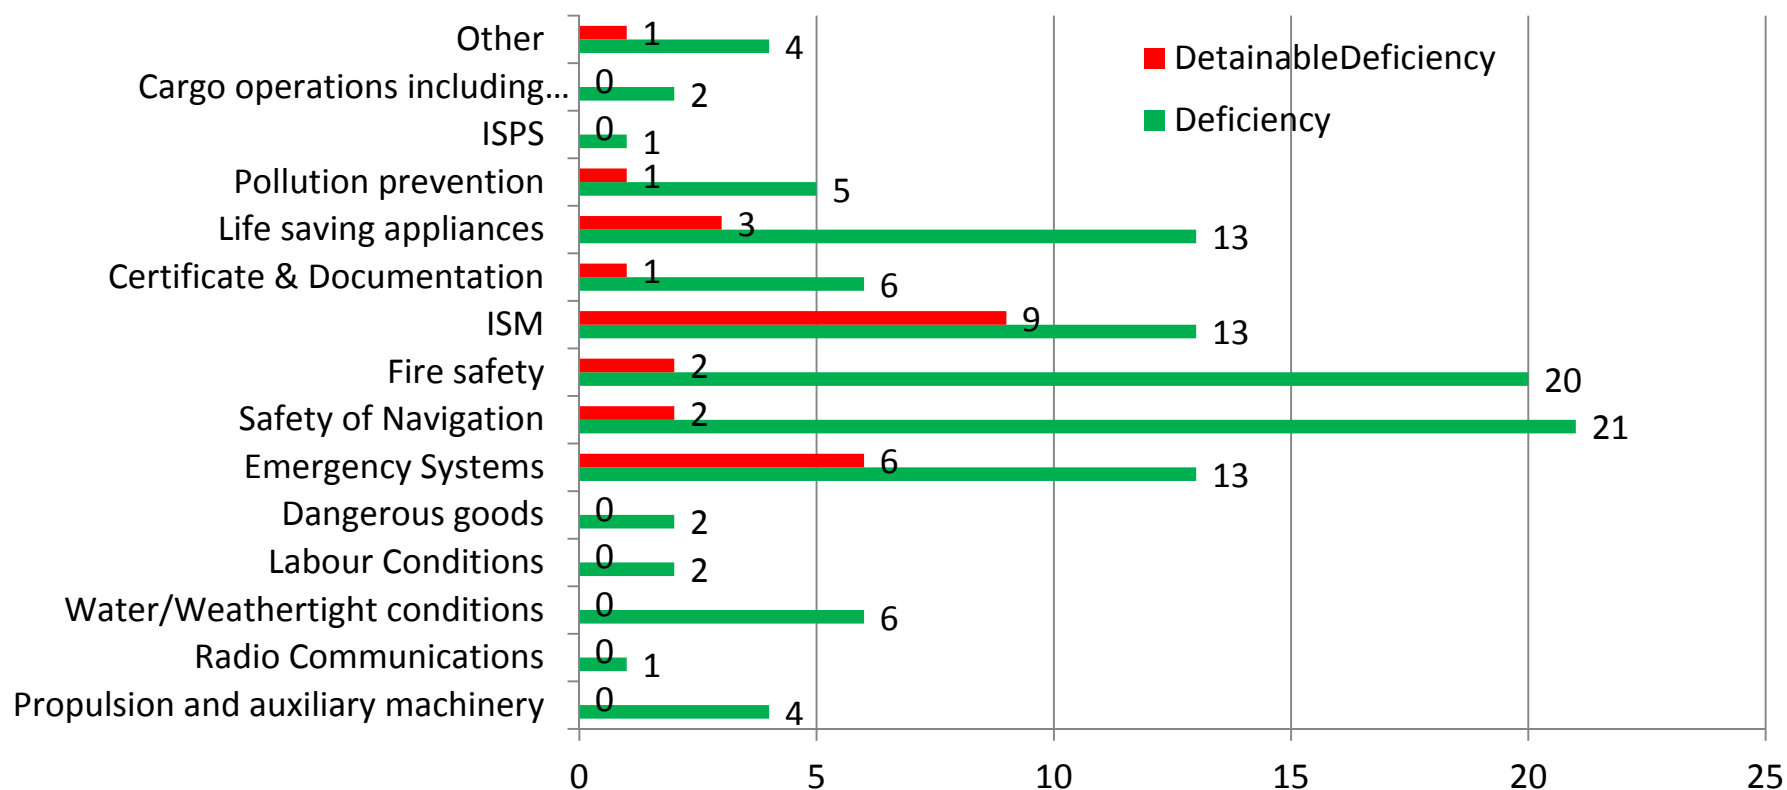
#### Key points of PSC inspections in Japan:

During recent 3 years, PSC detected deficiencies in Japan mainly covers navigation safety, fire safety, life-saving equipment, emergency system and ISM, etc.; detention deficiencies mainly include ISM, emergency system, life-saving equipment, fire safety and navigation safety, etc.; ISM detention deficiencies were mainly due to insufficient drills on fire-control and ship abandonment, senior crews' unfamiliarity with responsibilities during drills, and insufficient information of Japanese ECDIS, etc.

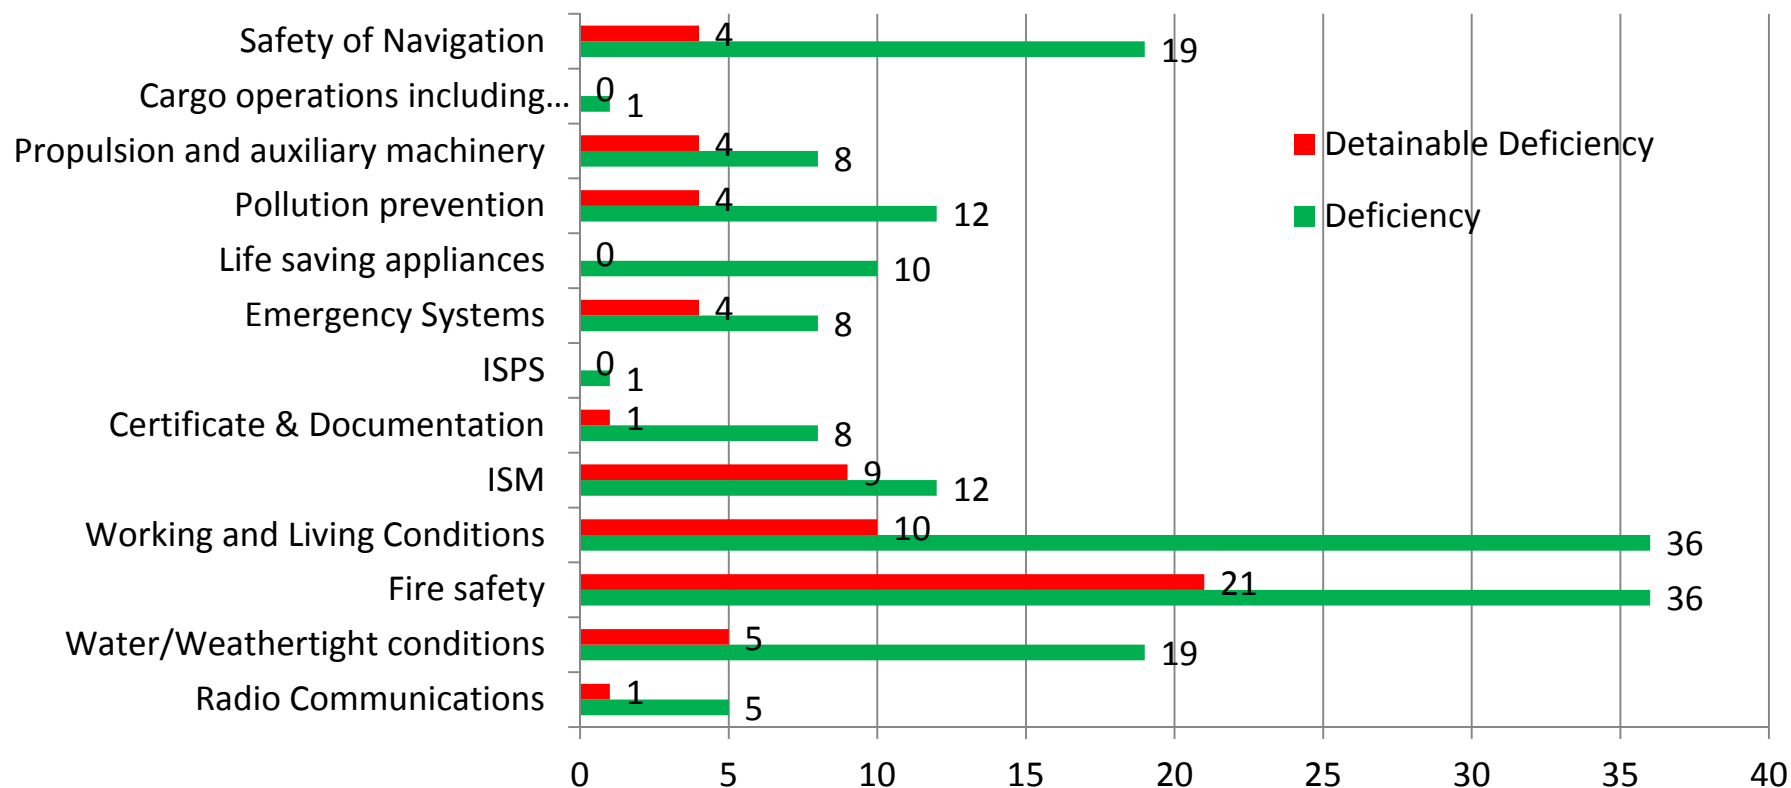
#### Key points of PSC inspections in Europe:

European PSC is also famous of being strict and noted with high rate of detention deficiencies. Once ships are found with deficiencies, detention is very likely to happen. In recent 3 years, AMSA detected deficiencies mainly are fire safety, working/living condition, navigation safety, life-saving equipment, wind/water tight, ISM, and pollution prevention, etc.; detention deficiencies mainly are fire safety, working/living condition, ISM, and wind/water tight, etc.; IMS detention deficiencies are mainly due to insufficient of ship's maintenance and drills; most of the detention deficiencies regarding working/living condition are due to ineffective MLC implementation, poor living facilities, insufficient food supply and no guarantee of crew's safety.
