MARINE SAFETY ADVISORY No. 03-17

Subject: SAFETY MANAGEMENT SYSTEM IMPLEMENTATION

Safety Alert 01-17

The Best Laid Plans for Safety Are Only as Good as Their Implementation!

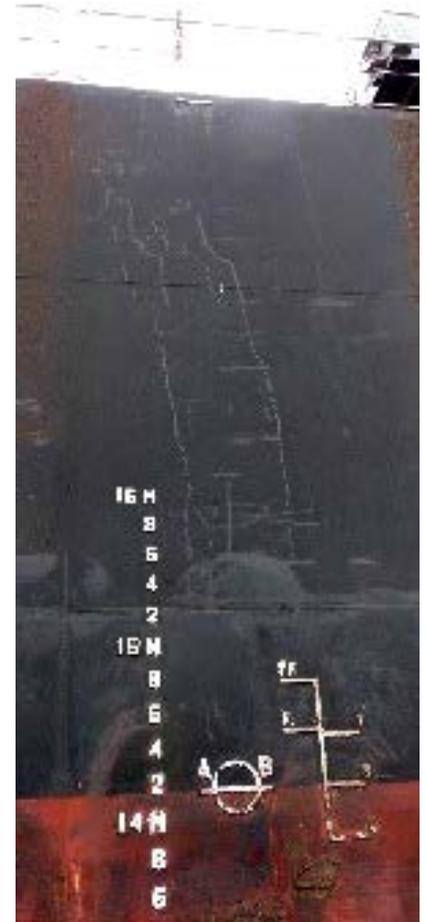
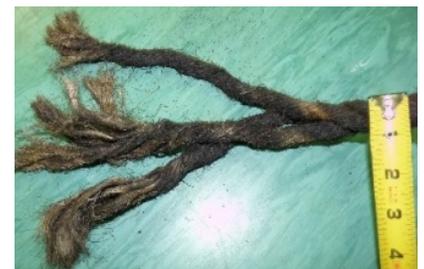
Recently, while a bulk carrier was at anchor off the coast of Texas, a crewmember that could not swim was put over the rail in a Bosun's Chair to paint the vessel's mid-ship draft marks and load lines. Unfortunately, when his shipmates on deck commenced to haul him up, the Bosun's Chair line parted and he fell into the water. He survived the fall and attempted to swim towards a life ring that had been thrown to him, but he ultimately submerged and was lost. Other crewmembers attempted to launch a rescue craft, but it failed to operate.

Putting a crewmember over the rail to paint while a vessel is at anchor is a typical shipboard operation, and this instance is a classic example of where following SMS procedures could have prevented a death or injury. Investigators found that the Captain and Chief Mate had met and developed a suitable work plan. This information was later communicated from the Chief Mate to the crewmembers involved. The plan had several important elements, including inspecting the Bosun's Chair and manila rope rigging and requiring that the crewmember going over the rail wear a personal flotation device (PFD) and use a safety harness and lifeline; however, the plan was not implemented. Crewmembers failed to adequately check the strength of the Bosun's Chair line, instead simply pulling on it. Also, the deceased crewmember was not wearing a PFD, and, even though he wore a safety harness along with a lifeline, the lifeline went untended and was not tied off to the vessel. The vessel's Bosun was not present, and it remains unknown as to who was supervising the operation. Finally, months before this tragedy, the Chief Mate had placed a requisition request for new manila line and for PFD work vests that were designed to be worn with the vessel's safety harness; however, the request went unfilled.

- Properly use safety equipment.
- Ensure adequate supervision of work teams.
- Develop workplace mindsets that properly develop and execute plans, including those for worst case scenarios.
- Implement barriers to prevent such scenarios.
- Fully implement and adhere to Safety Management System requirements.
